CRACK MONITORING

for Subsidence Management Services

8 Brookfield Park, London, NW5 1ER

Client:	Subsidence Management Services
Client Contact:	Cyril Nazareth
Claim Number:	102024304
Client Reference:	IFS-LBG-SUB-17-0073223
Policy Holder:	Mrs Inger Freeman
Report Date:	25 April 2018
Our Ref:	M10694

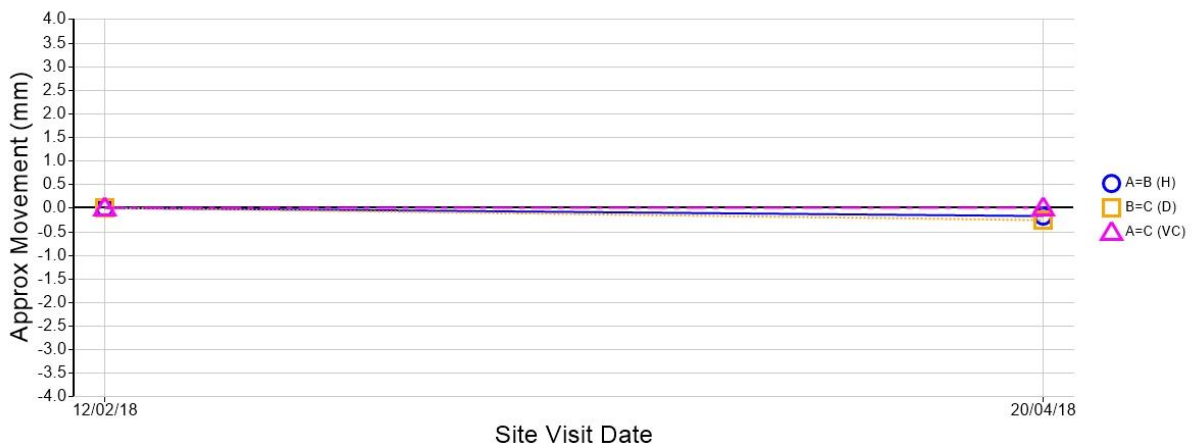
C1 - INT - Kitchen, above side window

The following graphs display the progressive movement that each Crack Monitoring Station recorded at each separate site visit date to give an overall look at how much the property is moving.
