Design and Access Statement:

Alterations to 5 Great James Street, London WC1N 3DB to improve Fire Separation.

Document Ref: 177A-D01-DAS-180501- Design and Access Statement
May 2018

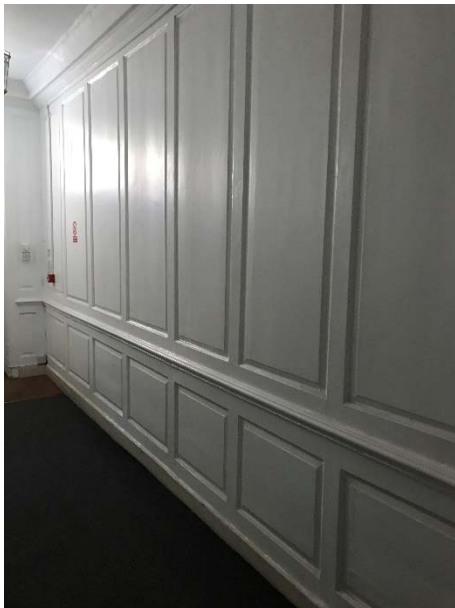
Fig 4 Ground Floor common hallway RM.0.1 timber panel wall

The existing timber panel wall separating the ground floor office from the common hallway and staircase RM.0.1 is structurally unstable and does not provide sufficient fire separation. On investigation of the panel wall, it has been found to contain asbestos panelling which has been poorly installed and has likely contributed to the structural instability of the existing wall.

It is proposed that the timber panelling is carefully removed from inside the office unit, labelled and stored. There is an existing layer of asbestos panels which can be appropriately removed and disposed of according to HSE guidelines. The studs of the wall will be stabilised and replaced as necessary to secure the wall. The studs will be fully filled with fire batts and a layer of 15mm fireline plasterboards installed. Finally, the timber panels will be reinstalled in place.

The proposed works will not disturb the cornice, and any damage will be appropriately repaired. The proposed construction may necessitate the wall thickness increasing to accommodate the necessary additional fire resistance materials. If this happens, the timber panels will be carefully scribed into the cornice above, losing a portion of the cornice details (anticipated approximately 15-20mm) and the junction sealed with intumescent silicone.

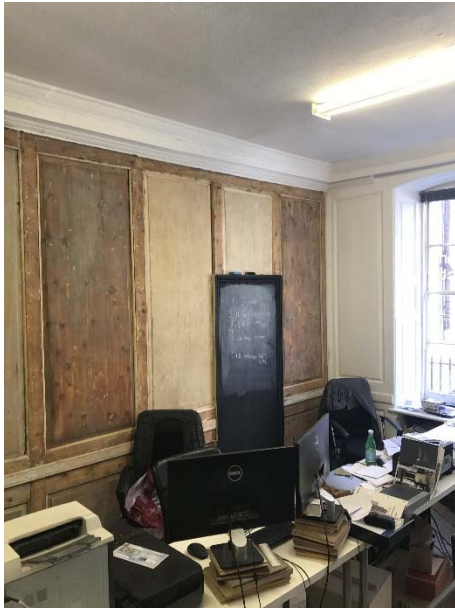
Fig 5 Ground Floor timber panel wall as seen from office RM.0.2

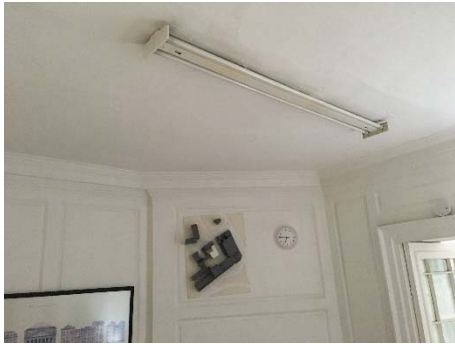
Fig 6 Ground floor ceiling with cornice seen in RM.0.3. Lath & Plaster.

Lath & Plaster

The existing lath and plaster will be repaired and stabilised while maintaining the existing cornice. Where the plaster is cracked but otherwise sound, the loose plaster will be scraped out and repaired with Plaster of Paris with canvas reinforcement as per the plaster specialist recommendation. Where larger patches of plaster are unstable and loose, the loose plaster will be removed back to sound plaster, any damaged laths replaced and the patch repaired with a traditional three coat lime plaster to match the existing.

Once the ceiling has been stabilised, the ceiling and cornices will be coated with Intumescent paint to provide 60 minutes fire resistance.

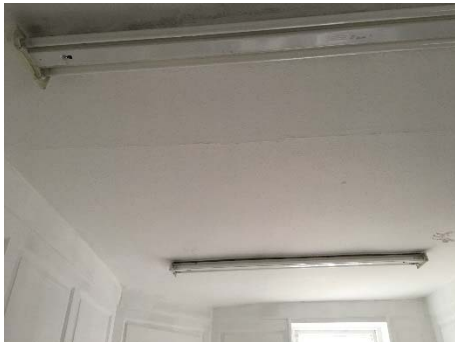
Fig 7 Ground floor ceiling without cornice seen in RM.0.4, plasterboard over lath & plaster

In most rooms with existing plasterboard ceilings, an additional layer of plasterboard will be fixed to the existing to increase the ceiling to 60 minutes fire resistance. This will not affect or conceal any existing visible historic features.

In rooms RM.B.6 and RM.O.4 the existing ceilings will need to be removed to give access to the joists and allow structural stabilisation work as per the structural engineer's specification. The existing lath & plaster ceiling above the plasterboard ceiling will be damaged in the resultant works and will likely be partially or wholly removed to give access. In these rooms it is proposed that a new lath & plaster ceiling is installed with a three coat lime plaster system. Before the new ceiling is installed, fire batt insulation will

be installed between the joists and secured in place with wire mesh to provide 60 minutes fire separation.

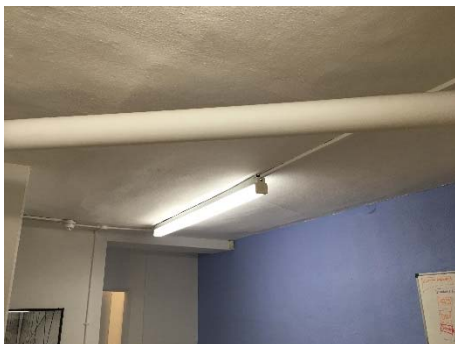
Fig 8 Basement floor ceiling without cornice seen in RM.B.5, plasterboard (unconfirmed lath & plaster above)

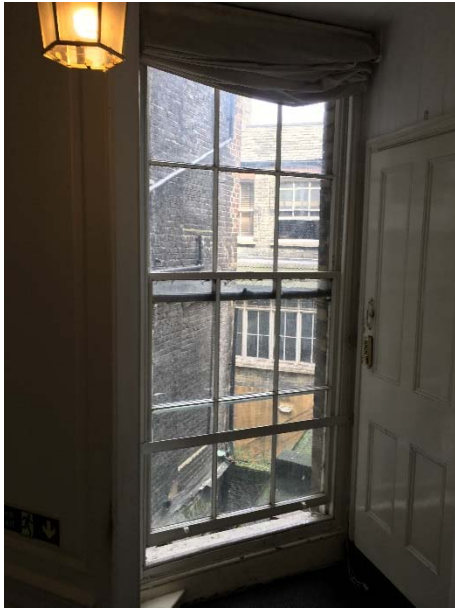
Fig 9 First floor window W.1.8

Window W.1.8 on the landing between the ground and first floors is a timber sash window and has a very low cill level of approximately 25cm from floor level. It is proposed to create an effective fall protection barrier in front of the window.

The glass panels in the lower sash will be replaced with single pane toughened safety glass.

A new toughened laminated barrier will be installed to a height of 1100mm to the inside of the window. The barrier will be secured to either side of the window reveal walls with a metal channel to provide the necessary fall restraint.

No existing historic features will be damaged to install the fall restraint.

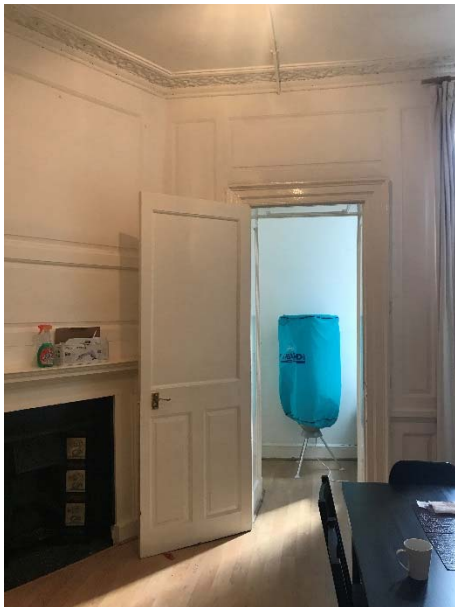
Fig 10 First floor door DR.1.5 and Lath & Plaster ceiling with cornice

The internal doors to the ground and first floor flat are non original and need to be replaced with 30 minute resistant doors in a style to match the existing.

The doors will be made as 4 panel solid timber doors as per the architects details. The accompanying door schedule gives additional details on the proposed finishes.

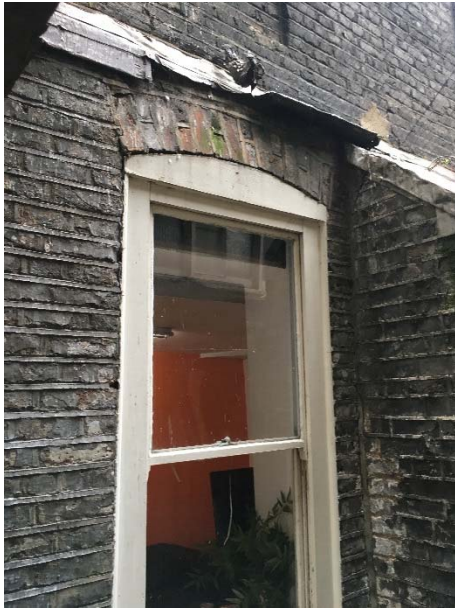
Fig 11 Rear basement light well window W.B.5 showing deformed lintel

The external rear lightwell wall has become unbonded and needs to be made structurally sound. The existing wall is constructed of two layers of 9 inch bricks and the outer layer has become unbonded from the inside layer and is leaning out, providing little structural support. It is proposed that the outer layer is carefully fully demolished and re-built using the reclaimed bricks. This will stabilise the structure and will maintain the existing appearance of the wall.

The head of the double skin wall will need new lead flashing installing to prevent the damage from occurring again. Additionally, the existing timber bracing will be removed and replaced with a new galvanised steel brace.

The existing windows lintels have become unstable with the movement of the wall and need to be replaced. The windows will be carefully removed and stored ready to be reinstalled, the lintels replaced with a pre-cast concrete lintel to match the arch of the existing window, and use pistol slip bricks made from the reclaimed bricks.

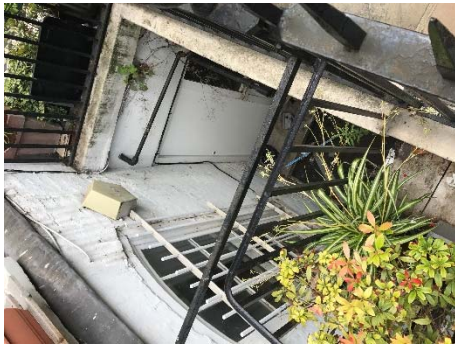
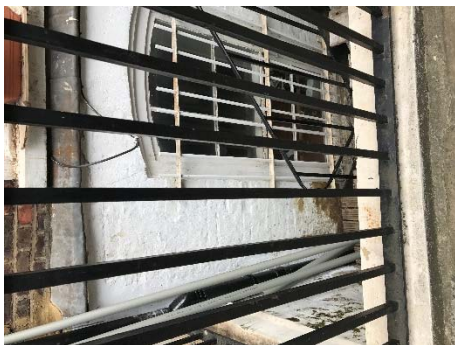
Fig 12 Partial view of front Lighwell and timber treads

Fig 13 Partial view of front Lighwell and timber treads

The front lightwell has an existing metal fire escape staircase with timber treads. The treads have become rotten and are unsafe as a means of escape. The timber treads will be replaced with new to match the existing.
