Window steps detail @ 1:5

Section /Elevation F window step detail @ 1:25

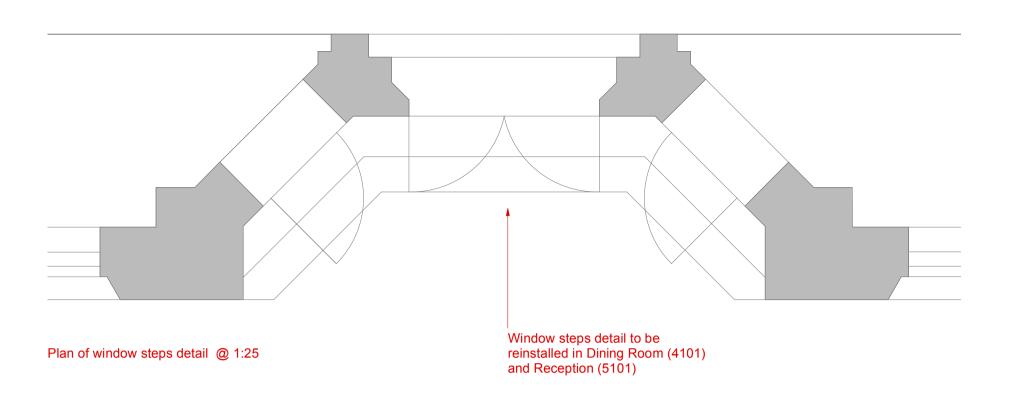
Existing photo timber staircase to be reinstalled to match historic in both Dining Room (4101) and Reception (5101)

Historic window steps in Dining Room (4101)

Historic window steps Reception (5101)
