72 Maresfield Gardens, NW3

Basement Impact Assessment for Planning

January 2018

Rev A

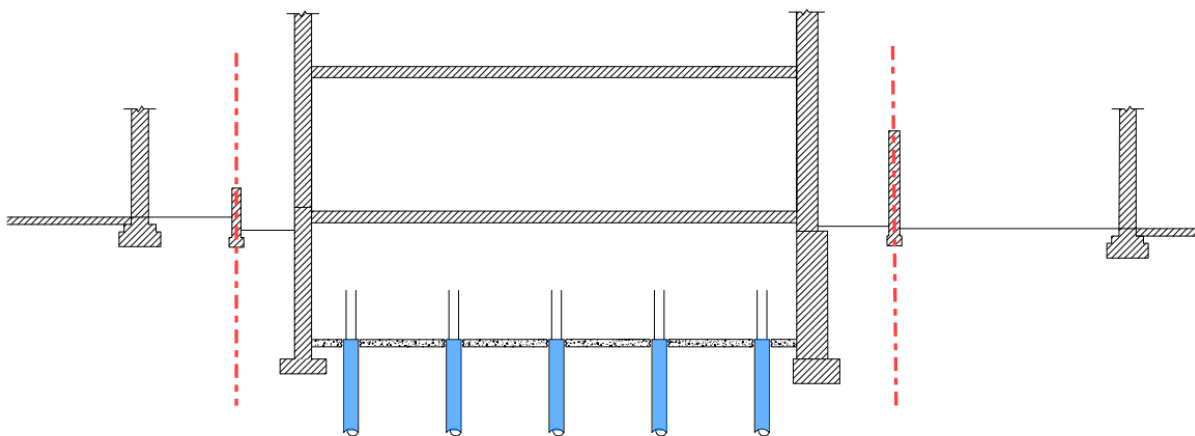
1. Clear site. Locally break existing basement slab to allow for piling installation. A suitable piling rig, such as a sectional flight auger (SFA) rig, can be positioned in the basement via the existing garage door from the main site entrance.
2. Install tension piles with extended-length reinforcement.

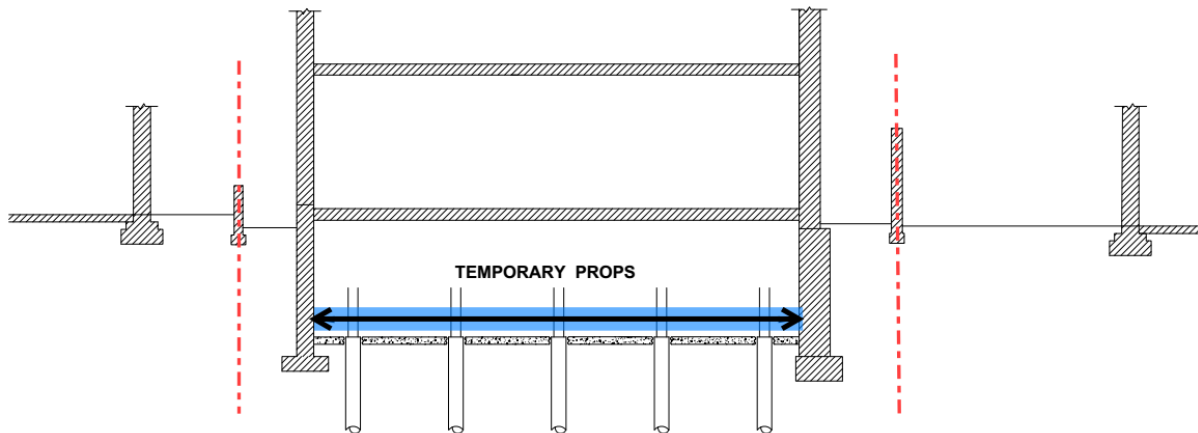
3. Install temporary lateral props to the base of all retaining walls above the existing basement slab level.

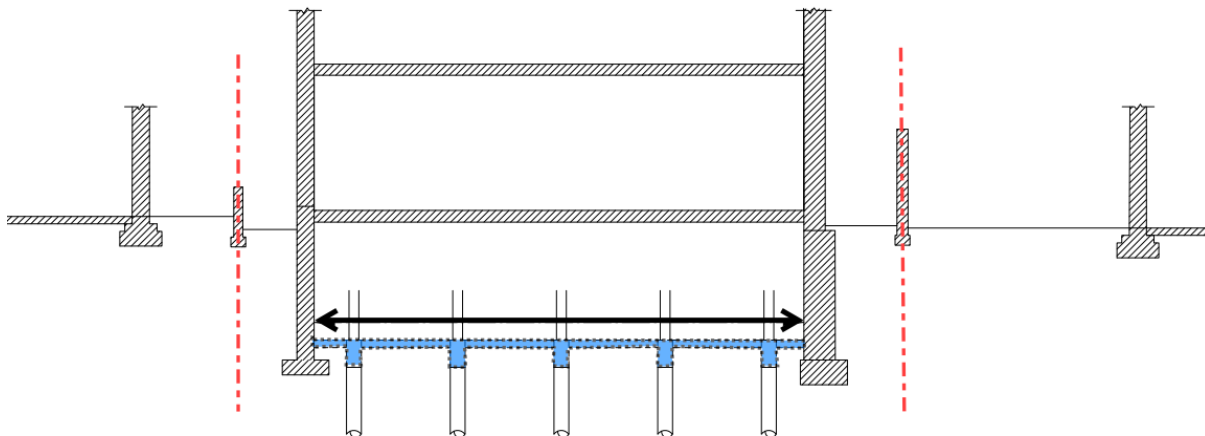
4. Once the temporary props are in place, carefully remove the existing basement slab. Locally excavate ground around the installed piles and carefully break down the top of piles to the required cut-off level using hand-held pneumatic breakers, leaving top of reinforcement to form an anchorage into the new slab.

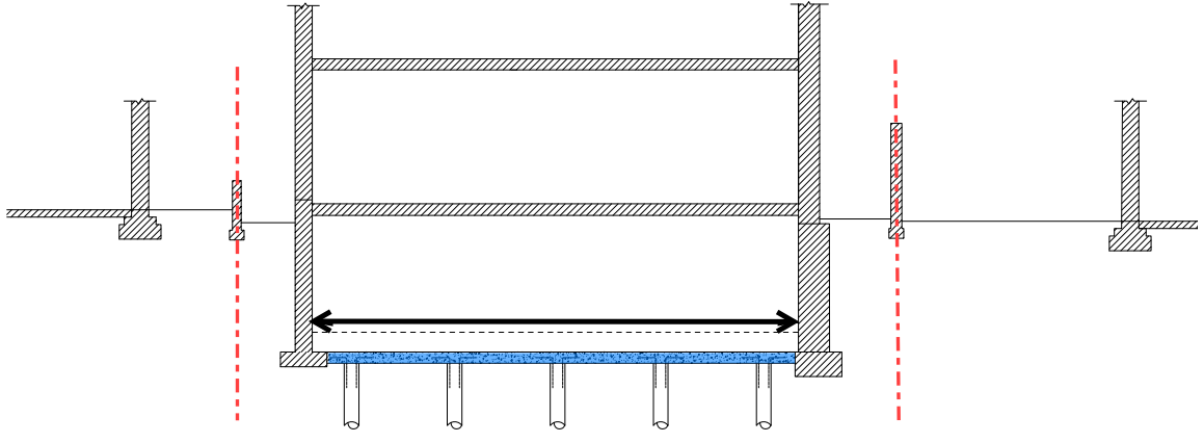
5. Excavate the soil to the required level (approximately 650mm below the existing slab level). Install resin anchored dowelled bars in the existing basement wall/foundation at regular spacing to tie the wall and the new RC slab, with hydrophilic strip.
6. Level the ground and cast a layer of blinding across the basement footprint. Install waterproofing membrane and slab reinforcement bending the pile reinforcement to lap.

7. Cast new concrete slab. Once the concrete is cured, the temporary lateral props can be removed.

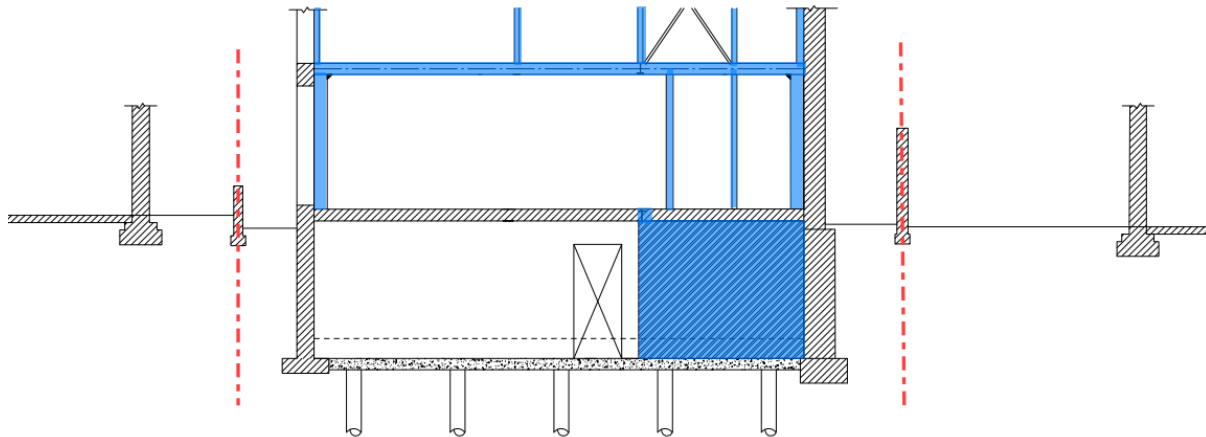
8. Install temporary supports to the existing walls above which are to be removed using needling or stooling techniques, as appropriate. Provide adequate spreaders at bases of all the temporary supports to ensure loads are distributed on the new basement slab and/or piles. Remove sections of existing masonry walls as required.
9. Construct new load bearing masonry walls at basement level, dry-packing between the underside of existing structures and the top of the new walls.
10. Install new steel columns and beams from bottom up with dry-pack between all existing and new structural elements.
11. Once new superstructure is completed, temporary supports can then be removed.
