METHOD STATEMENT

British Museum Perimeter Properties Refurbishment

P2007246
DRAWING TITLE
1A Montague Street First Floor Level 1AMS/3/005 Internal Elevations 5 - 6
First Floor Level 1AMS/3/005
Internal Elevations 5 - 6

d Radiator routes - Pictures

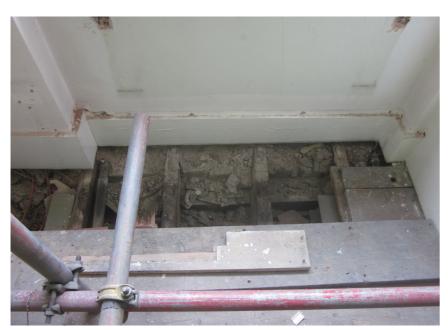
Picture 1 - Ground floor. Existing radiator pipes.

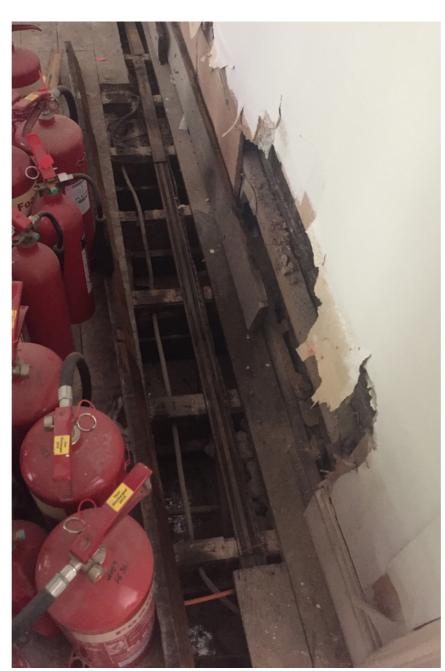
Picture 2 - Ground floor. Existing notching.

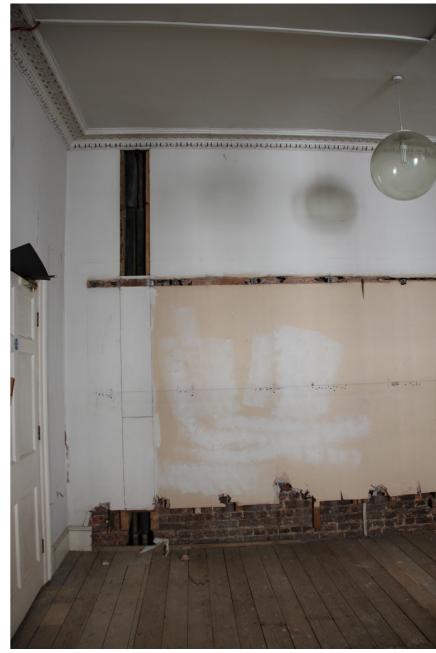
Picture 3 - Ground floor. Vertical pipes into wall void.

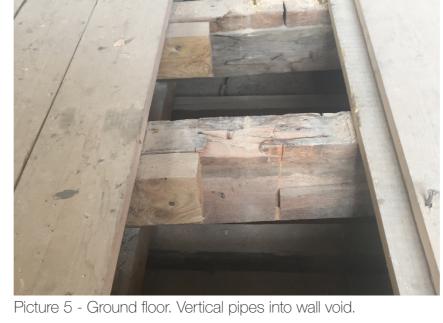
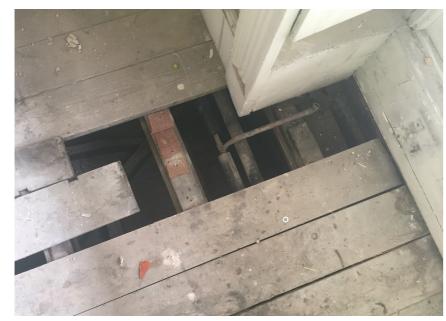
Picture 4 - First floor. Existing radiator pipes and notches.

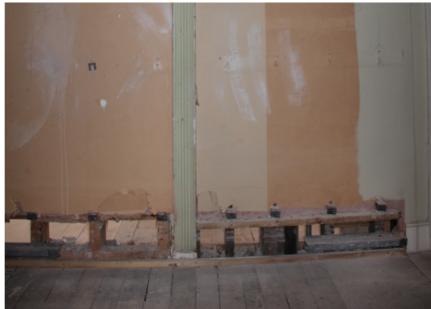
Picture 6 - Ground floor. Vertical pipes into wall void.

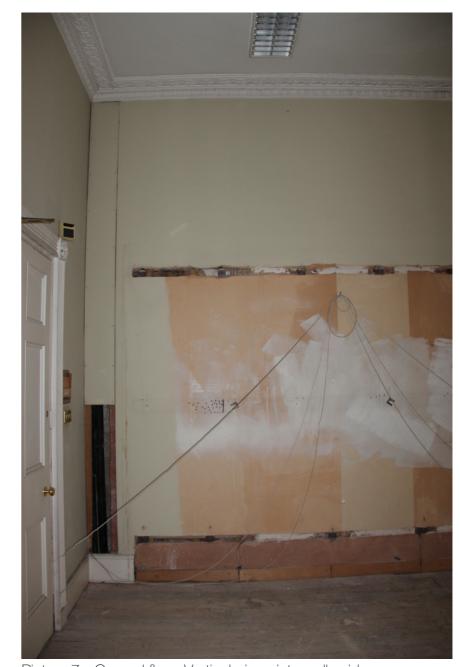
Picture 7 - Ground floor. Vertical pipes into wall void.
