Provider Details		Client Details		Risk Address	
Name:	MHN Ltd	Insurance Co.:		Occupier:	Mr David Blagbrough
Date of Issue:	7/1/13	Client Name:	[REDACTED]	Address:	160 Camden Road
		Contact:	[REDACTED]	Address:	
		Email:	[REDACTED]	Town:	London
		Client Ref:	[REDACTED]	County:	
		Address:	[REDACTED]	Post Code:	NW1 9HJ
		Address:	[REDACTED]	Tel Home:	0207 267 7701
		Town:	[REDACTED]	Tel Work:	[REDACTED]
		County:	[REDACTED]	Mobile:	[REDACTED]
		Post Code:	[REDACTED]	Other:	
		Other Email:	[REDACTED]	Other:

Client: Marishal Thompson

Client Ref: M384

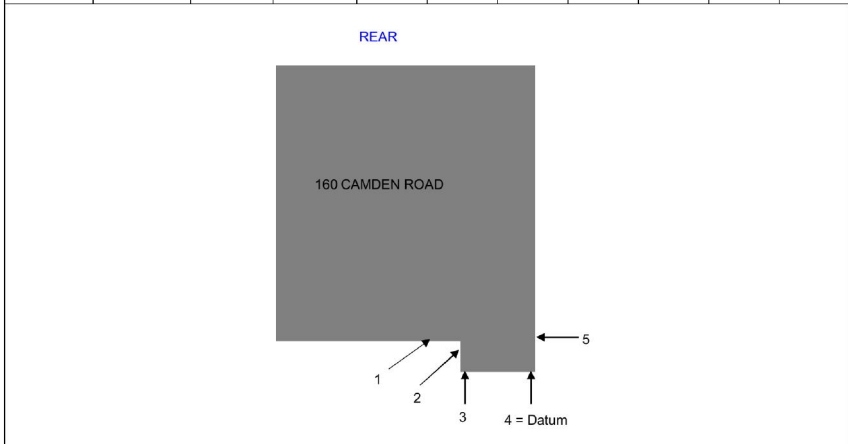
- The Occupier raised no new conce
- Due to the render surface of the pr was not possible to install all statior the same brick course. There fore i readings can not be interpreted as Data
- Readings are relative to level statio requested. It has an assumed valu 10.0000m

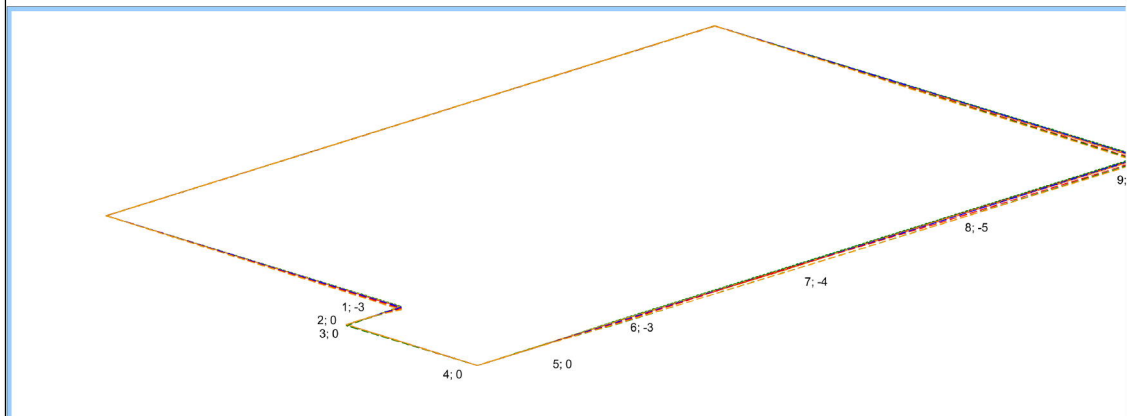
Reading 37 (28/12/16)	Reading 38 (26/1/17)	Reading 39 (28/2/17)	Reading 40 (26/3/17)	Reading 41 (25/4/17)	Reading 42 (25/4/17)
Reading 43 (24/5/17)	Reading 44 (9/7/17)	Reading 45 (7/8/17)	Reading 46 (27/9/17)	Reading 47 (1/11/17)	Reading 48 (28/11/17)

Notes:  
Vertical distorted scale 1: 20

Point labels give level difference of last reading from original datum in mm.
