Stair Section

Stair Plan

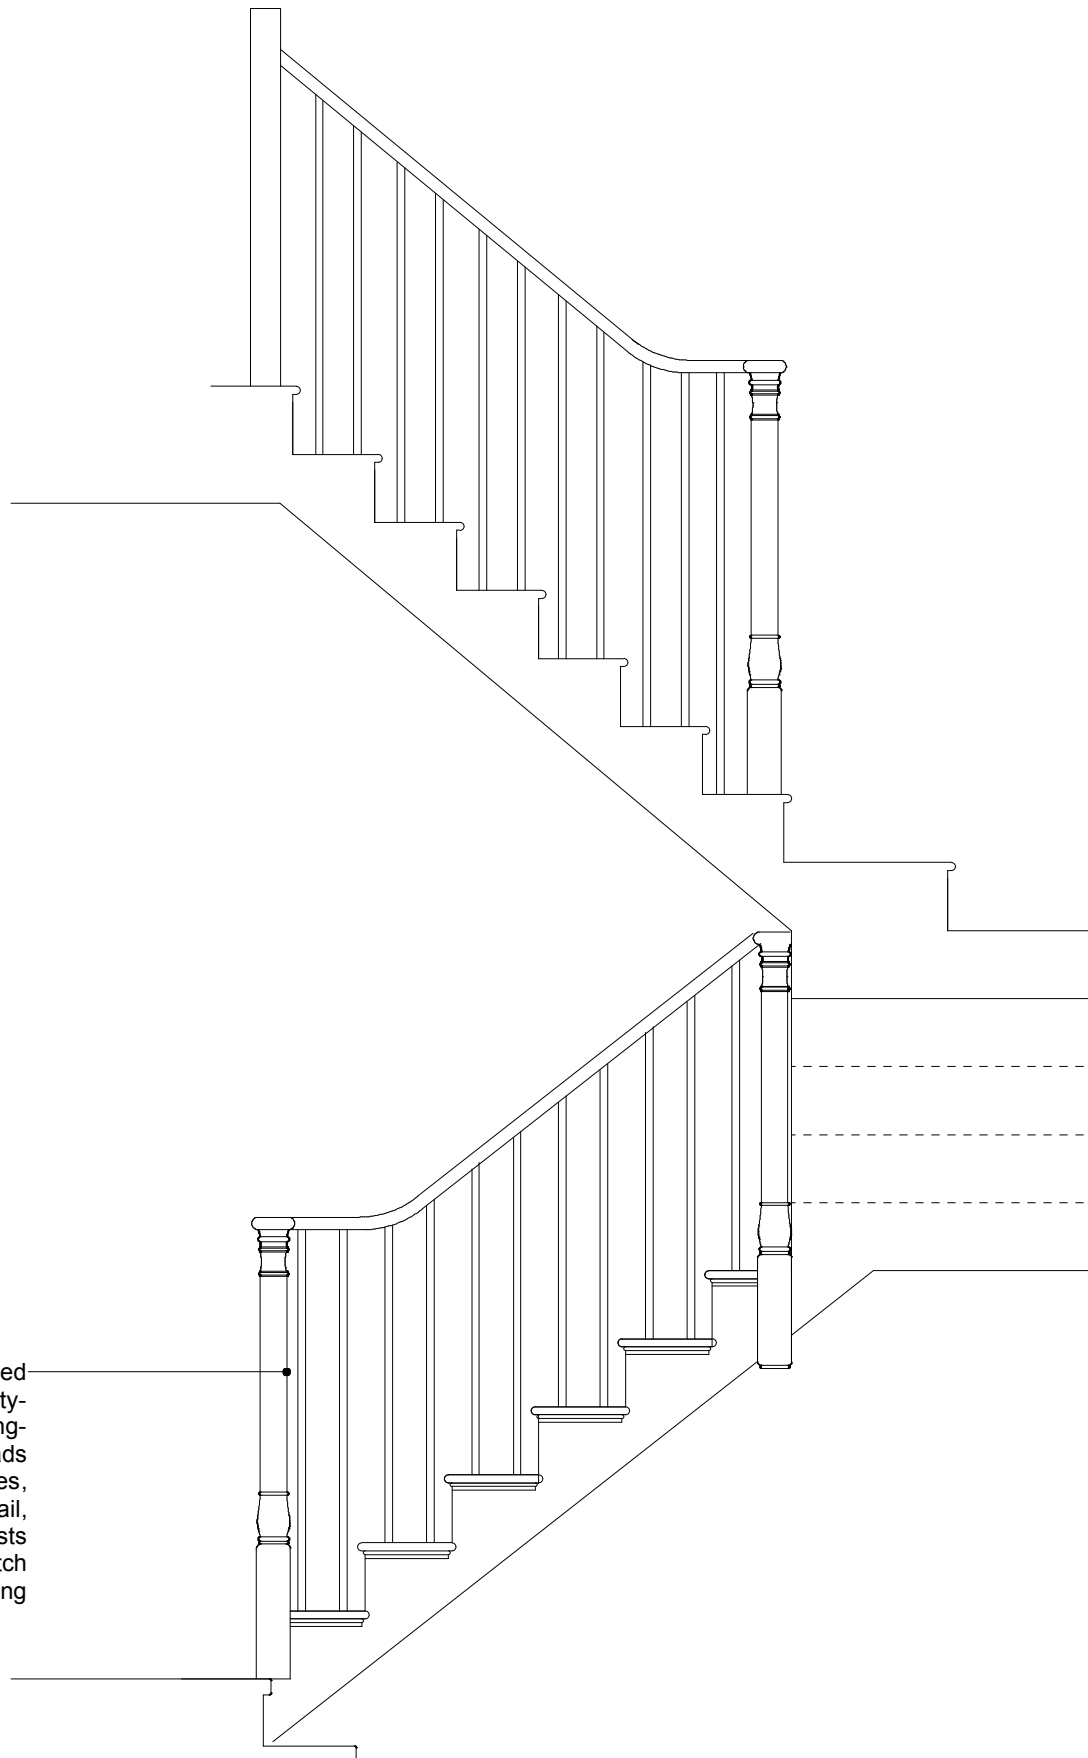
Existing leaning stair to be replaced due to structural instability- new stair to match existing- softwood timber stringers, treads and risers, square section spindles, painted and timber handrail, polished as existing, newl posts reused if possible or to match existing
