# 1.5 1935 Ground Floor Plan

## 1.5 Historic Fabric Alterations / Comparison 1935-2001

## 1.5 Historic Fabric Alterations / Comparison 1935-2017

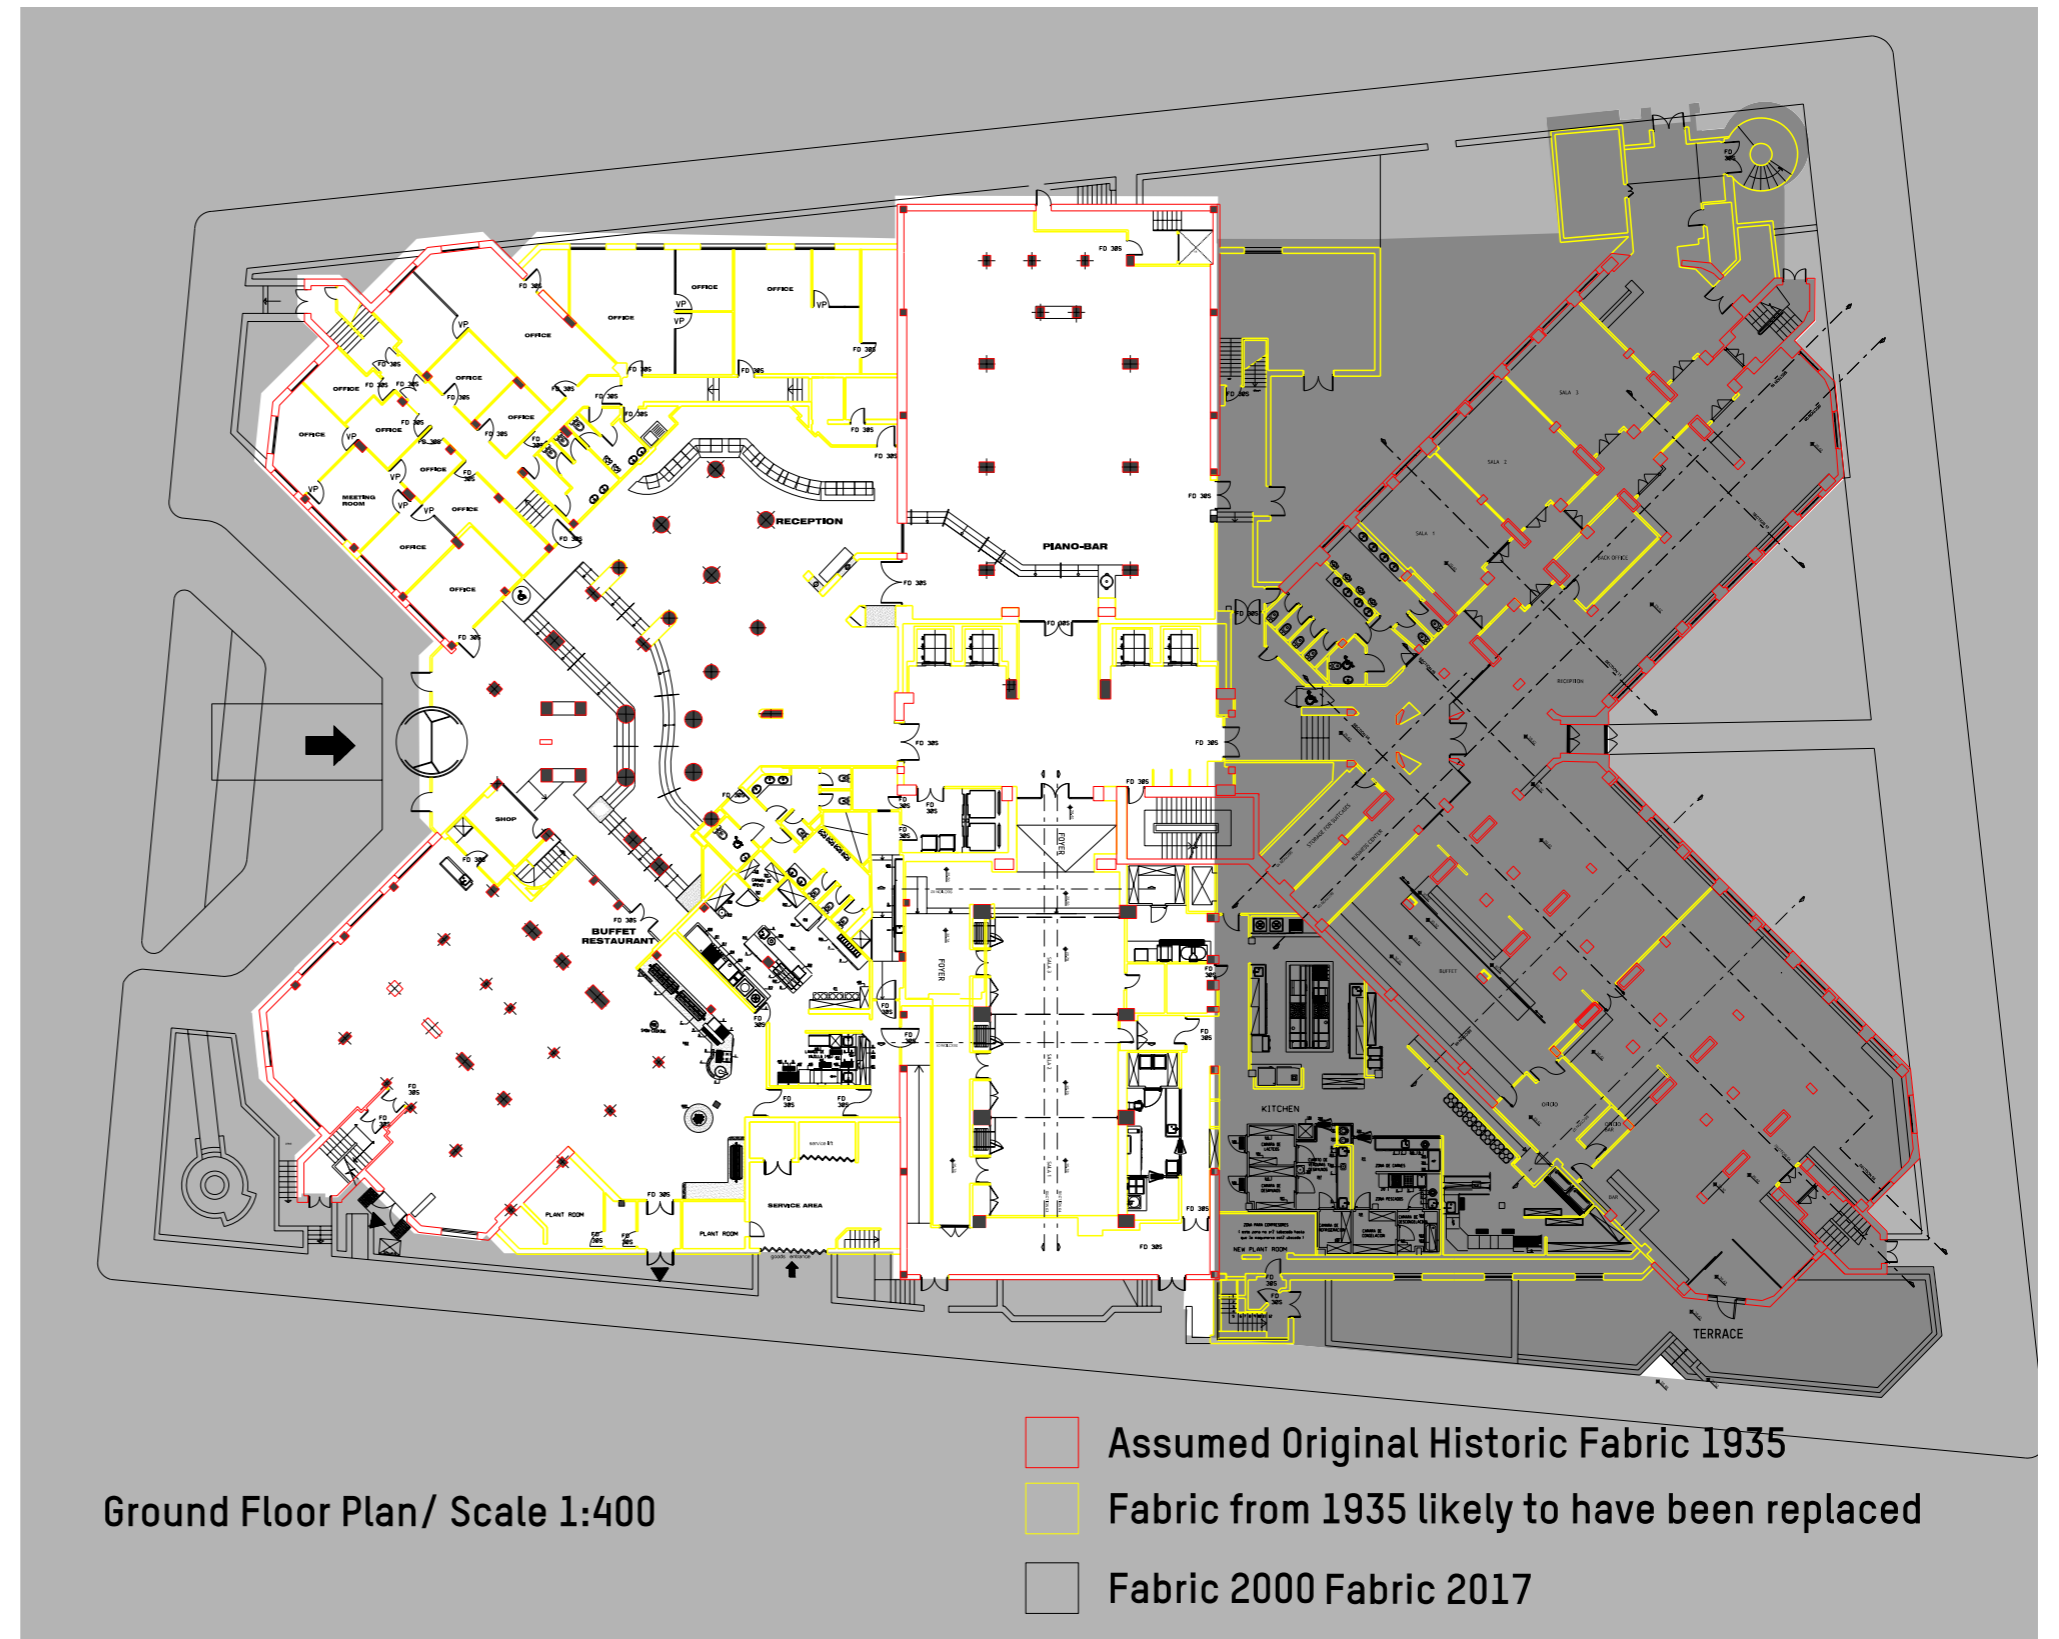
The last refurbishment in 1999-2001 was the last one of a series of previous refurbishments made during the 1960's and 1970's when the building was converted into a hotel.

It appears that most of the original interior historic fabric in the Ground Floor was removed previously except for the external walls and the the structure. Risers and some parts of walls at their sides remain. Taking into account they were enclosing the original bathrooms, stacks and Soil Ventilation Pipes at GF, we assume that most of the original corridors walls were demolished when taking out the original pipeworks, sanitary ware and tiling for bathrooms.

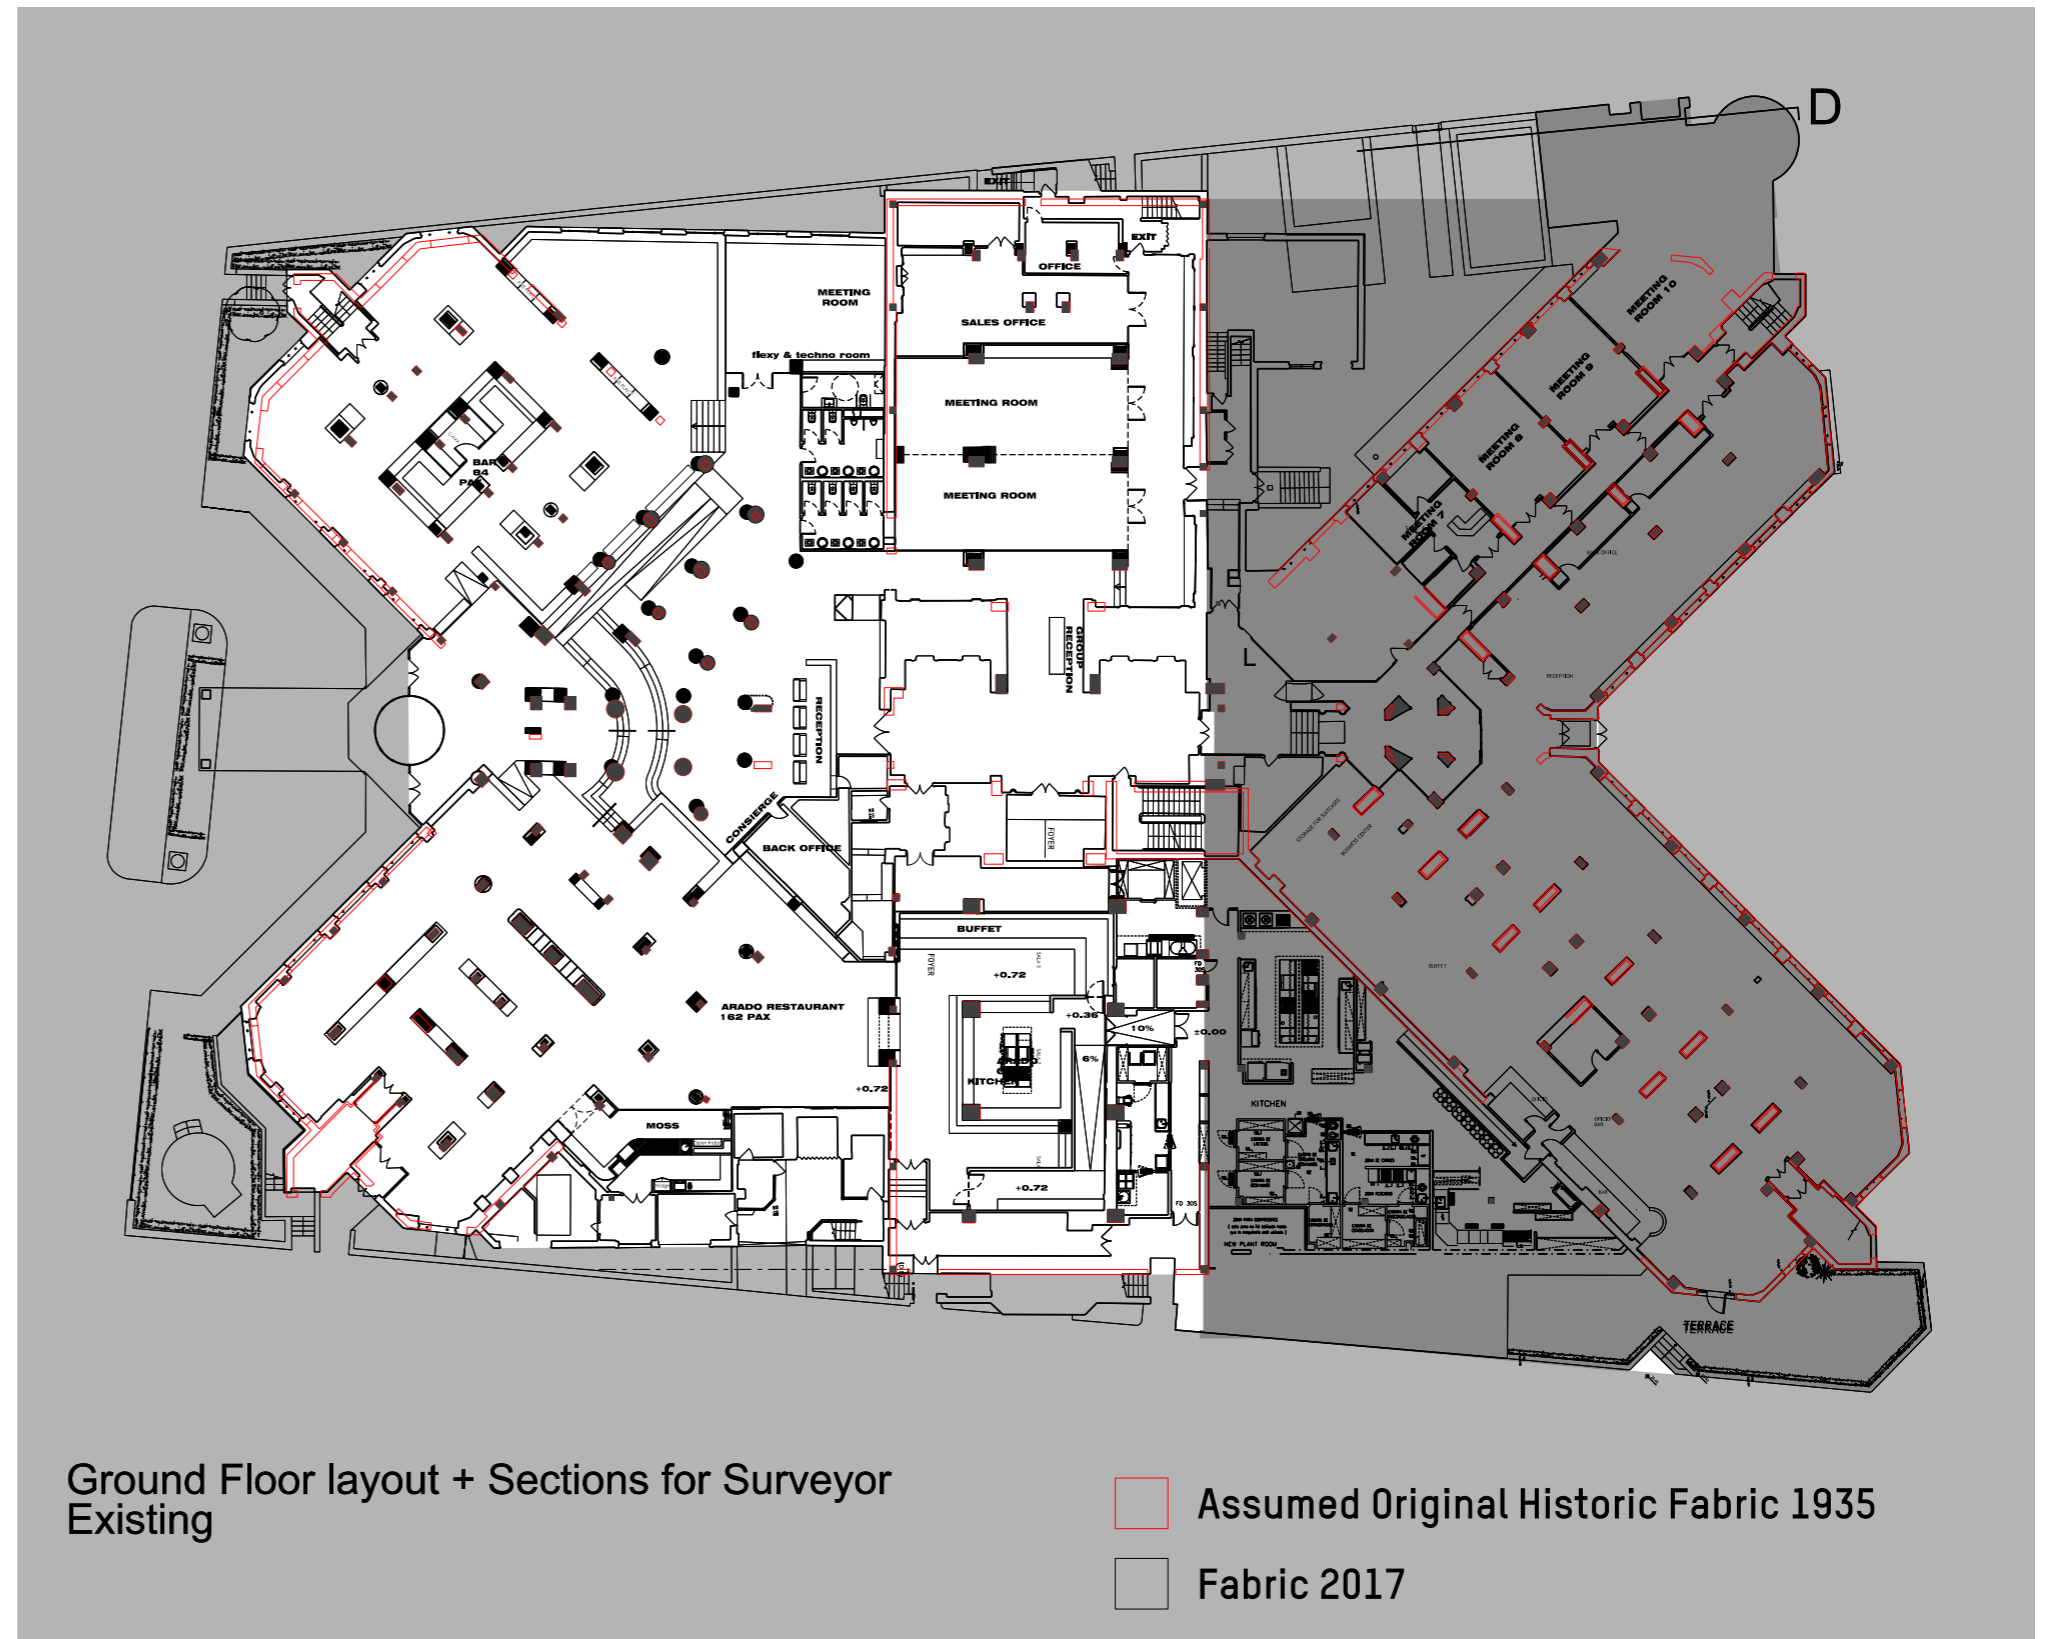
Due to several refurbishments, none of the original historic fabric appears to be preserved on the Ground Floor, except for the external walls and the structure.

Most of the original risers are unlikely to be original. According to Hotel Operator, Stacks and Soil ventilation pipes are not the original from 1935. The assumption is that the original ones were replaced during the 1970s. That means even the original fabric around the risers had to be removed at least partially in order to allow the new pipeworks to be fitted.

Therefore this proposal leaves the remaining historic fabric largely untouched.
