**150 HOLBORN
LONDON EC1N 2NS**

**PHASE 1 PRELIMINARY RISK ASSESSMENT AND PHASE 2
ENVIRONMENTAL AND GEOTECHNICAL SITE INVESTIGATION REPORT**

Our Ref: HLEI389025/001R

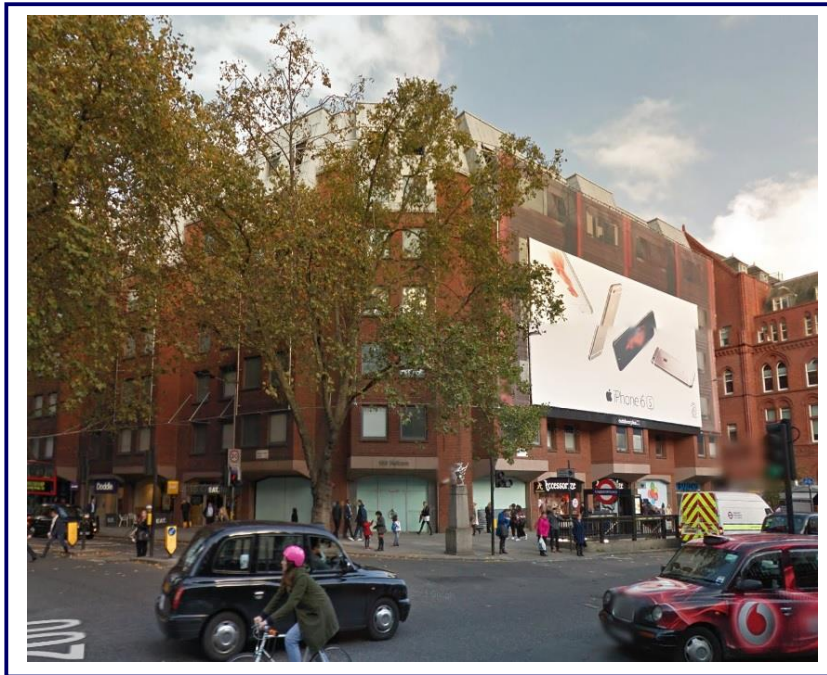
General view of the site (facing northeast).

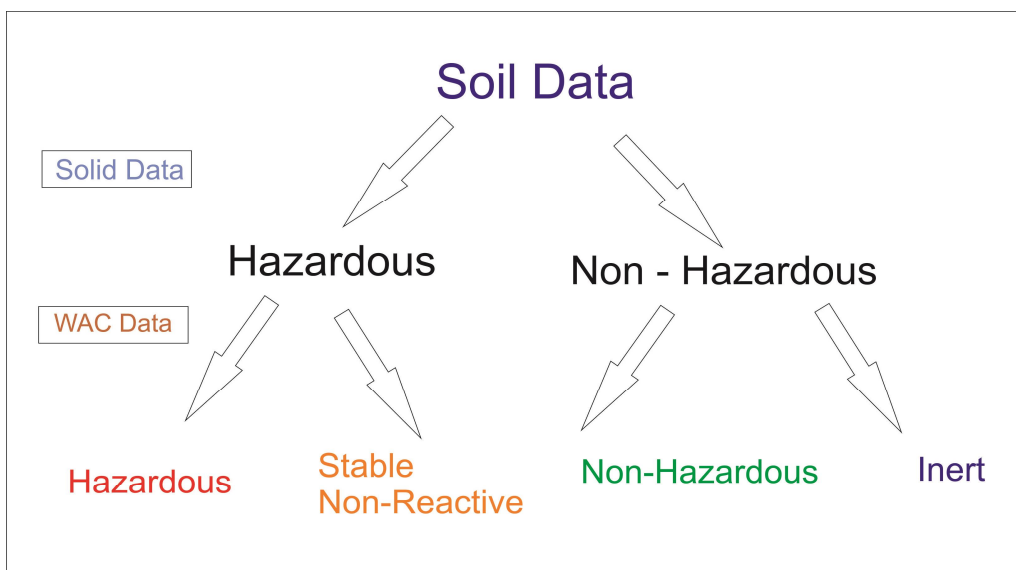
Waste Characterisation Categories

If disposal to landfill is required, the excavated material would be considered as waste and should be classified in line with the Hazardous Waste Directive - HWD, Council Directive 91/689/EC. This legislation divides waste into two categories, hazardous and non-hazardous. These two categories can then be subdivided into a number of classes relating to the type of landfill/cell to which the material can be sent; these are illustrated below.
