**Site Specific Habitat Management Plan for Agar Grove Block F and H Intensive planted roof.**

Client: Hill Partnership Ltd for Camden Council  
 Project: Agar Grove Block F

Drawing Title: Green roof typical section

Project: T14011 - ART - DR - A - 1b F 00 - PL-405

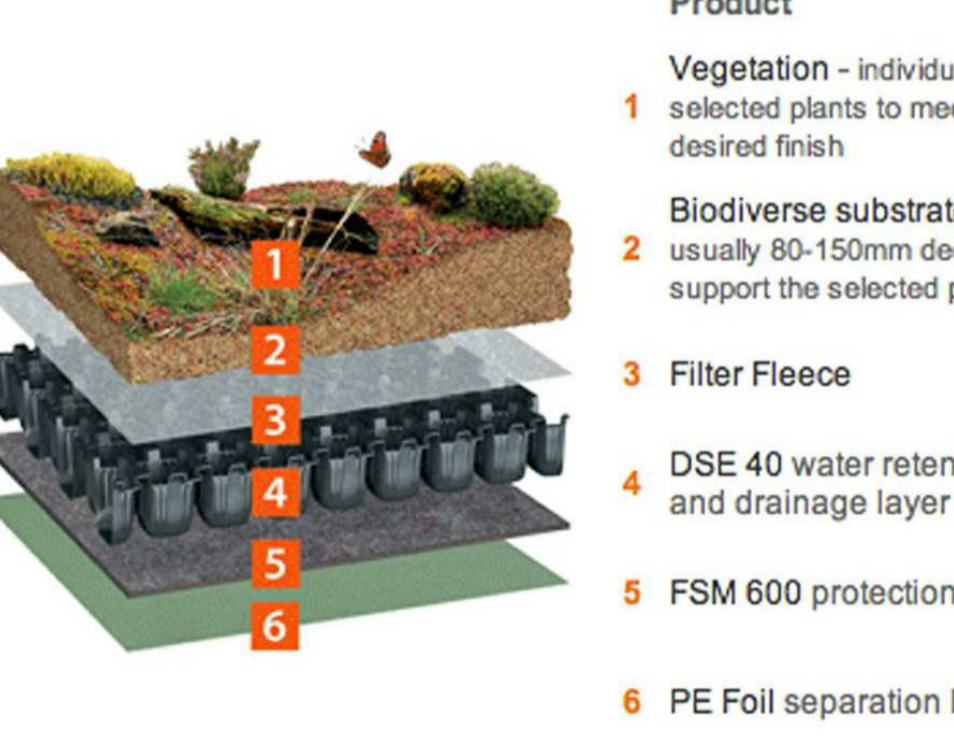
**3D Sectional Diagram of Roof Build Up of Flora 3/UK Native British Provenance Seed Mix**

**70% seed mix for Extensive green roof build up for main roofs on block H and F (see 30% Plug plant species in separate list)**

**UK Native British Provenance Seed Mix**  
 Mix percentages 65% perennial wild flowers, 20% annuals and 15% grasses  
 49 Species  
 - 31 annual species including 8 Grasses/Sedge  
 - 2 Sedum species  
 - 12 Butterfly and moth larval food plants.  
 Shade tolerant species.  
 Low growing to medium height.
