Landmark Trees

Re: 22 Frogal Way Pile wall change

Root Excavation Report

22 Frogna1 Way

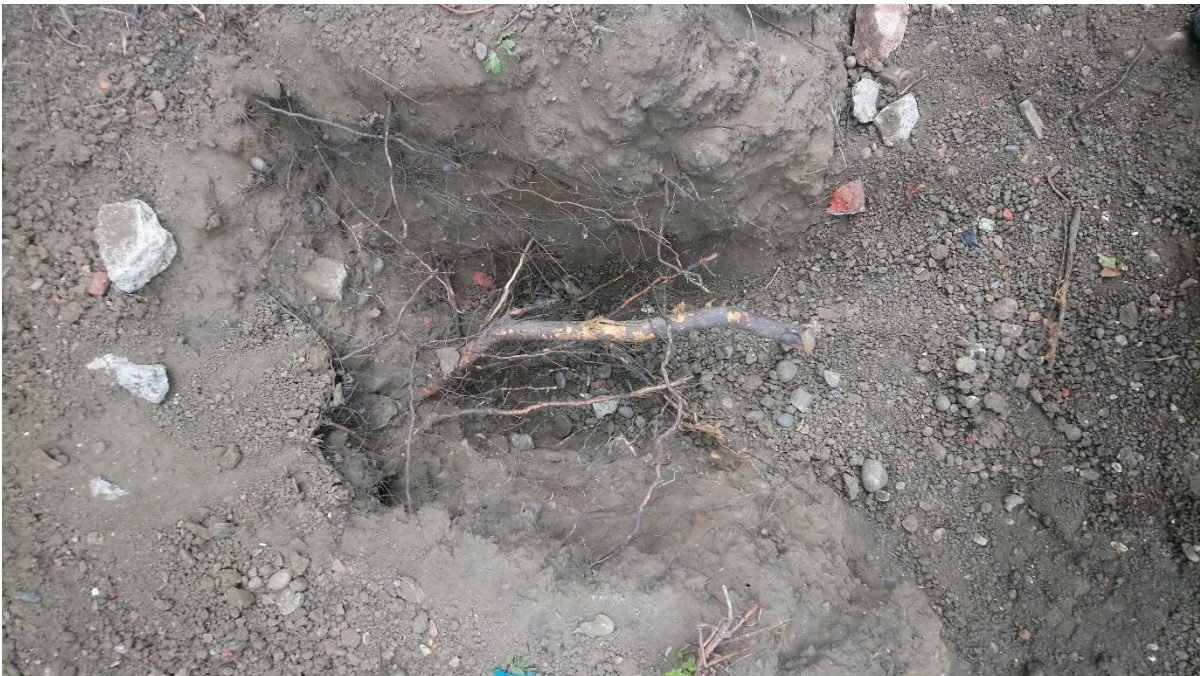
Trial pit 1

Trial Pit 1	0.5m x 0.5m x0.5m 1x 40mm Root previously severed
Trial Pit 2	0.5m x 0.5m x0.5m No significant roots
Trial Pit 3	0.5m x 0.5m x0.5m 2x30mm roots 2x20mm roots

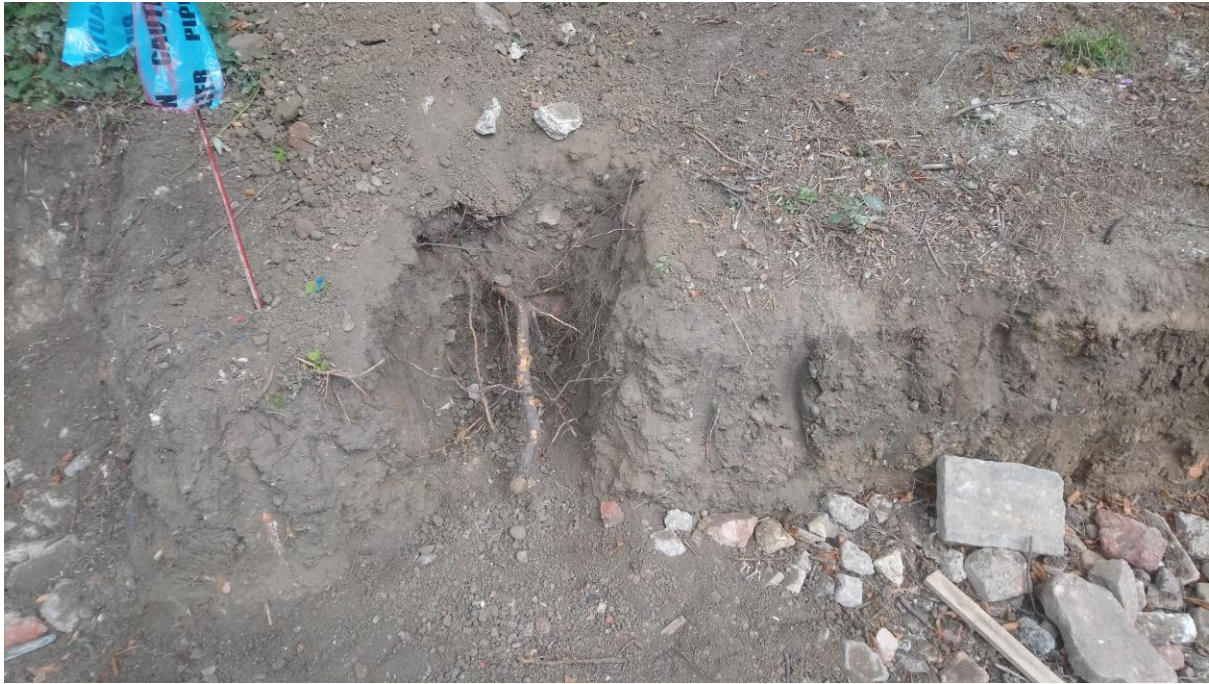
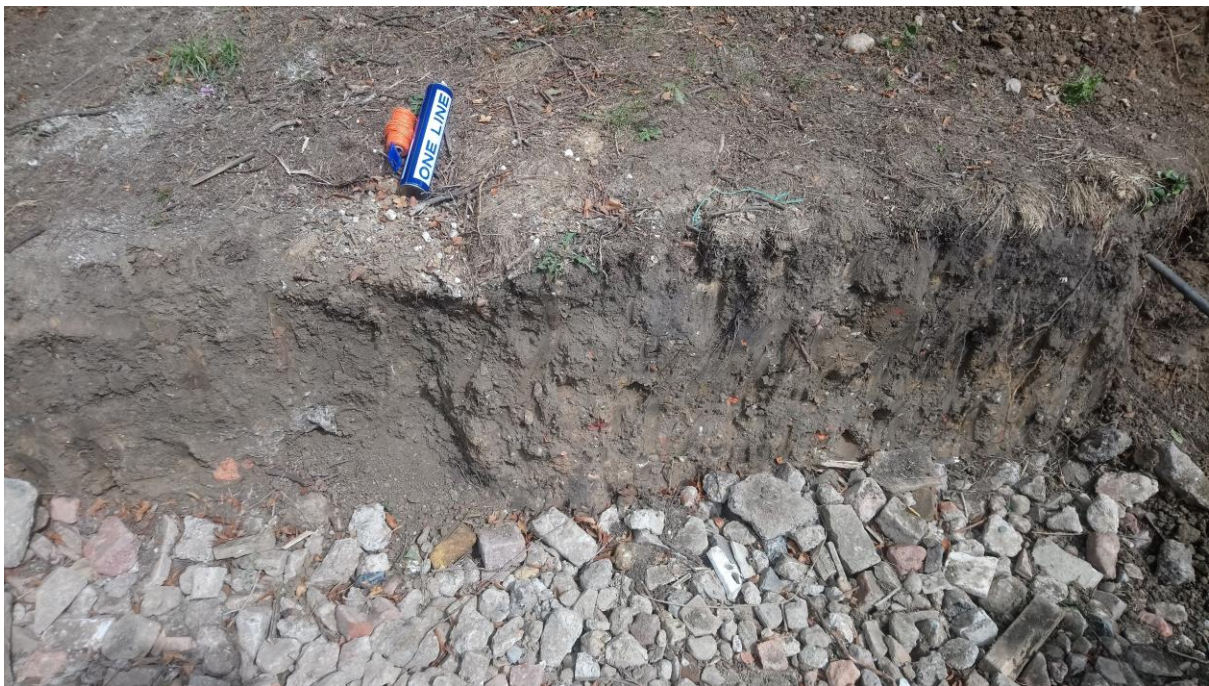
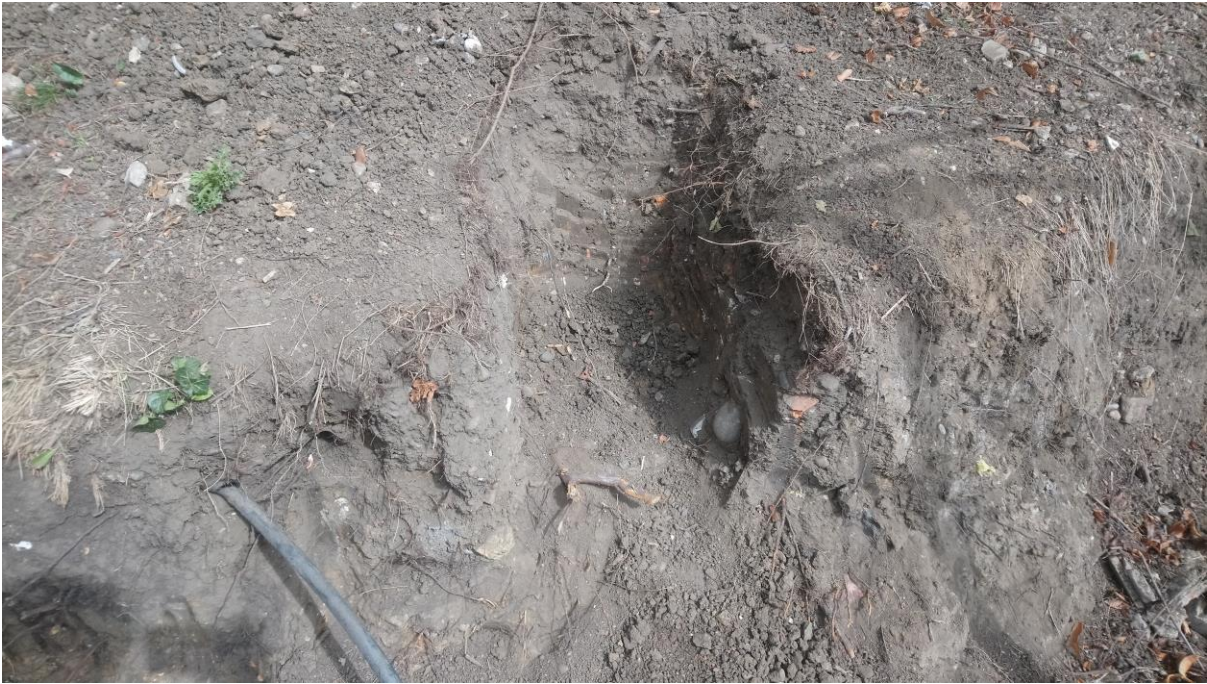
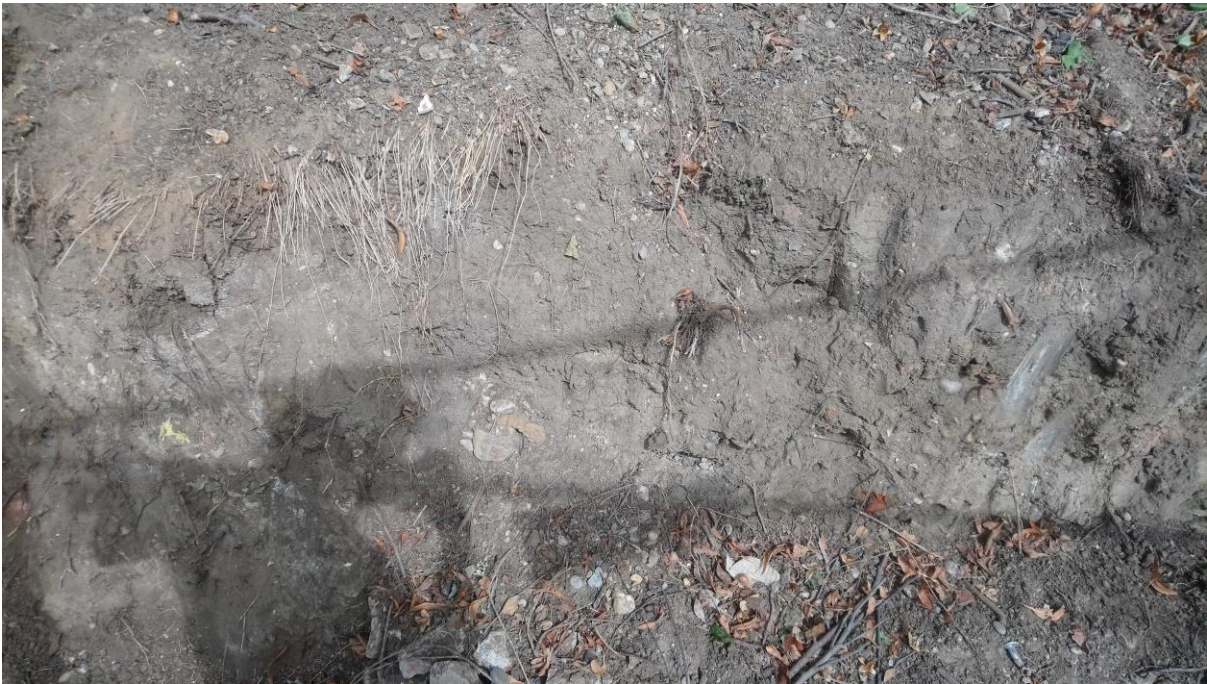
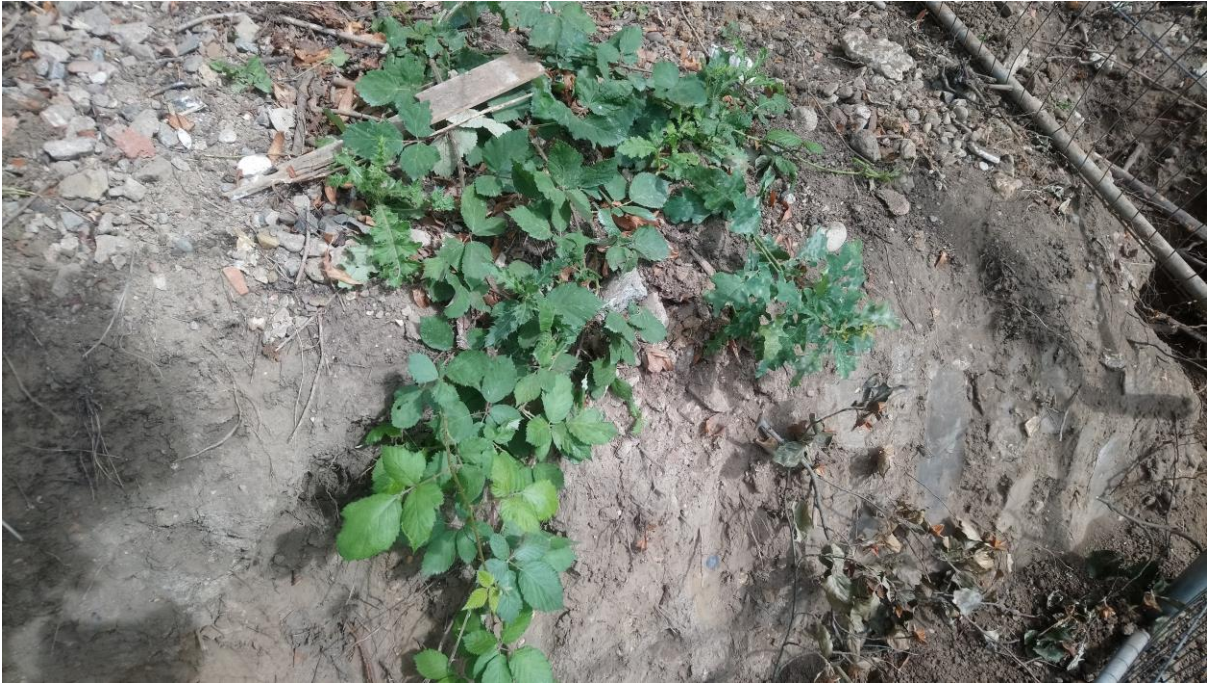
Additional

There seemed to be very little rooting across the rest of the exposed bank.
