APPENDIX

Borehole Records
SPT & Cohesion/Depth Graph
Trial Pit Records
Weather Reports for Groundwater Monitoring
Geotechnical Test Results
Contamination Test Results
Generic Risk-based Screening Values
Risk Assessment Tables
Envirocheck Extracts
Historical Maps
UXO Preliminary Risk Assessment
Site Plan

Site
58a Redington Road, London NW3 7RS
Borehole Number
BH2

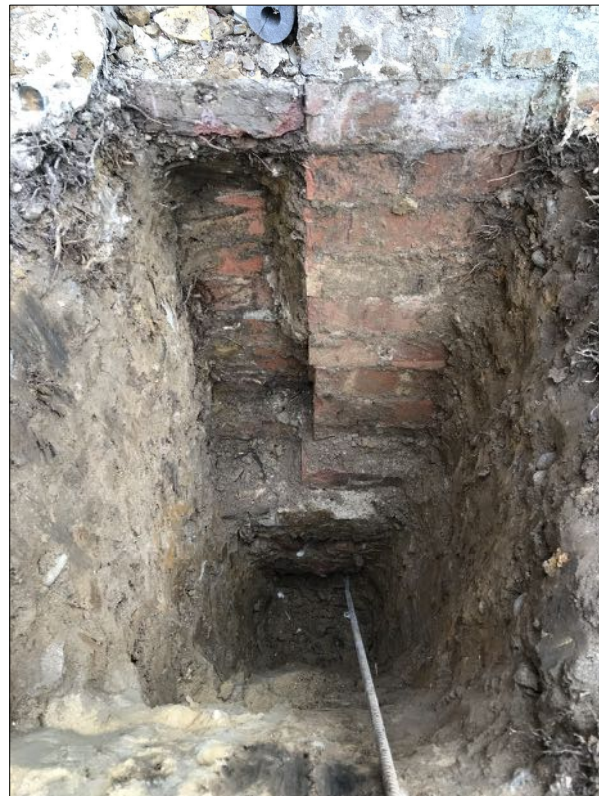
MADE GROUND (light brown silty very sandy gravelly clay with occasional fragments of brick and coal. Occasional rootlets to 0.4 m. Initially very dry and friable.)

Firm orange-brown and light grey silty very sandy slightly gravelly CLAY. Sand is fine. Gravel is medium to coarse rounded to subangular flint)

Notes:
Groundwater not encountered; trial pit dry on completion

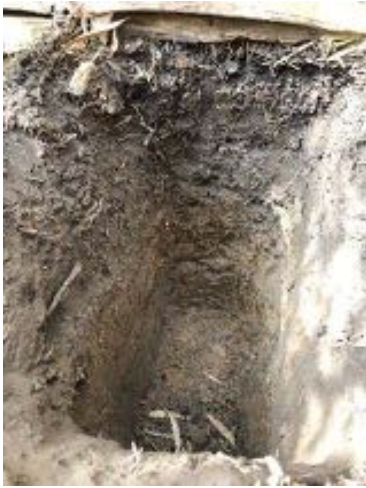
Scale (approx) 1:50	Logged By KM	Figure No. J18142.TP2
-------------------------------	------------------------	---------------------------------

Depth (m)	Sample / Tests	Water Depth (m)	Field Records	Level (mOD)	Depth (m) (Thickness)	Description	Legend	Water
				44.43	(0.30) 0.30	MADE GROUND (brownish grey clayey sandy gravelly silt with frequent rootlets and occasional fragments of brick and coal)

43.83	(0.60) 0.90	Firm orange-brown and light grey silty very sandy slightly gravelly CLAY with occasional rootlets. Sand is fine. Gravel is medium to coarse rounded to subangular flint

Complete at 0.90m

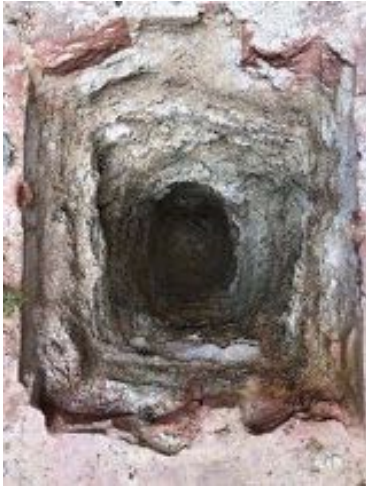
Scale (approx) 1:50	Logged By KM	Figure No. J18142.TP3
-------------------------------	------------------------	---------------------------------

Depth (m)	Sample / Tests	Water Depth (m)	Field Records	Level (mOD)	Depth (m) (Thickness)	Description	Legend	Water
				45.80	0.85	MADE GROUND (50 mm brick paving over concrete poured in several layers with no reinforcement)

45.60	0.85 (0.20) 1.05	MADE GROUND (light grey mottled orange-brown very silty slightly sandy gravelly clay with occasional fragments of concrete) Complete at 1.05m

Remarks
Starter pit for BH4

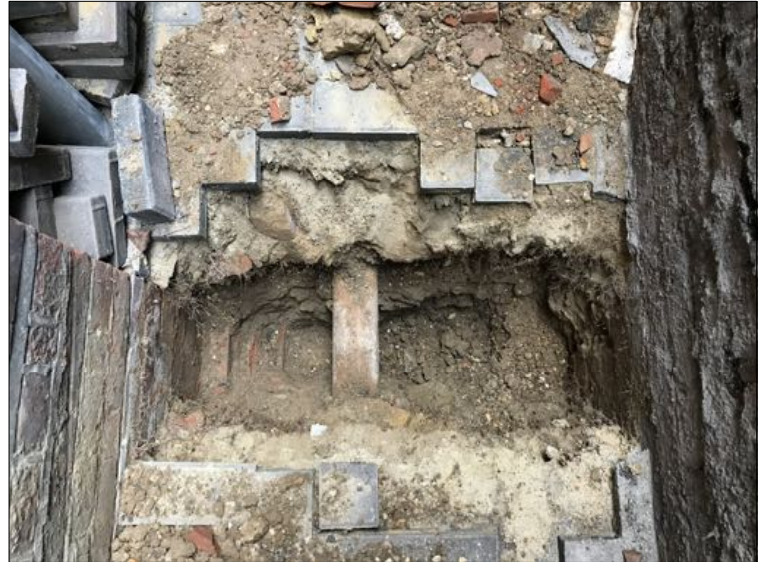
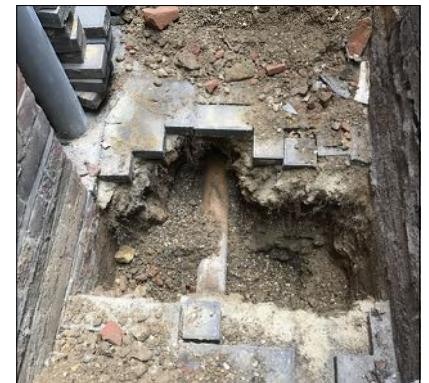
Notes:
Groundwater not encountered; trial pit dry on completion

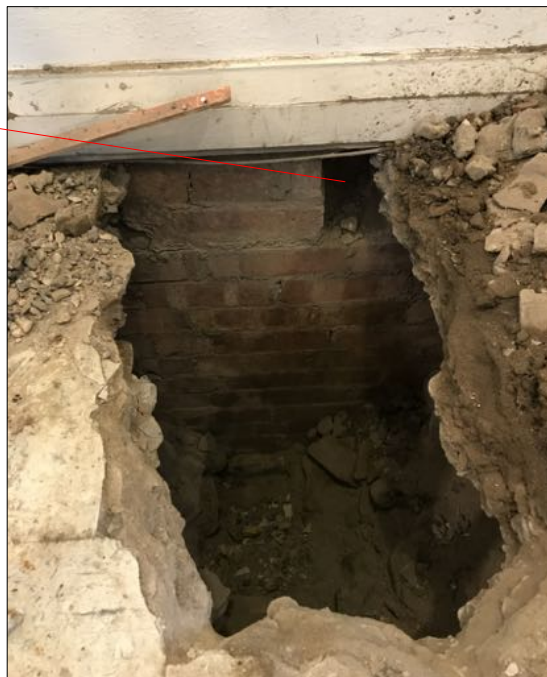
Notes:
 Groundwater not encountered; trial pit dry on completion

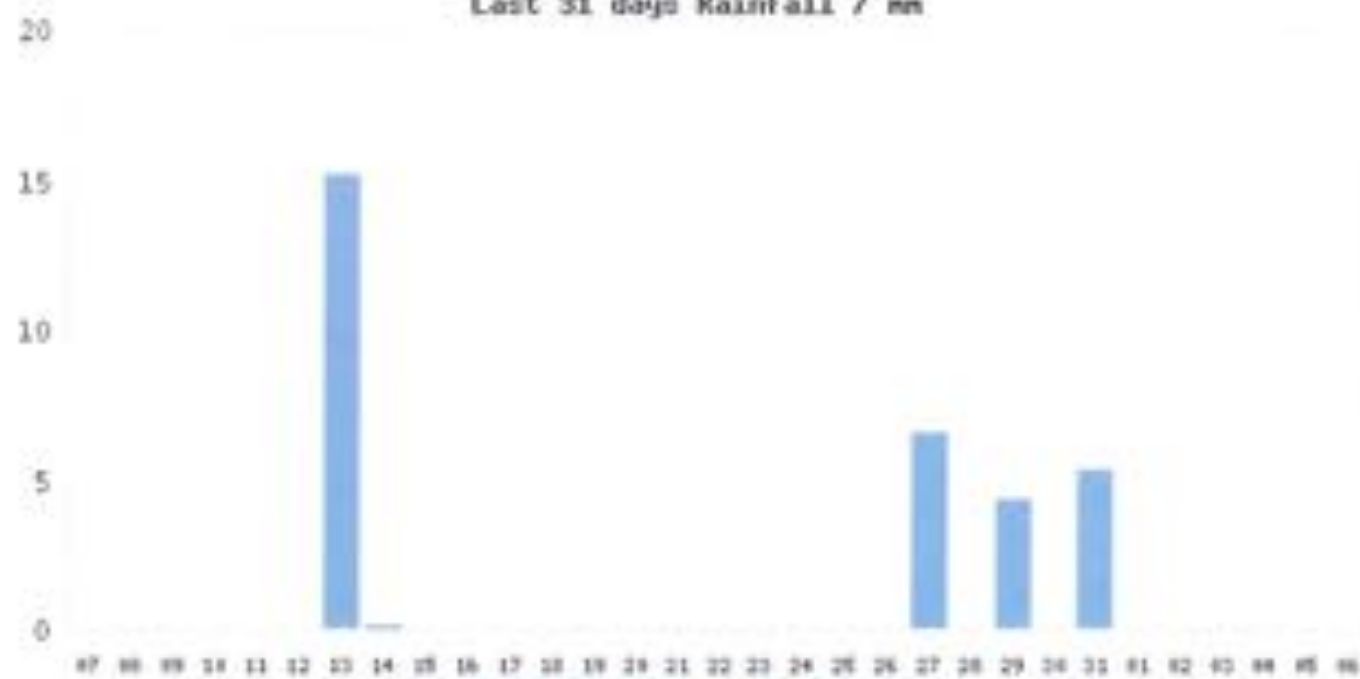
Last 31 days Rainfall / mm

Date monitored - 03/08/2018
