24 Church Row

Title: Proposed Panelling Repair Detail

Drawing No : 0919317/ Sk44 Scale : 1: 5 & 1: 2 @A3

Title: Proposed GF Panelling Repairs

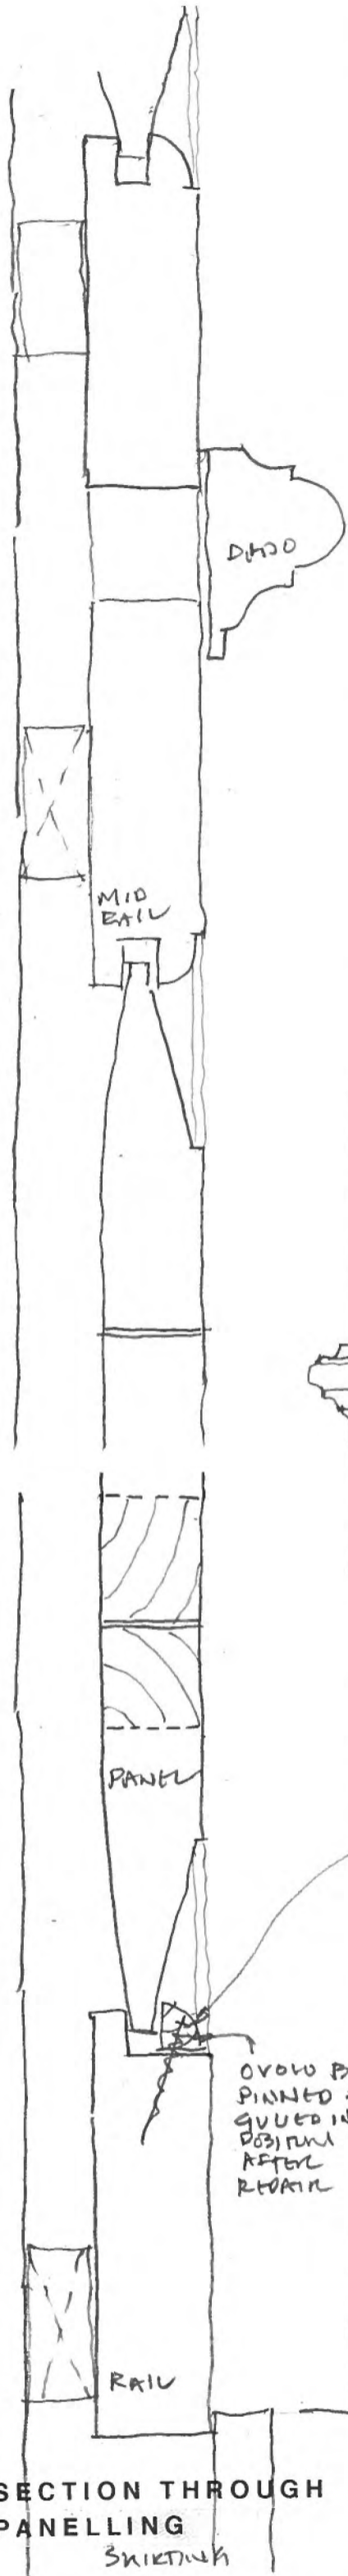
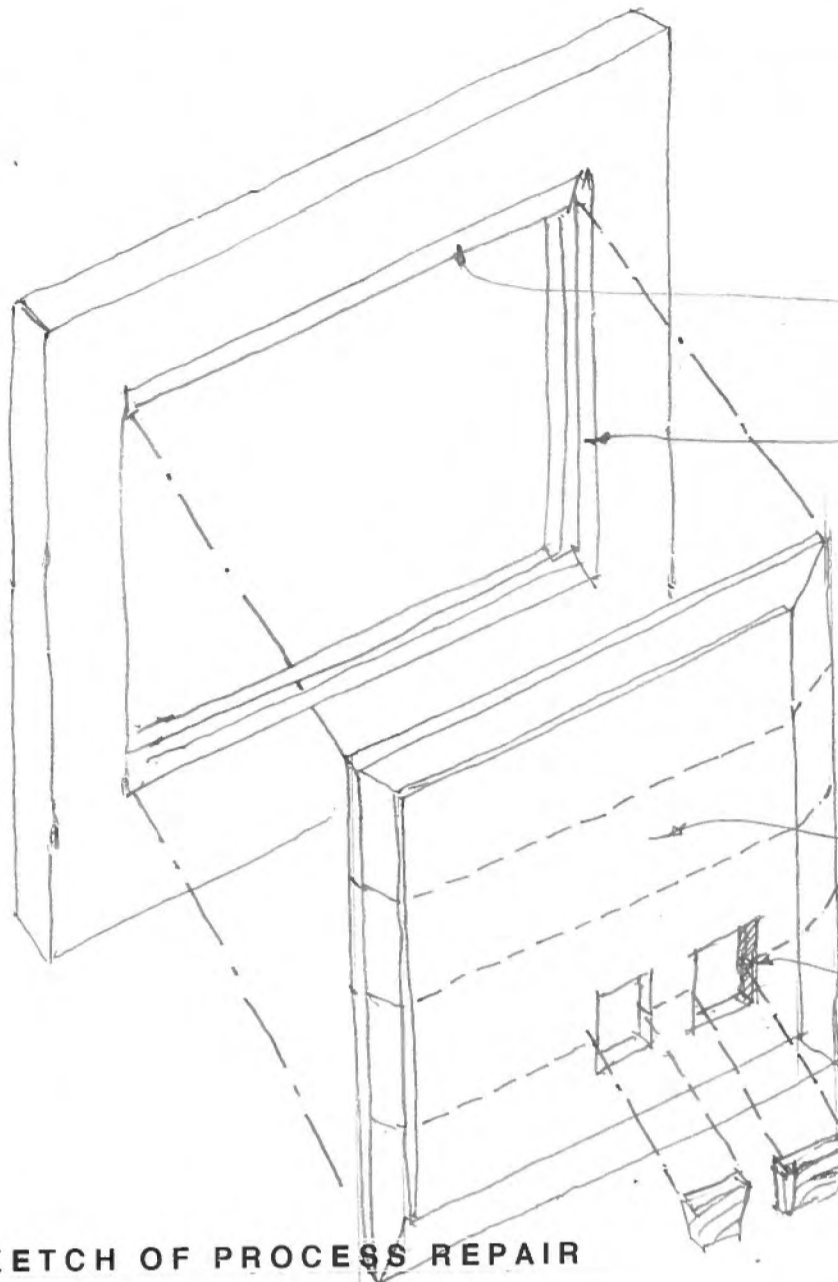
SKETCH OF PROCESS REPAIR

MOULDING CUT AWAY FROM 2 OR 3 SIDES TO RELEASE PANEL FOR REPAIR

OVOL MOULDING CUT AWAY WITH RECIPROCATING TOOL TO RELEASE PANEL

OVOL MOULDING REPLACED WITH SAME PROFILE BEAD ON COMPLETION OF REPAIR

PANELS REMOVED FROM PANELLING TO EXPOSE REPAIRS

HOLE CUT FOR ELECTRICAL FITTINGS THRU PANELS

SW REPAIRS TO PIECE IN EACH BOARD OF PANEL

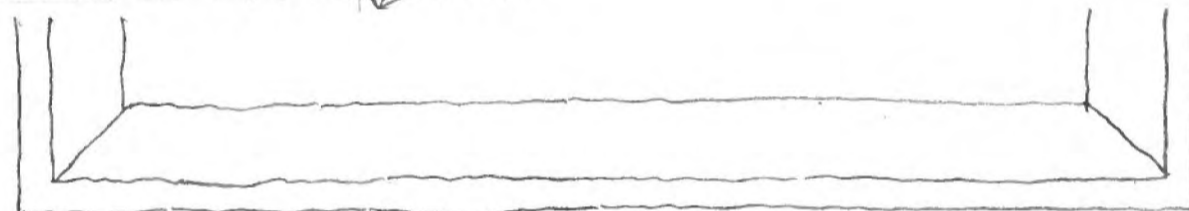
SECTION THROUGH PANELLING  
SKIRTING

TOP PANEL

DADO RAIL RETAINED

OVOL RETAINED WHERE POSSIBLE

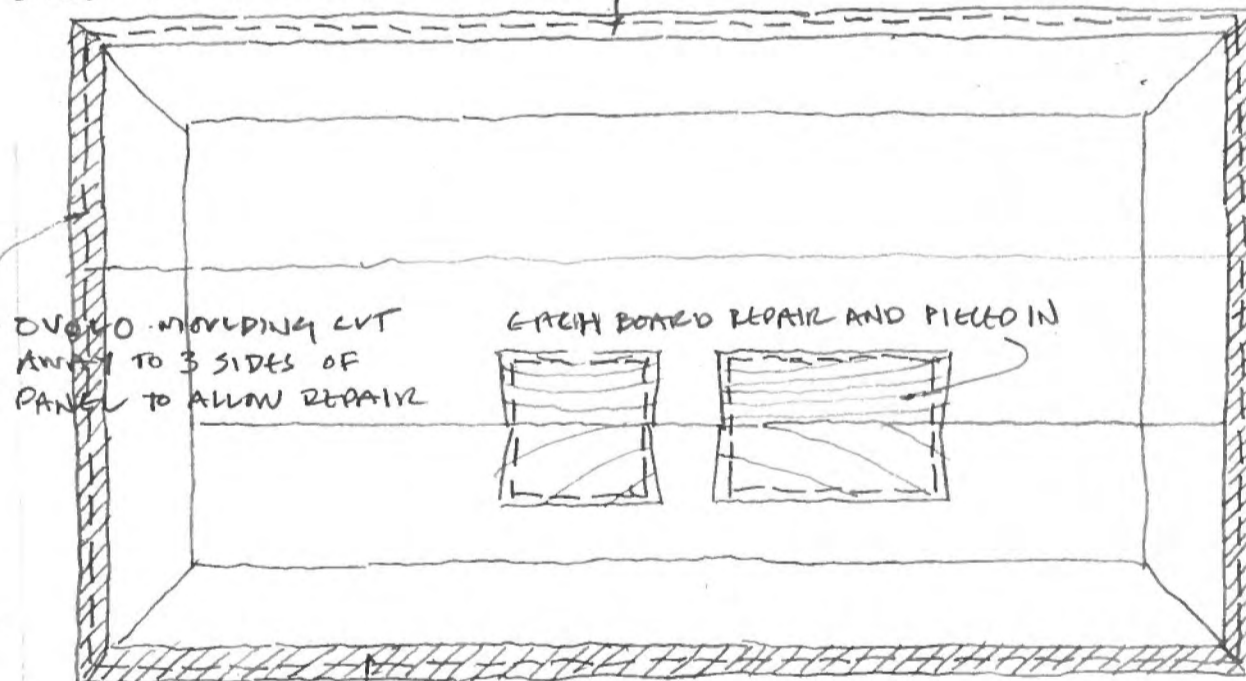
TYPICAL ELEVATION PANELLING

OVOL MOULDING CUT AWAY TO 3 SIDES OF PANEL TO ALLOW REPAIR

EACH BOARD REPAIR AND PIECED IN

OVOL CUT AWAY SO PANEL CAN BE REMOVED

SKIRTING

NOTE: PANELLING RETAINED IN POSITION

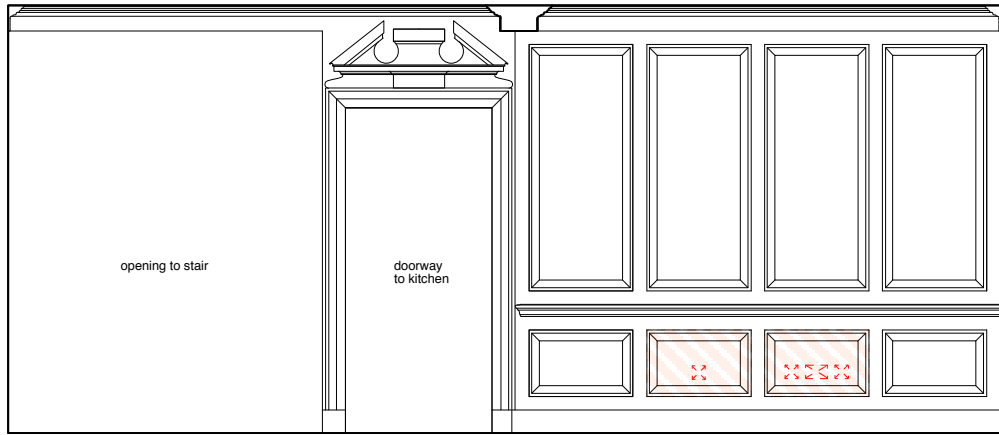
ROOM G.01 - Ground Floor Entrance Hall  
ELEVATION A

**Proposed remedial works :**  
repair timber panelling

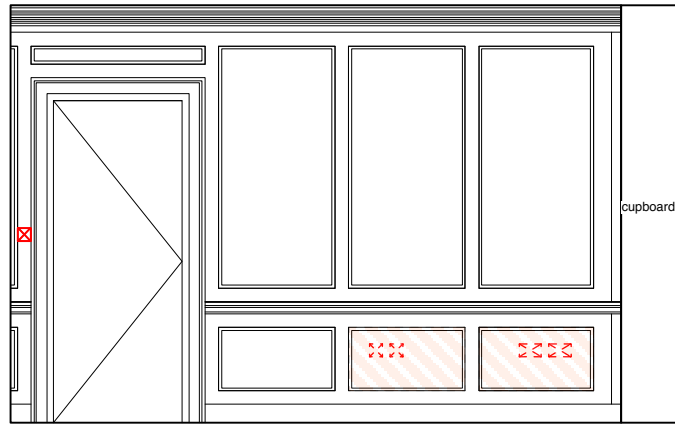
ROOM 2.02 - 2nd Floor Bedroom  
ELEVATION A

**Proposed remedial works :**  
repair timber panelling

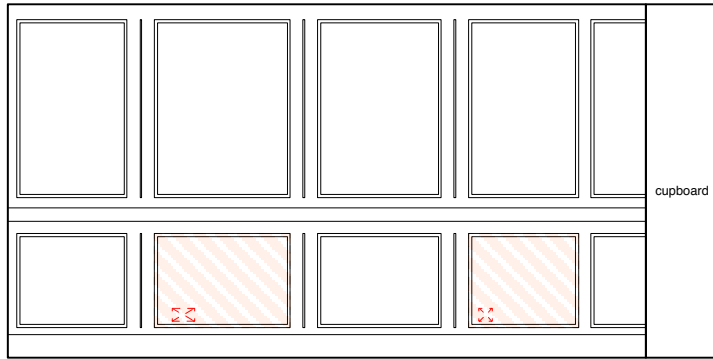
ROOM 3.02 - 3rd Floor Bedroom  
ELEVATION A

Proposed remedial works :  
repair timber panelling
