**front garden:
sections NE & D/1**

**external works
front garden**
Proposed New House: 15a Parliament Hill

01.11.18
P/extwrks/1:20/216

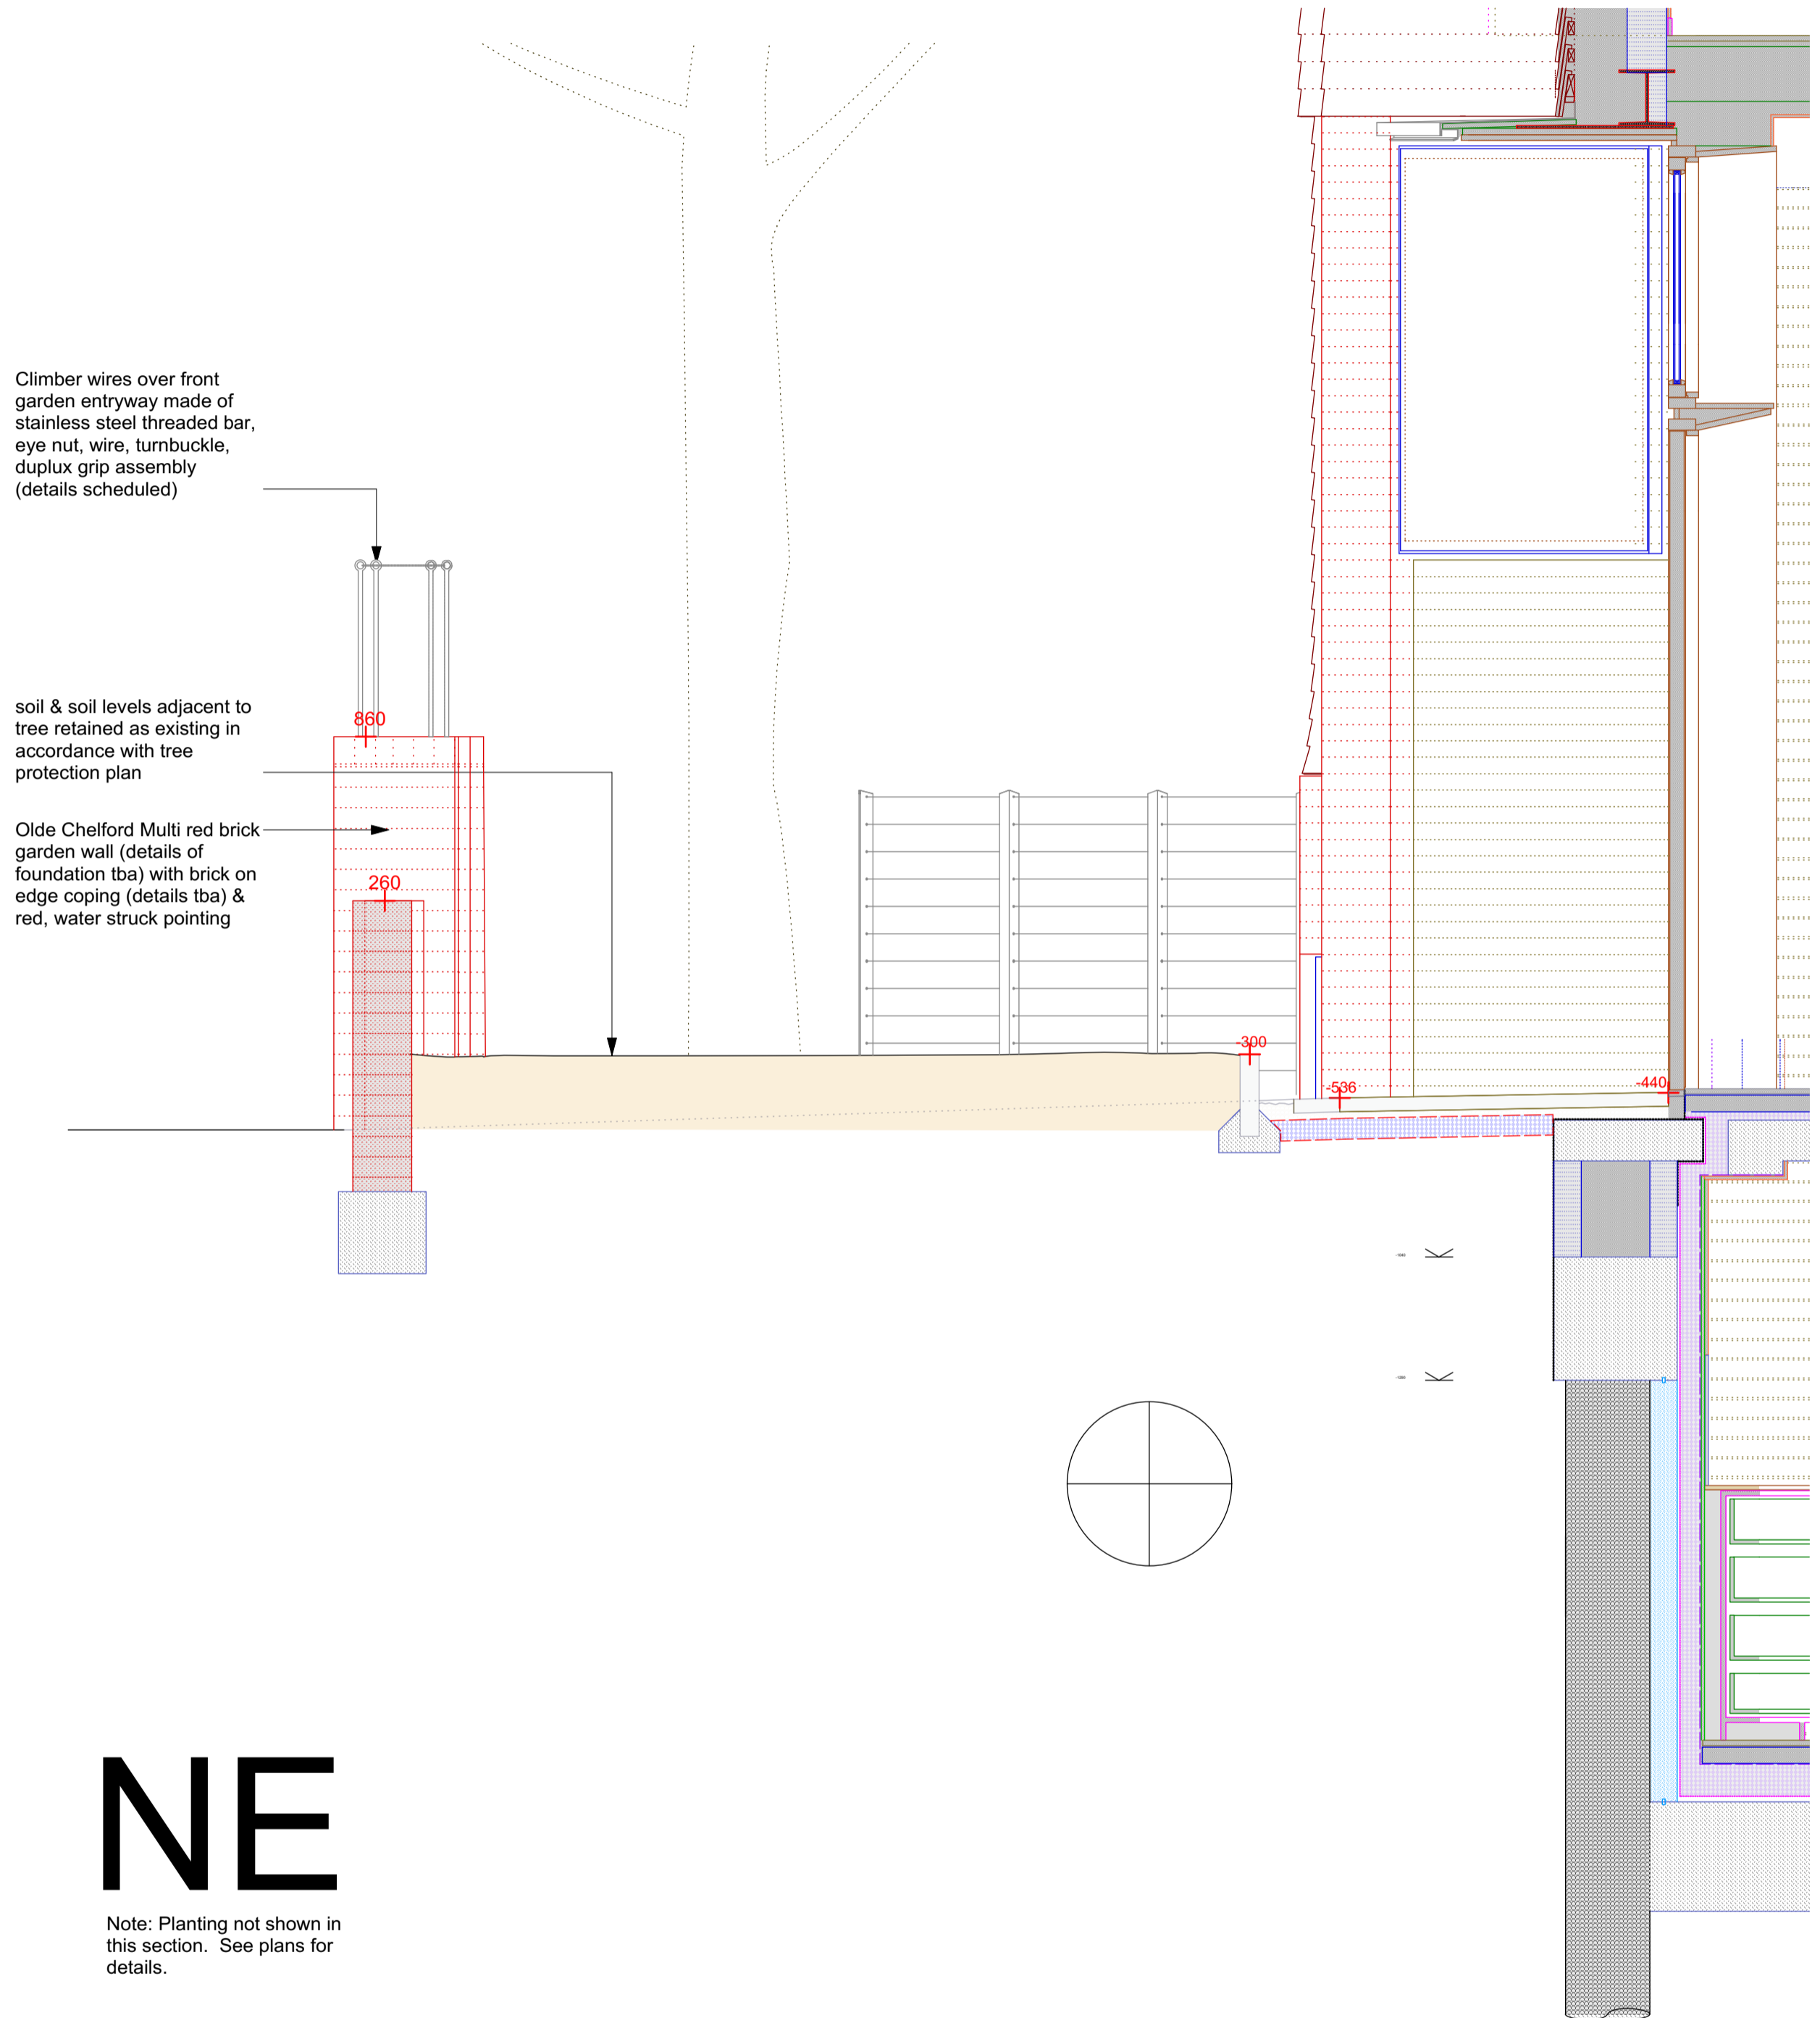
NE

Climber wires over front garden entryway made of stainless steel threaded bar, eye nut, wire, turnbuckle, duplex grip assembly (details scheduled)

soil & soil levels adjacent to tree retained as existing in accordance with tree protection plan

Olde Chelford Multi red brick garden wall (details of foundation tba) with brick on edge coping (details tba) & red, water struck pointing

Note: Planting not shown in this section. See plans for details.

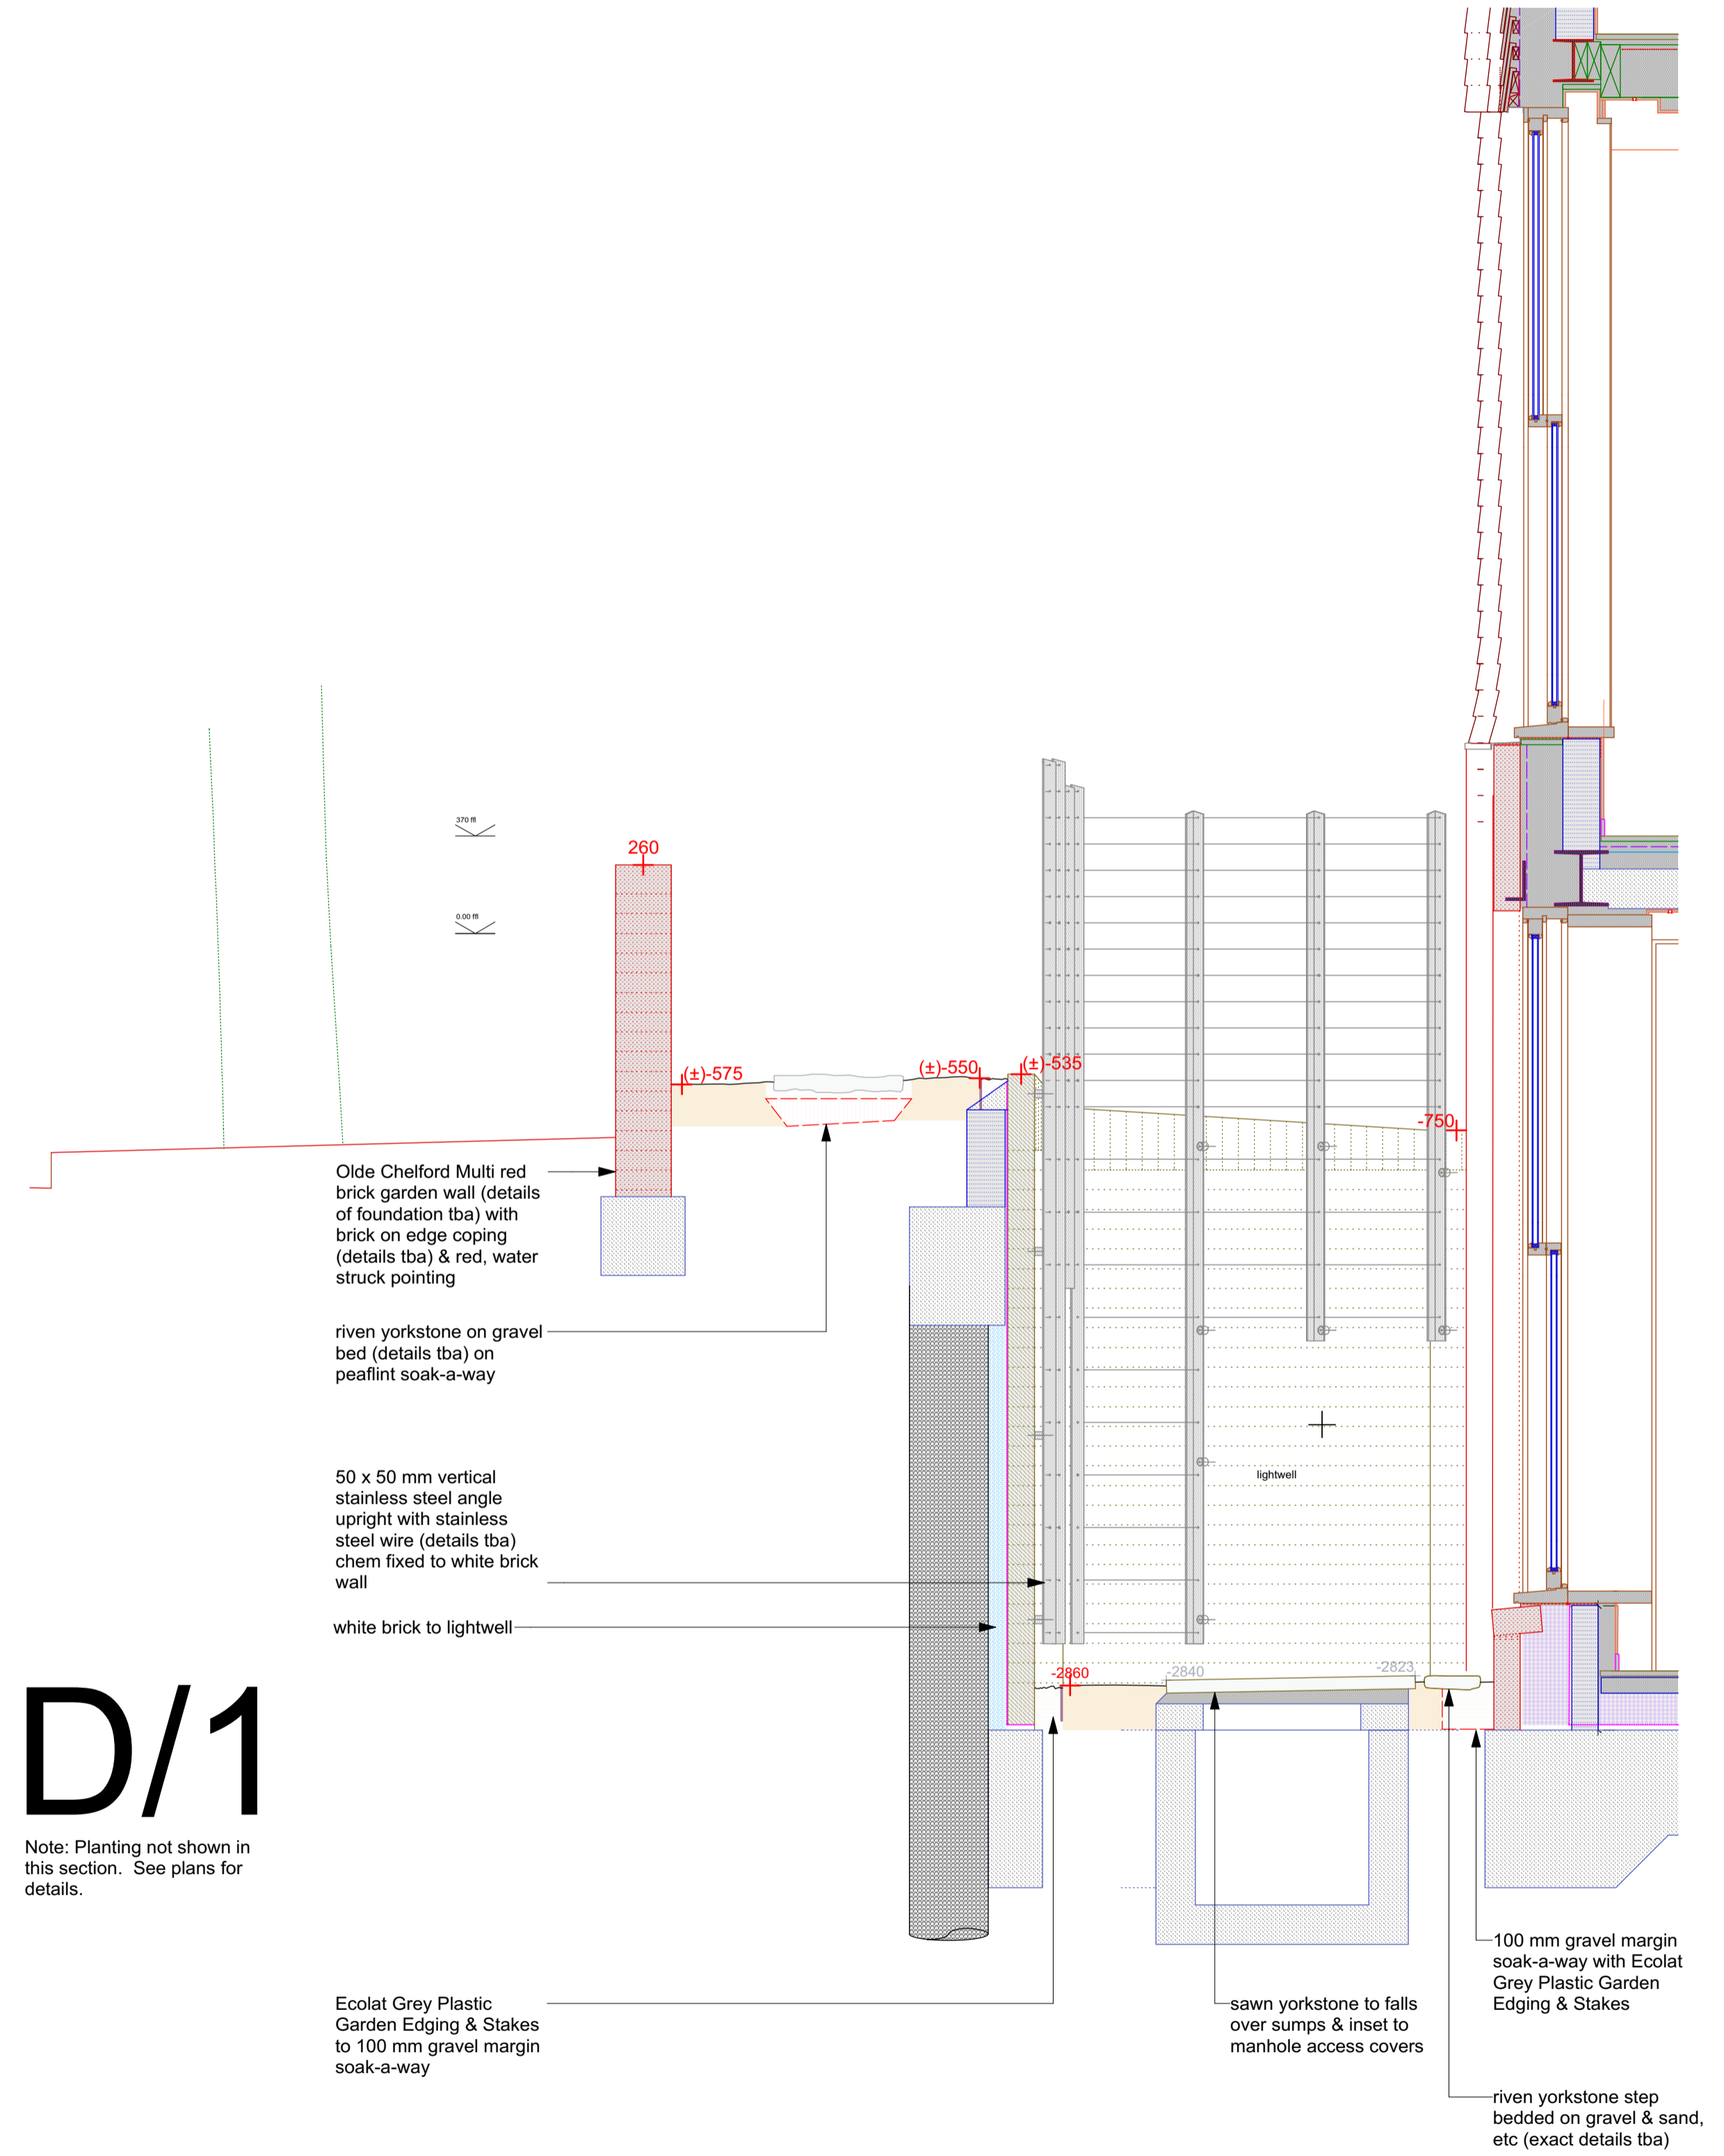
D/1

Note: Planting not shown in this section. See plans for details.
