Project
100 Chetwynd Road
London NW5

Drawing
Landscape Plan
as Existing

Project No.	Drawing No.	Revision
18008	CWN-PL-09	P01

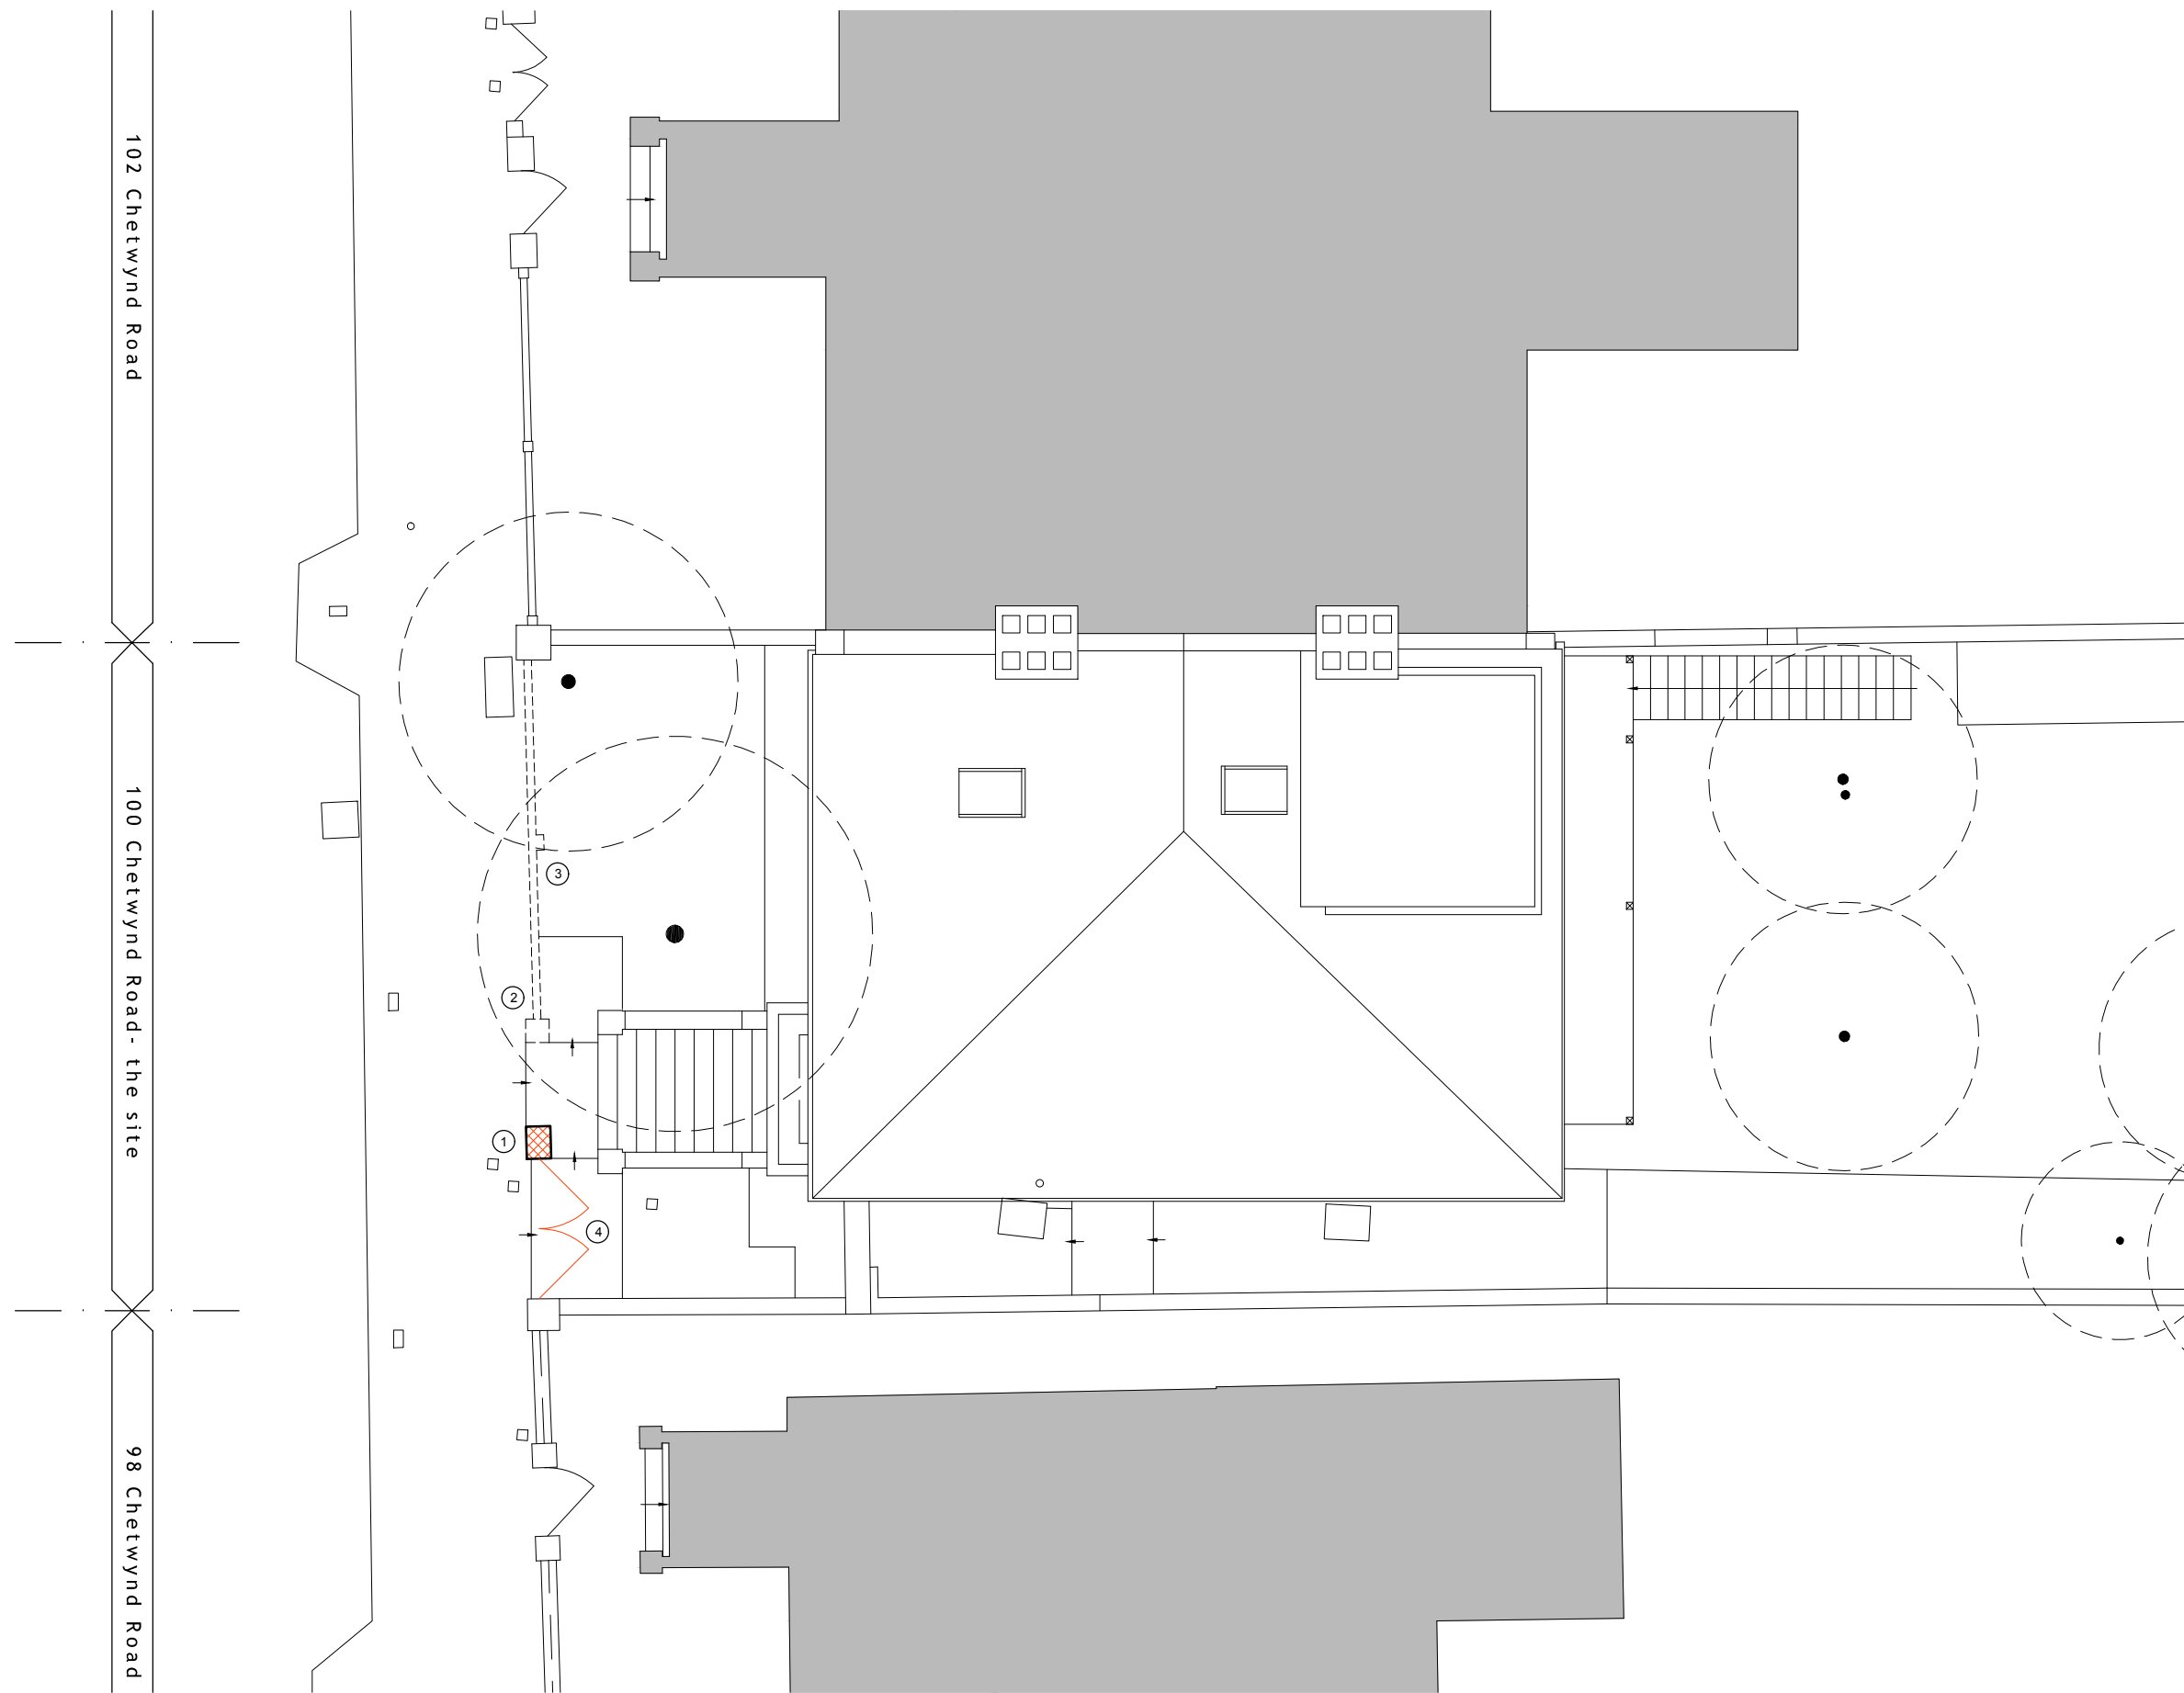
SCHEDULE OF PROPOSED WORKS

FRONT BOUNDARY WALL

1. Existing sloping brick pier to be taken down and reconstructed using the existing bricks
2. Indicative location of brick pier which has collapsed
3. Indicative location of front boundary brick wall which has collapsed
4. Existing modern metal gates to be taken down and removed
