JOB TITLE
22A THEOBALDS ROAD

DRAWING TITLE
BASEMENT PLAN

AS EXISTING

JOB No. N2422

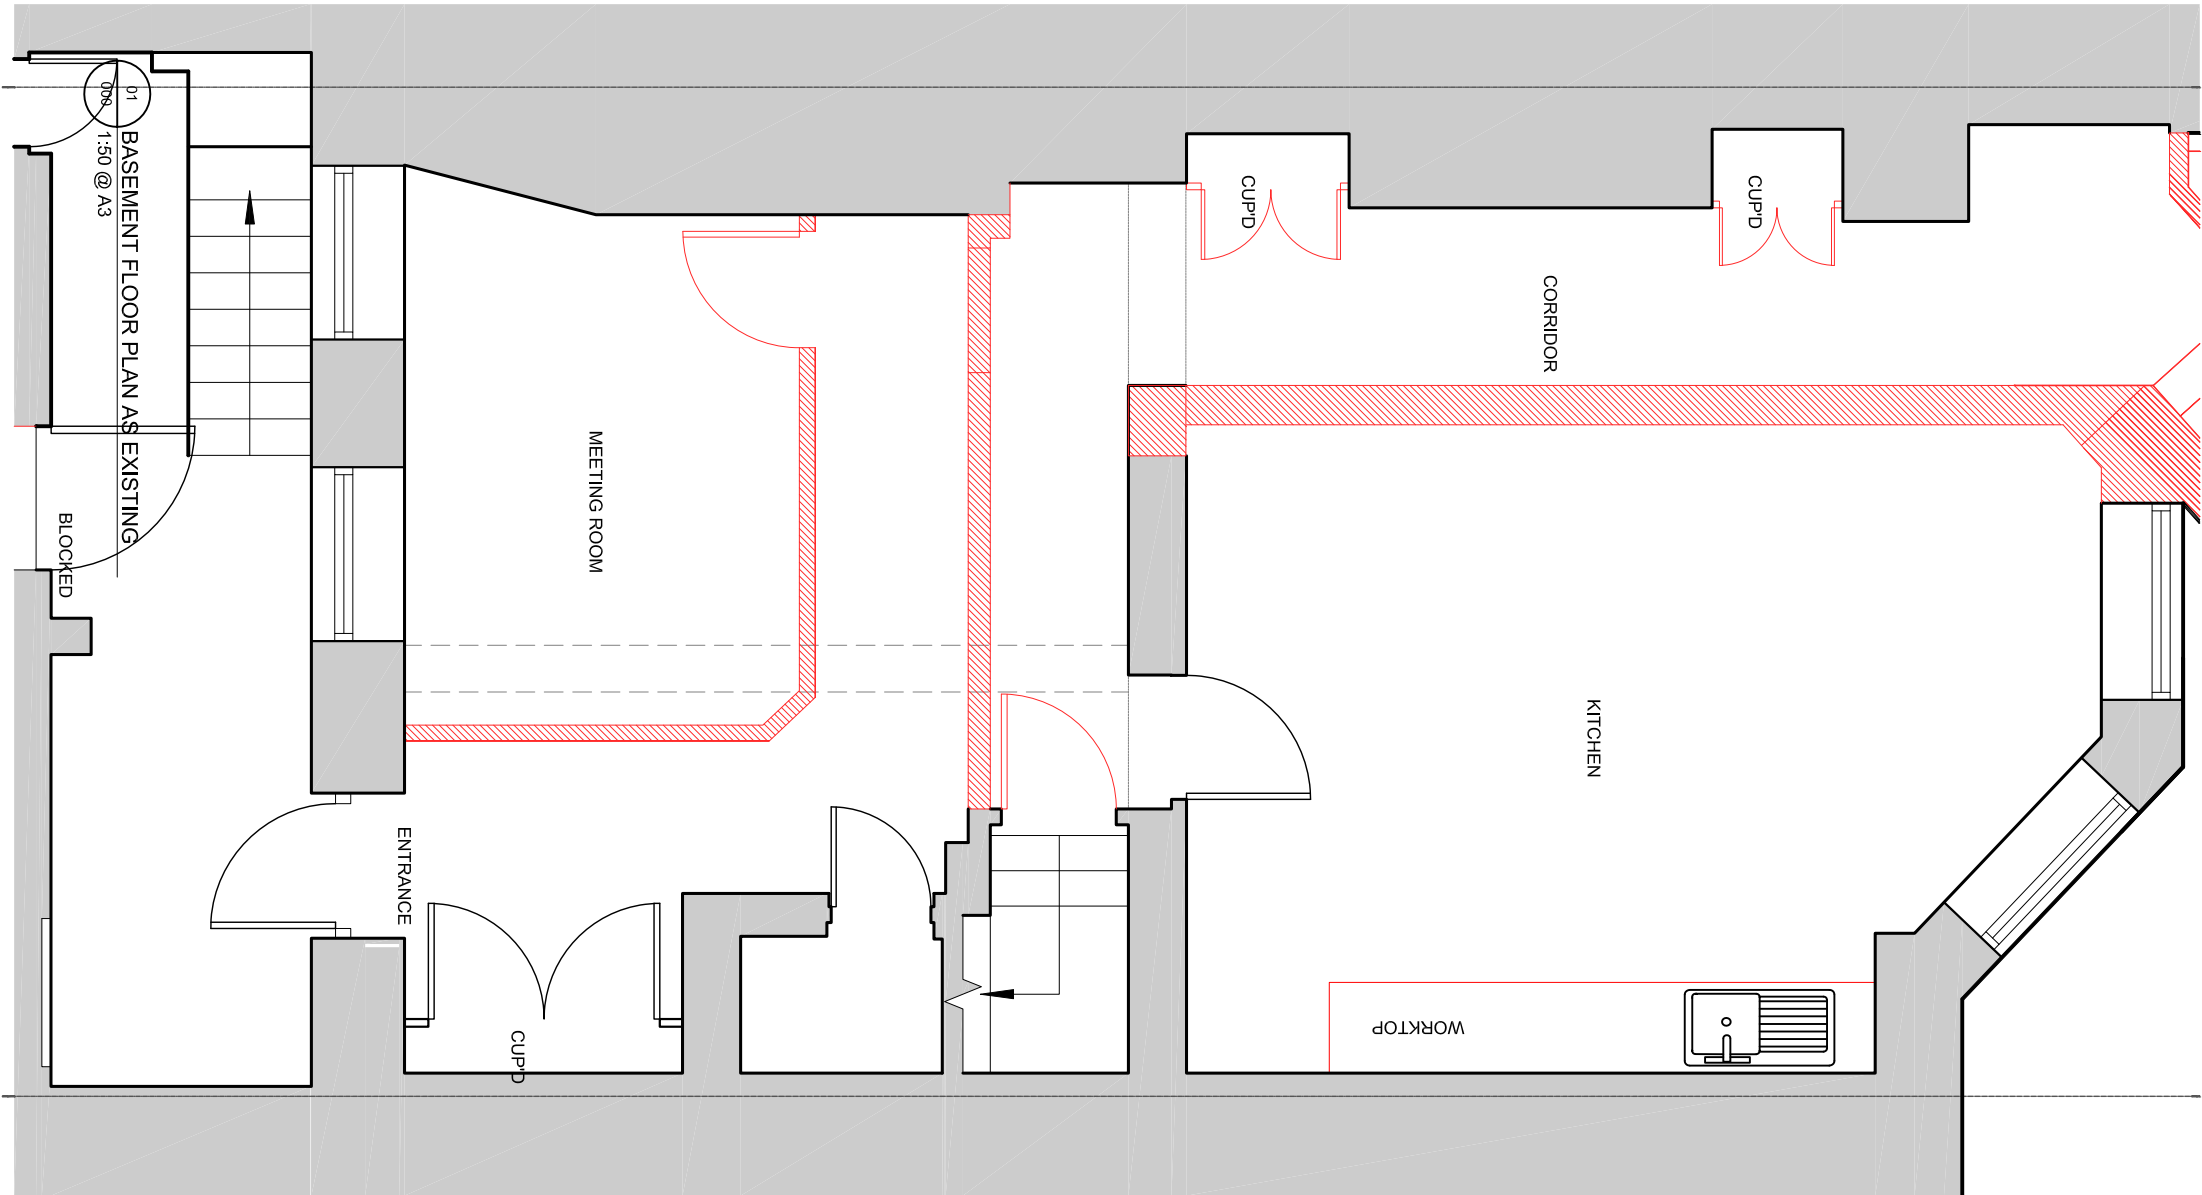
01 BASEMENT FLOOR PLAN AS EXISTING
000 1:50 @ A3

1. Paint accumulation removed from plaster cornice using paint-stripping paint-sheer such as Peel Away or similar. Residual paint carefully removed with fine pick-tools and brush to fully recover cornice moulding detail.
2. Timber framed and plasterboard partition taken down. Partition fixing holes to wall and ceiling plaster in level to the adjacent surfaces.
3. All timber paneling, skirting, cornices, dado and picture rails to be retained and rubbed down.
4. All fireplaces to be retained, cleaned and polished
5. All existing windows to be retained, overhauled and repaired as necessary.
