- SALISBURY HOUSE IS A GRADE II LISTED BUILDING IN BULLENS YARD, HIGHGATE, NORTH LONDON. As a consequence of these designations it is statutorily protected.

**WINDOW REPAIRS**

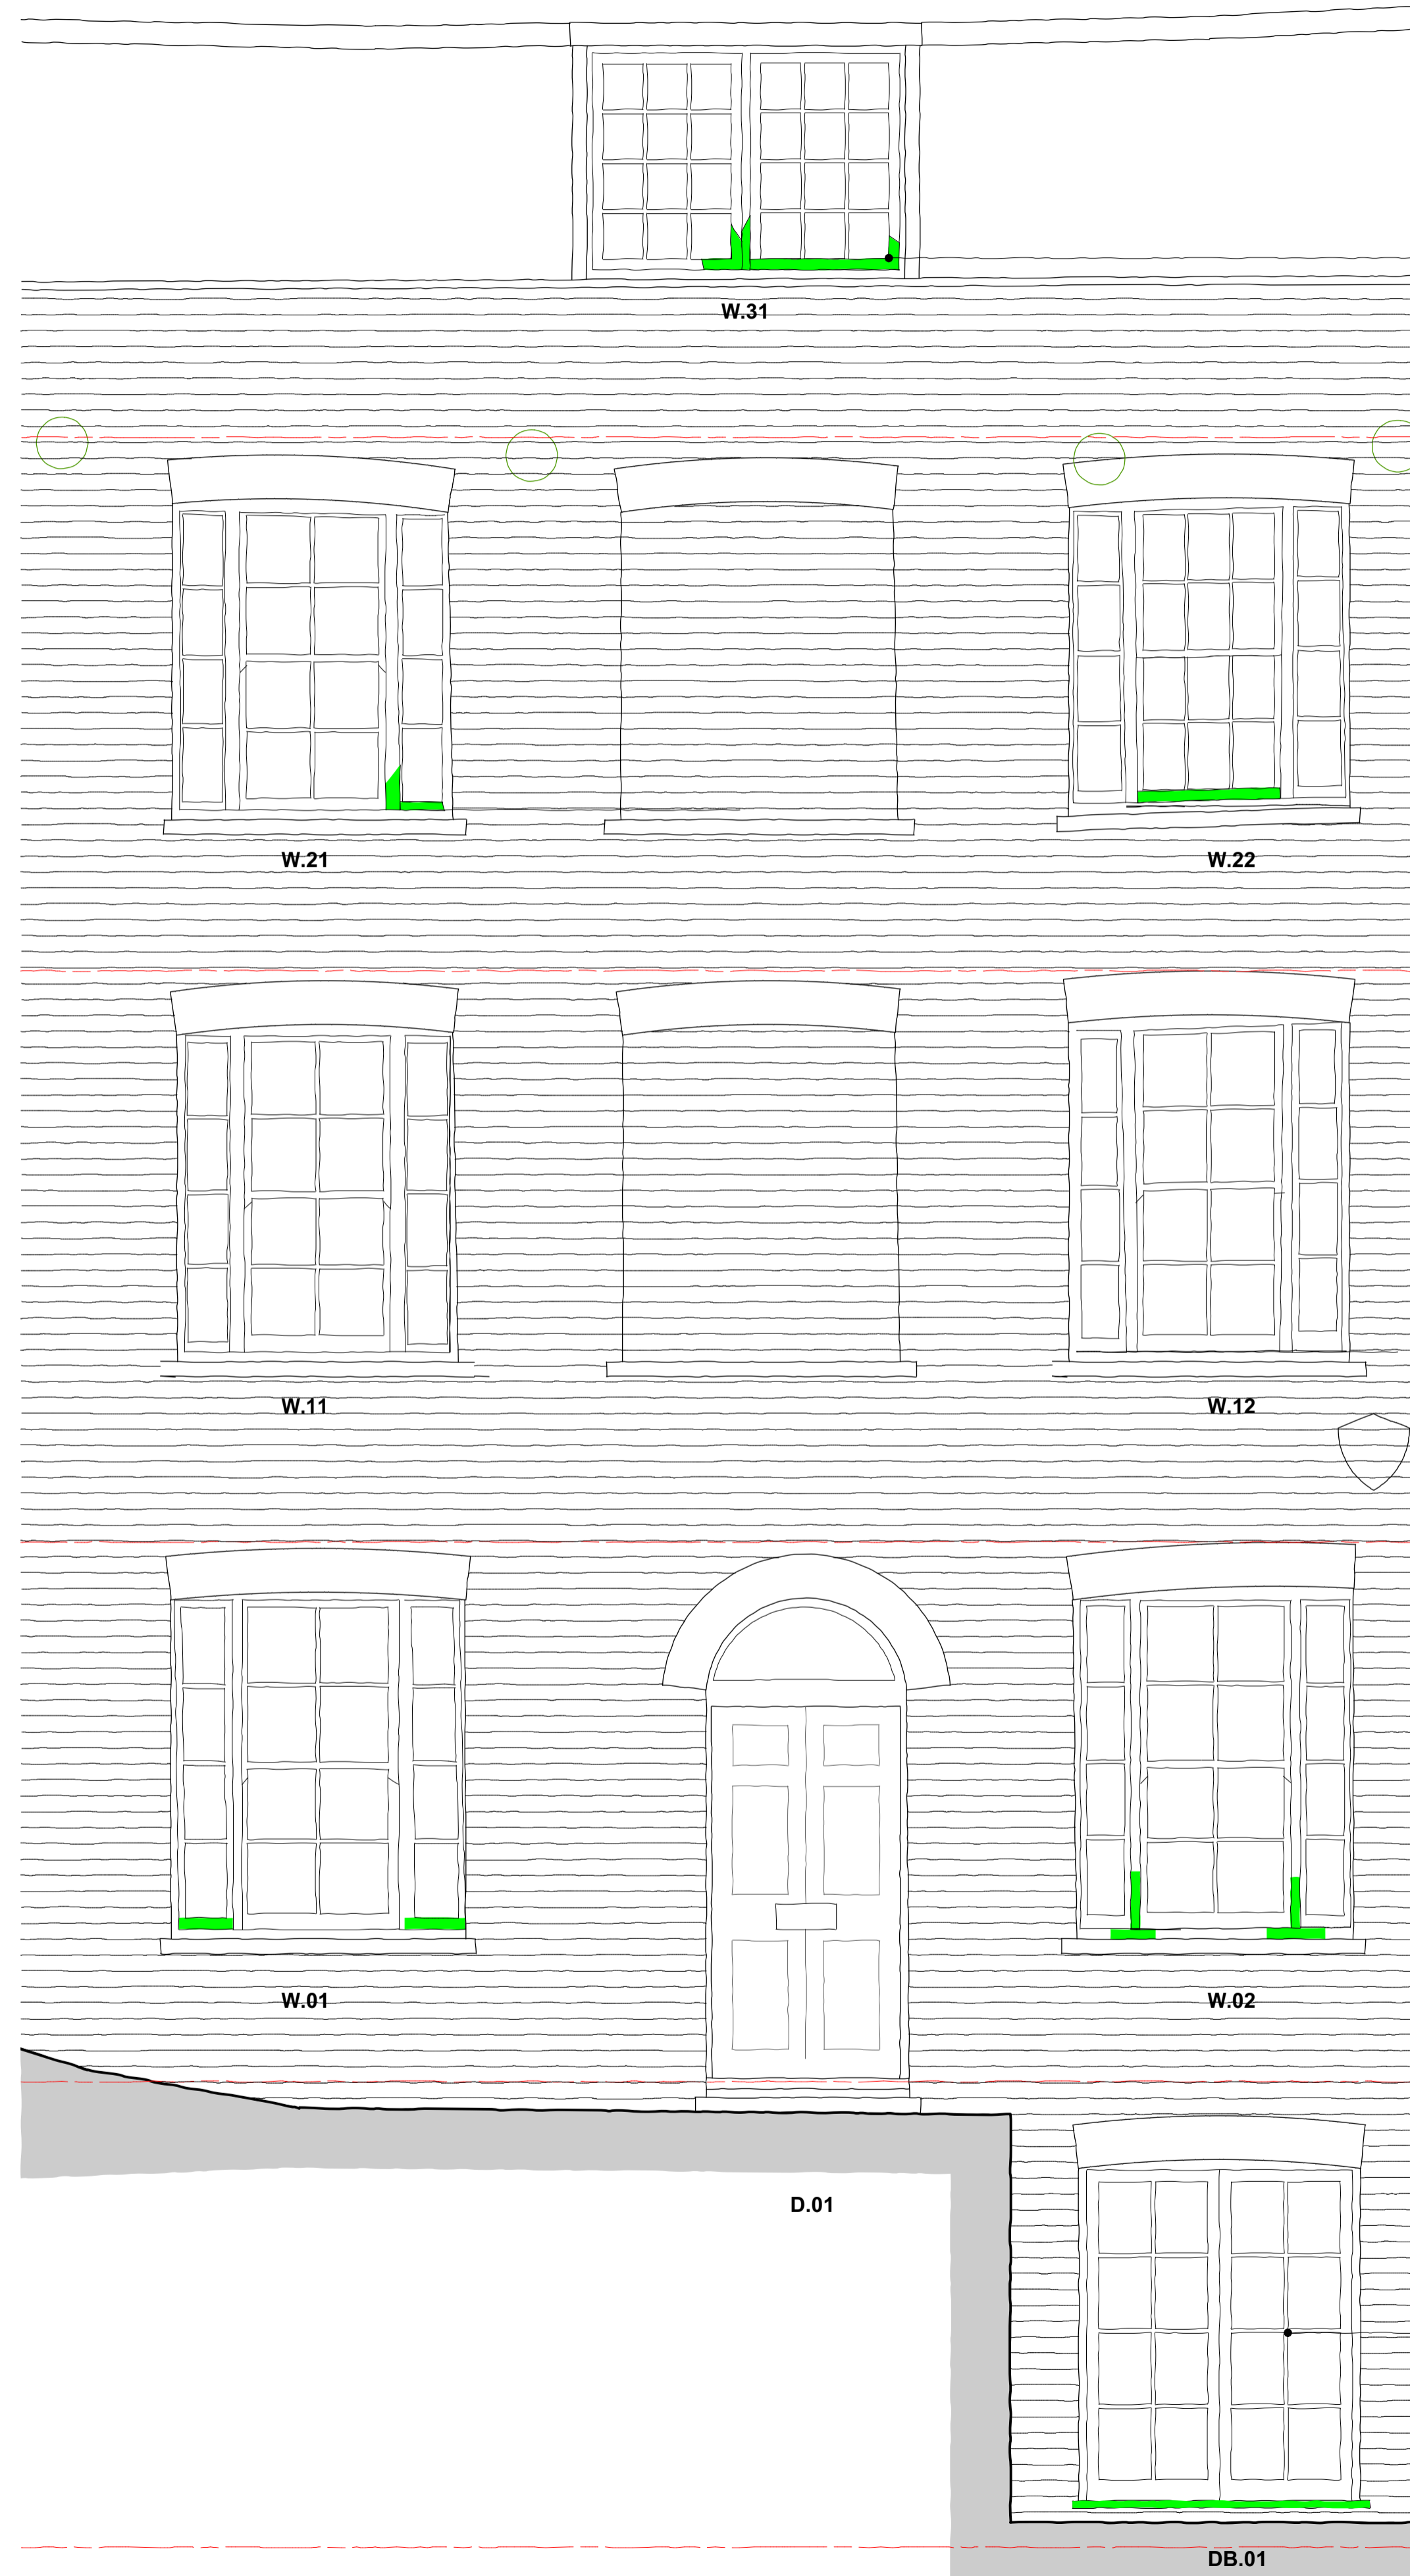
Sashes have swollen and are jammed shut. Allow for easing the doors and providing a new cill in accoya wood. Remove existing bolts and provide new antique brass ironmongery including 2 no 150mm constable bolts and 1 no french style oval knob locking espagnolette bolt.

Replace bottom rail where indicated. Cut back existing damaged timber to ensure new timber sections are spliced into sound timber (mullions and sash).

- Generally windows are to be carefully stripped of all surface decoration. Redecorate using appropriate method as specified by architect.
- Remove existing weather seals and thoroughly clean

- Rotten sections of timber are to be cut back to sound material with new sections of timber to be cut in to match existing.
- The profiles of decayed sections should be copied exactly and precisely married in to the existing.

- Timber used in the repair should be of the same species and of the same moisture content of that of the existing to avoid differential movement between the old and the new.

- Modern alterations to existing windows are to be carefully removed and replaced with traditional details to match the original
- Cracked window panes are to be carefully removed and replaced with glazing to match existing.

- Deteriorated putty should be removed manually, taking care not to damage the wood along the rebate. If the glass is to be removed, the glazing points which hold the glass in place can be extracted and the panes numbered and removed for cleaning and reuse in the same openings. The remaining putty can be removed. Hardened putty in the rabbets may be softened by heating with a soldering iron at the point of removal. Any Putty remaining on the glass may be softened by soaking the panes in linseed oil.

- Provide new discreet weather seals and ensure the window are fully functional prior to handover.
- Provide new architectural quality heavy duty Brighton screws, similar to the existing in Antique brass.
