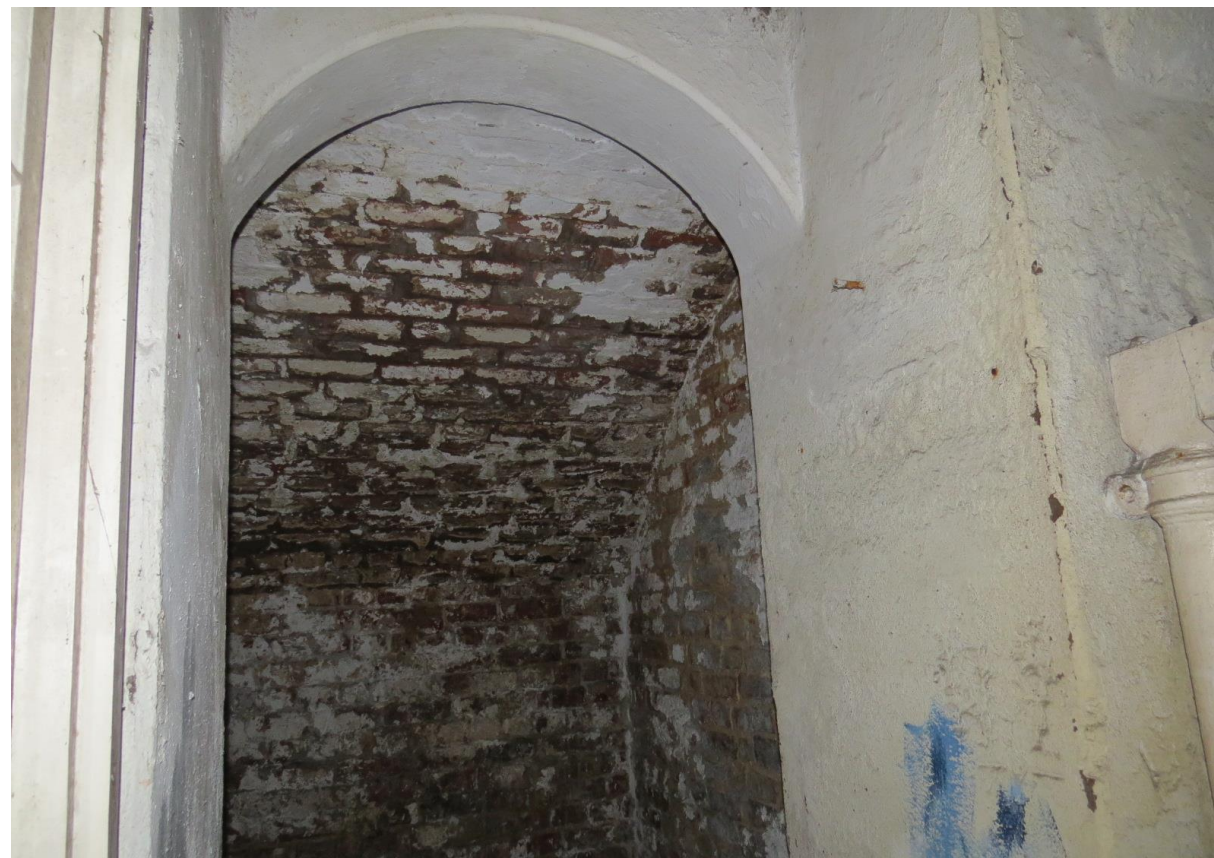
Figure 64. A photograph of one of the vaults at the basement level of Kidderpore Hall located underneath the pavement.

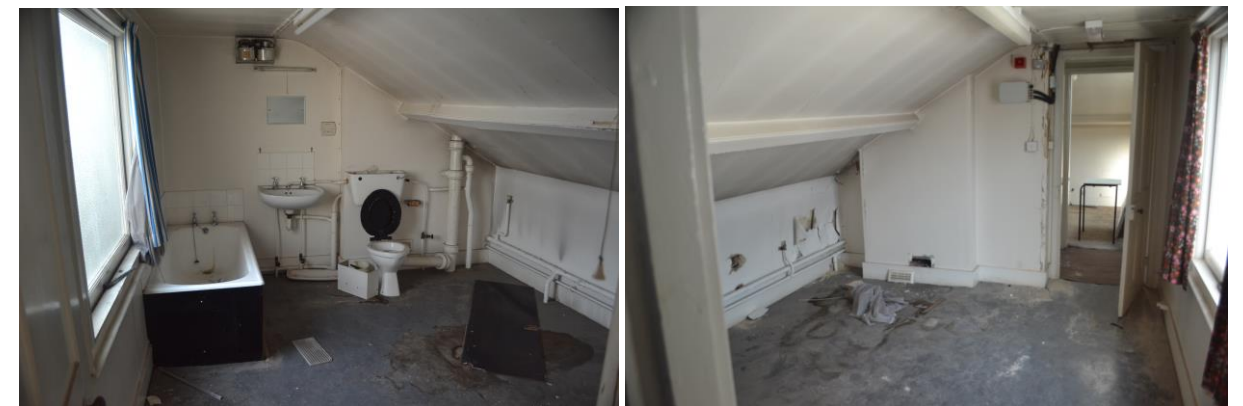
- 3.84 The rooms at the second floor level are within the roofspace. These rooms have not been maintained in recent years and the quality of these interiors is degraded. A photograph of a typical room and bathroom at the second floor level is shown at Figure 65.

Figure 65. A photograph of a typical bathroom (left) and former bedroom (right) at the second floor level.

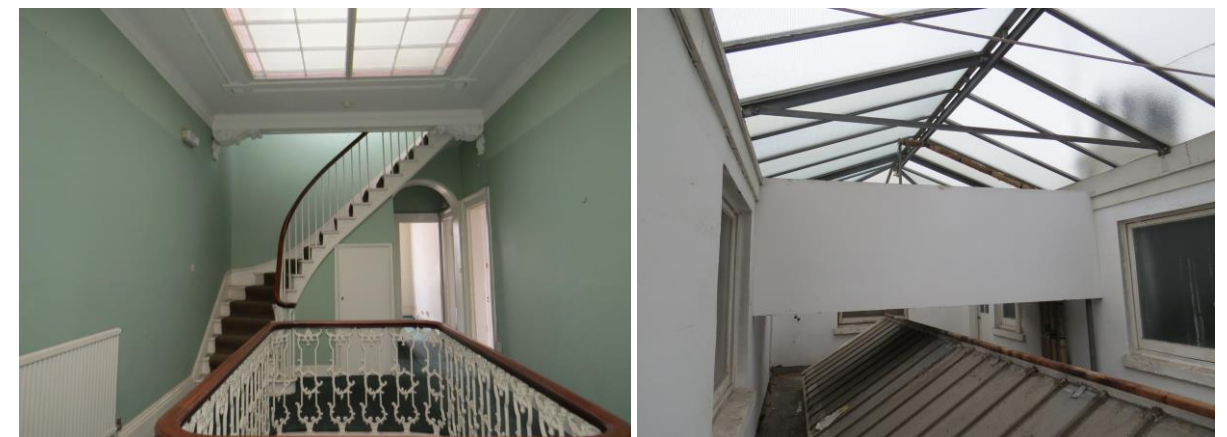
- 3.85 The rooms at the second floor level are located around the central rooflight which allows light in from the A frame truss structure. This is a later, harmful addition which detracts from an appreciation of this central space. No original plans have been found for the detail of how this area was originally laid out at the second floor level.

Figure 66. A photograph of the decorative skylight seen from a location on the first floor level landing, and the second floor level, and the structure located over the skylight at the second floor level.

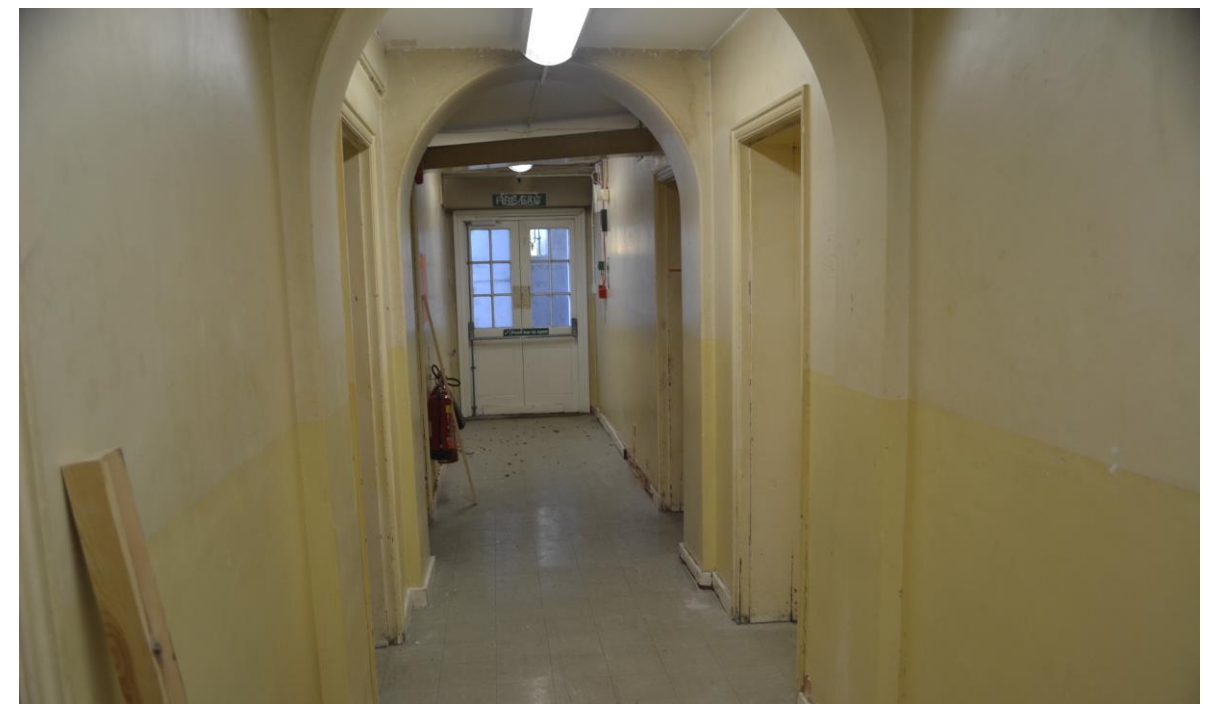
Figure 67. A photograph of the corridor at the basement level of Kidderpore Hall. The interiors at the basement level are, as one would expect, utilitarian in character and reflect their function as the original service areas of the residence.

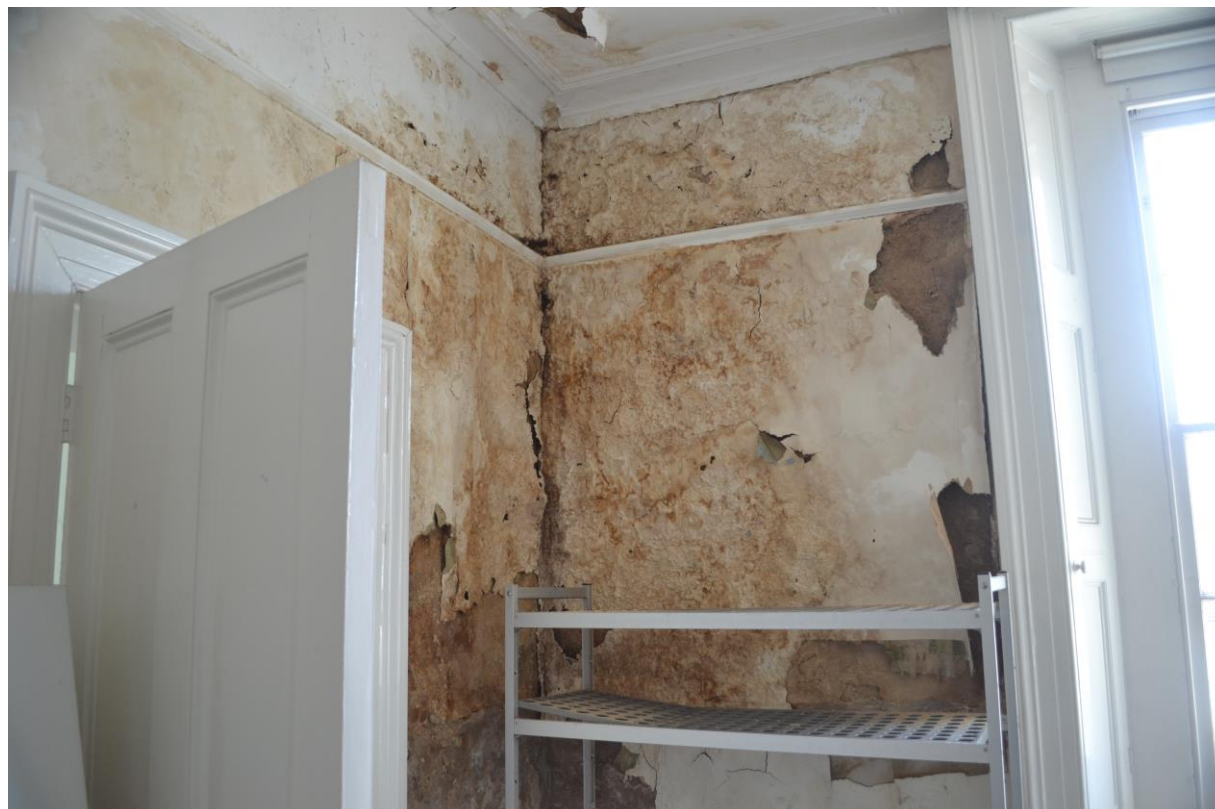
- 3.87 Kidderpore Hall has not been in a sustained, active use for a period of ten years. The fabric of the building has suffered from lack of maintenance and in some rooms, the quality of some of the interiors has been thoroughly degraded by the effects of water ingress. Photographs of the degraded interiors are shown at Figure 68.

Figure 68. An image of the damage caused by water ingress at the first floor level.

- 3.88 The building is clearly at risk of further decay and degradation of the quality of the internal fabric without attention. The building needs considerable attention and expenditure and is in need of modernisation. The quality of the services currently within the building are very poor, as evidenced in the photographs included in this statement.

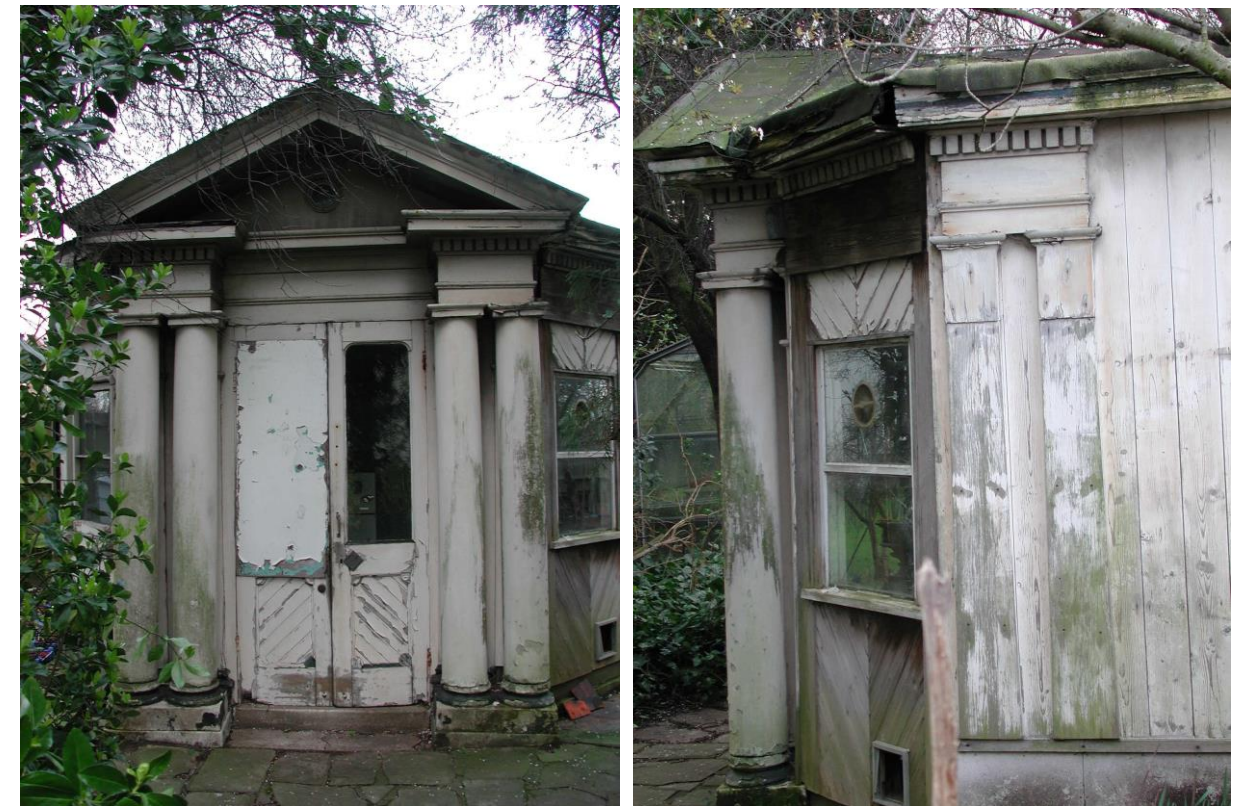
3.95 The Summerhouse is currently supported by scaffolding and is in a state of disrepair. The structure is clearly unstable and entry is not possible. This is a listed building at risk of being lost as a result of decay and neglect. It is not included on Historic England At Risk Register.

Figure 71 A photograph of the Summerhouse taken in 2002. These give an indication of the physical state of the building 13 years ago.

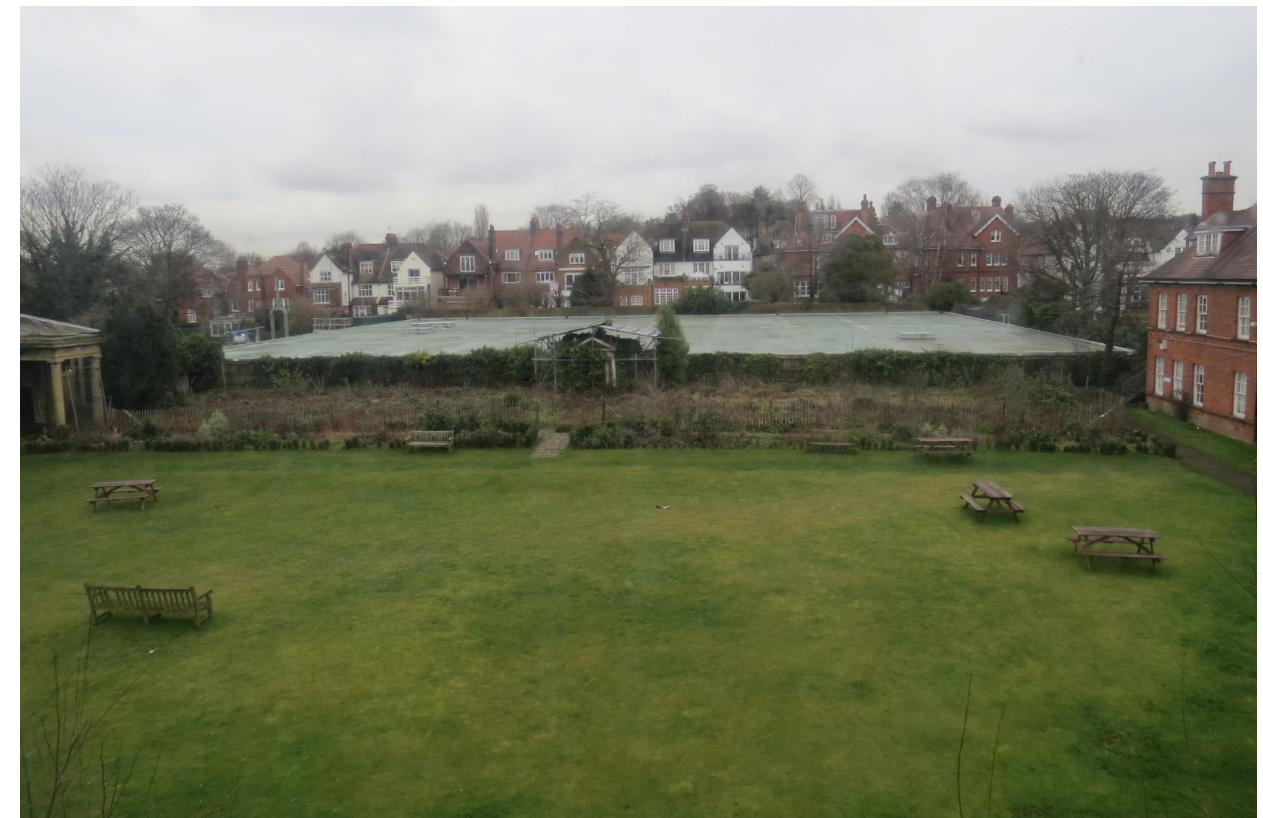
Figure 72 A photograph of the Summerhouse as seen from Kidderpore Hall, current date.

3.93 The summerhouse is currently located to the north of Kidderpore Hall, within an area overgrown with shrubbery. The location of the summerhouse, on the northern boundary of the site close to the Reservoir is shown in Figure 72.

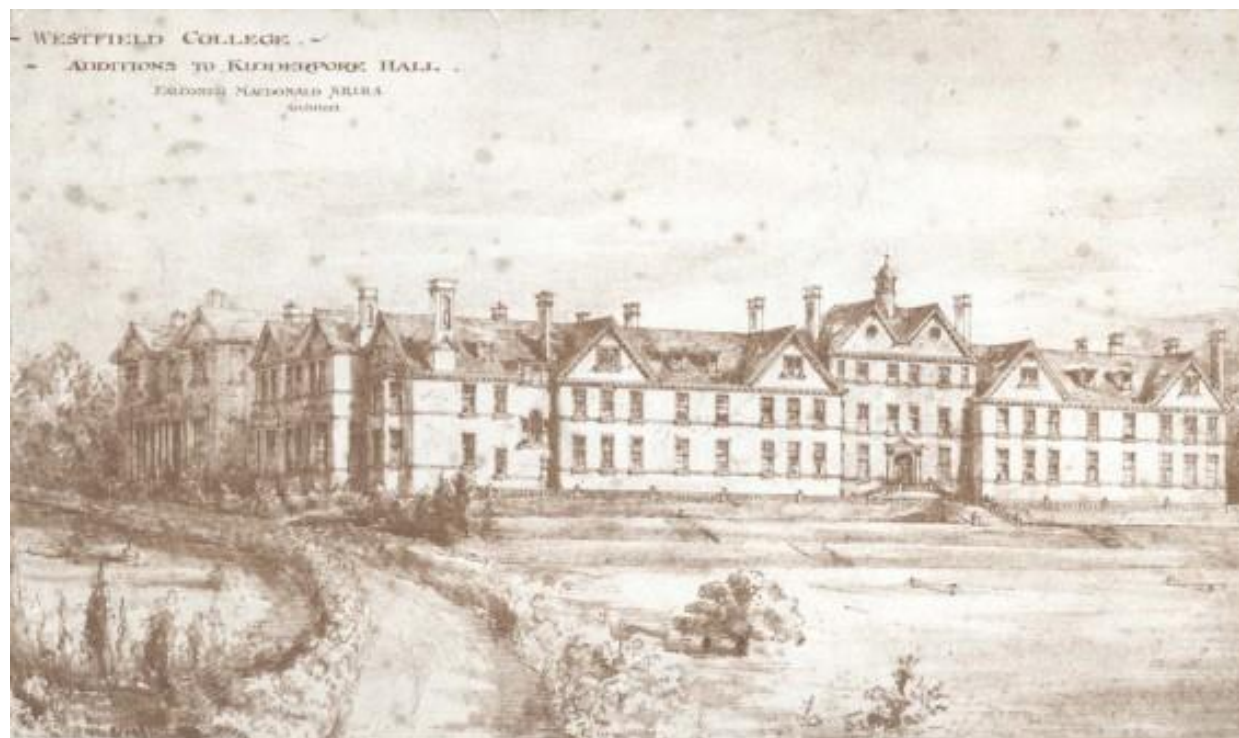
Figure 73 An architect's view of the additions to Kidderpore Hall, Falconer Macdonald c. 1891.

- 3.99 As one of his first commissions, and one for an institution on a tight budget, Robert employed, therefore, an economic approach to the Queen Anne style, with two long ranges of symmetrical elevations to the north and south. The south elevation faced onto open fields when it was first built, as shown in Figure 73.

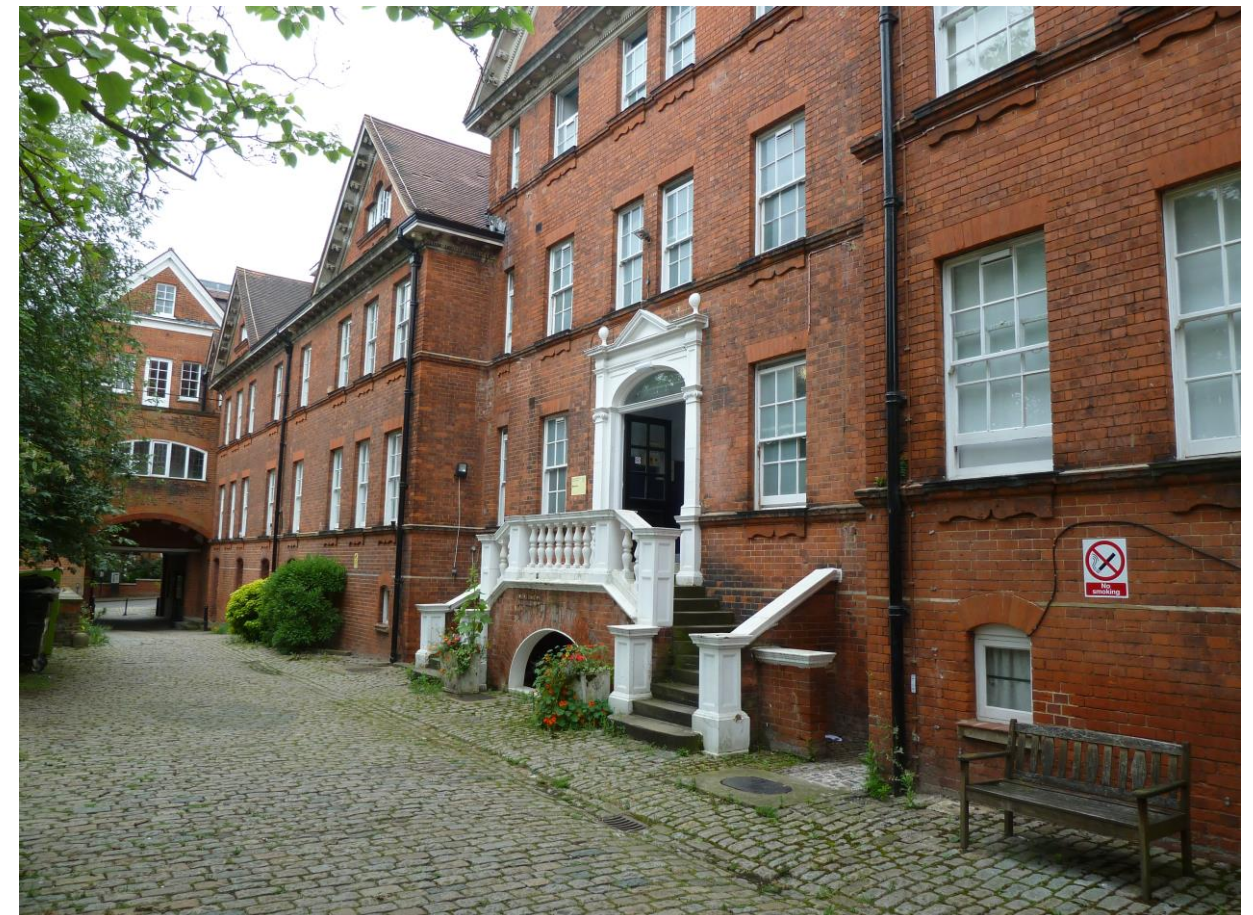
Figure 76 A photograph of the east elevation to the Maynard Wing photographed looking south with one's back to Lady Chapman Hall.

3.107 The cobbled walkway outside the south elevation to Maynard can be seen in early photographs of the student wing c. 1905 and is shown currently at Figure 76. The original extent of the walkway has, however, been reduced by the later extension to the rear of Skeel Library which can be seen in Figure 78.

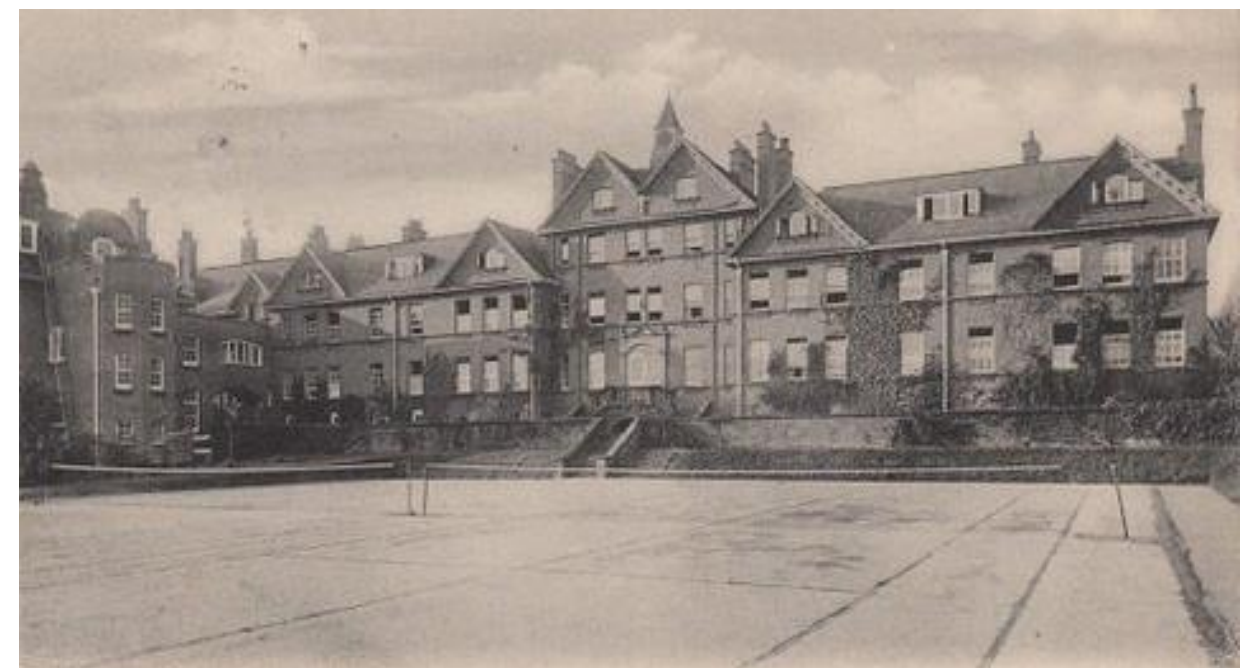
Figure 77 A view c. 1905 looking northeast across the tennis courts which formerly occupied the space to the south of Maynard Wing. The rear two storey extension to Skeel Library had not been built at this point.

3.106 The heavy modillion eaves cornice which runs on the inside of the gable ends on the Maynard Wing is an architectural feature that was picked up subsequently in the design of later buildings by Falconer MacDonald at Dudin Brown Hall, and by Thompson and Walford at Lady Chapman Hall. The chimneys can be seen in the photograph at Figure 77.

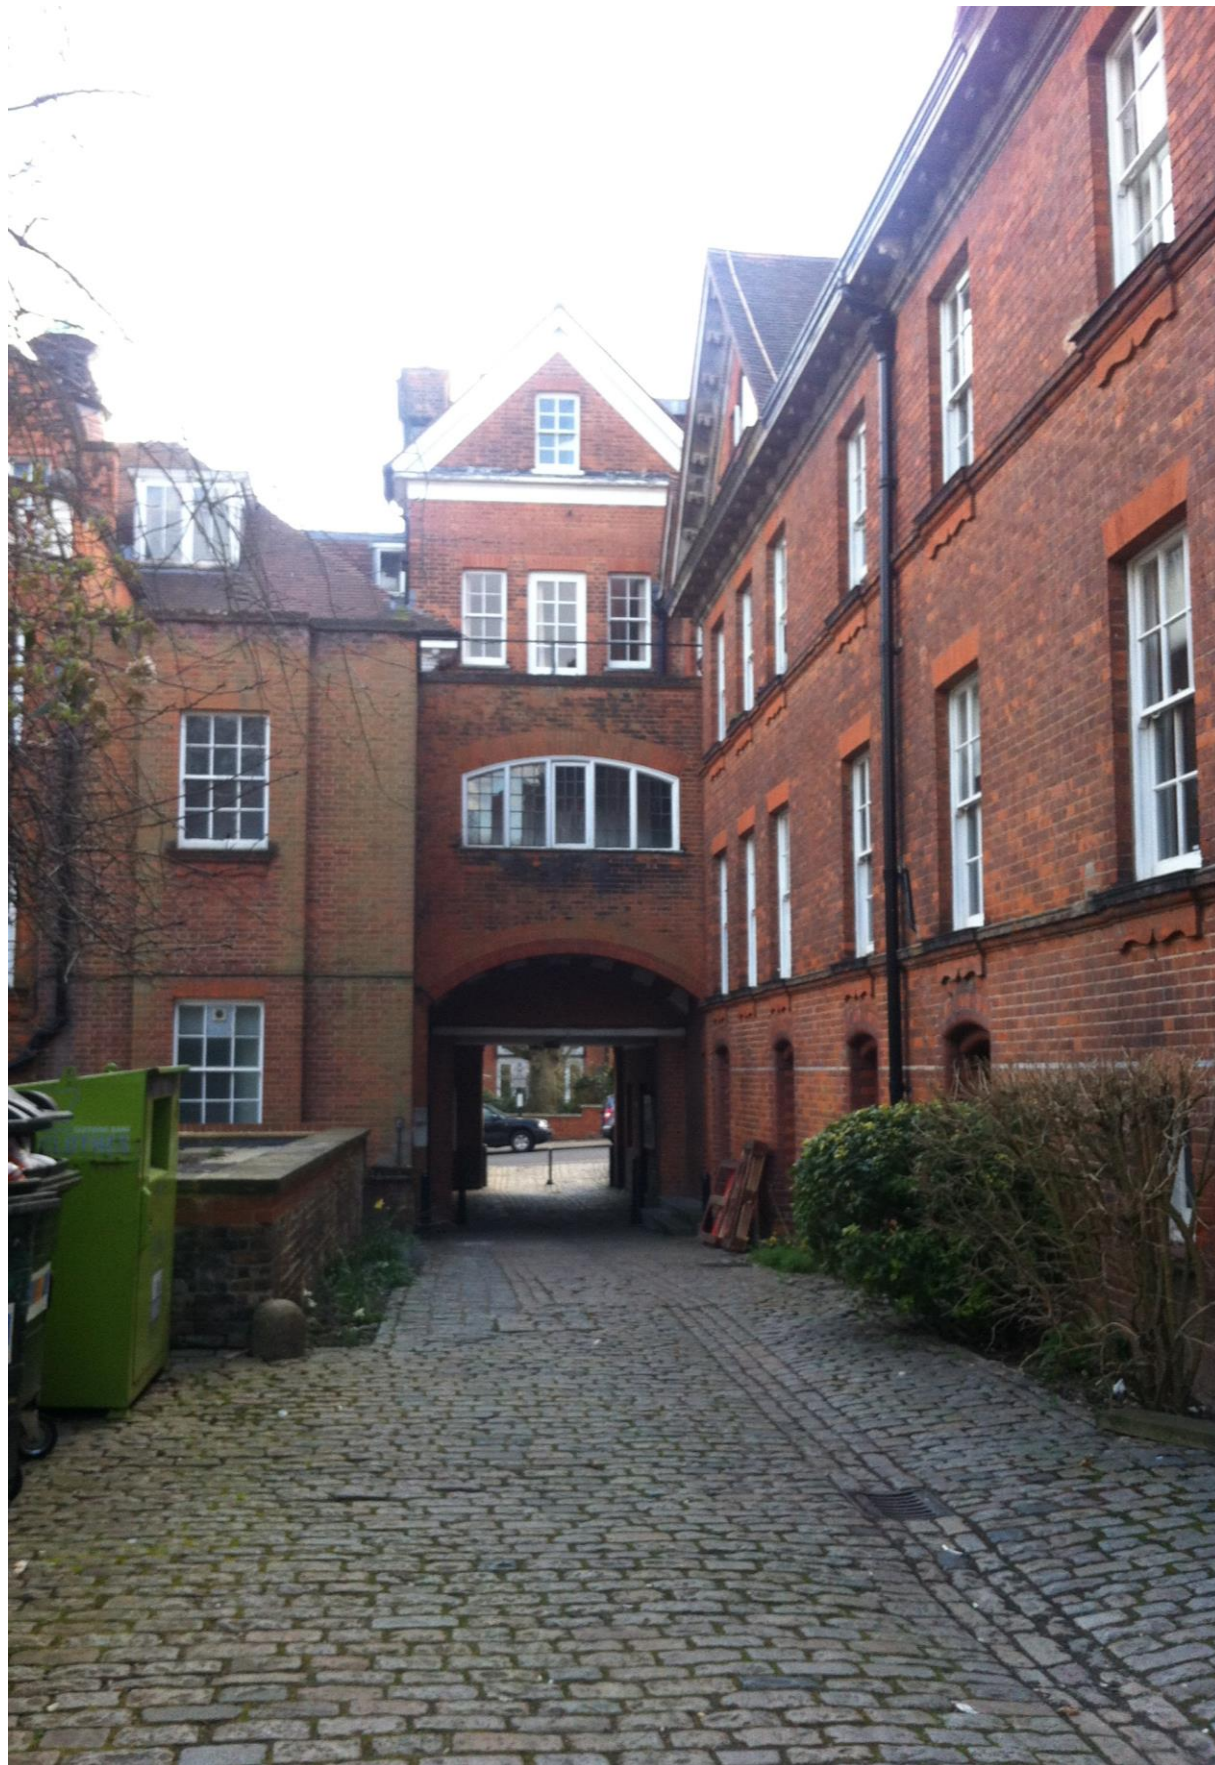
Figure 78 A photograph of the cobbled walkway to the east of Maynard wing looking towards Kidderpore Avenue.

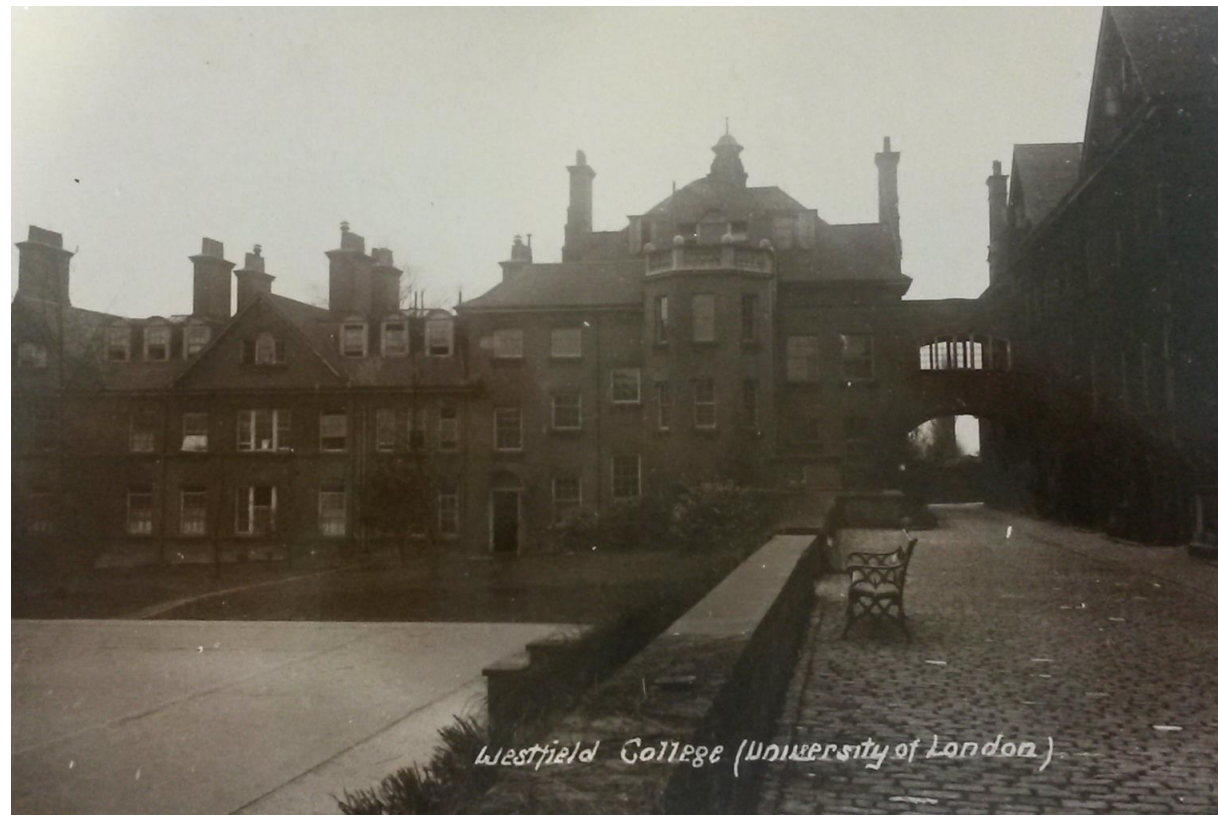
Figure 88 An image c.1905 showing the rear elevation of Skeel Library and the original bridge link between Skeel and Maynard.

- 3.119 The sketch plan showing the proposals to build Skeel Library in 1903 is included at Figure 13. This plan shows the frontage of the completed Maynard Wing as set back from that of Kidderpore Hall, with a narrow bridge connection between them which would have allowed an observer to read the new Skeel building and Maynard as separate buildings in the streetscene.
- 3.120 The photograph of the elevation of the Westfield site as seen from Kidderpore Avenue, taken c. 1929, shows that this was the case. The original extent and design of the archway over the cobbled walkway, referred to as the 'Bridge of Sighs' by J Sondheimer, and mentioned in the list entry summary, can be seen in the photographs at Figure 88 and Figure 89.

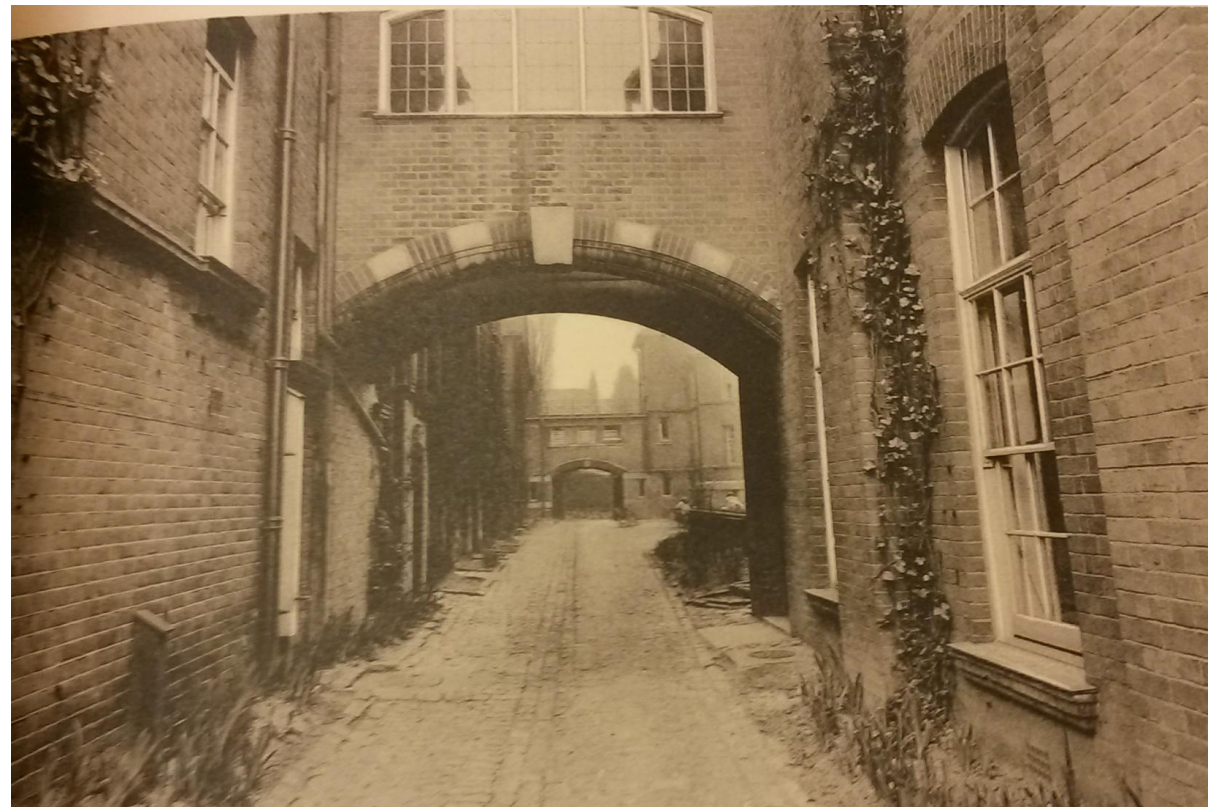
Figure 89. A photograph of the bridge structure which provided the original link between Skeel Library and Maynard Wing.

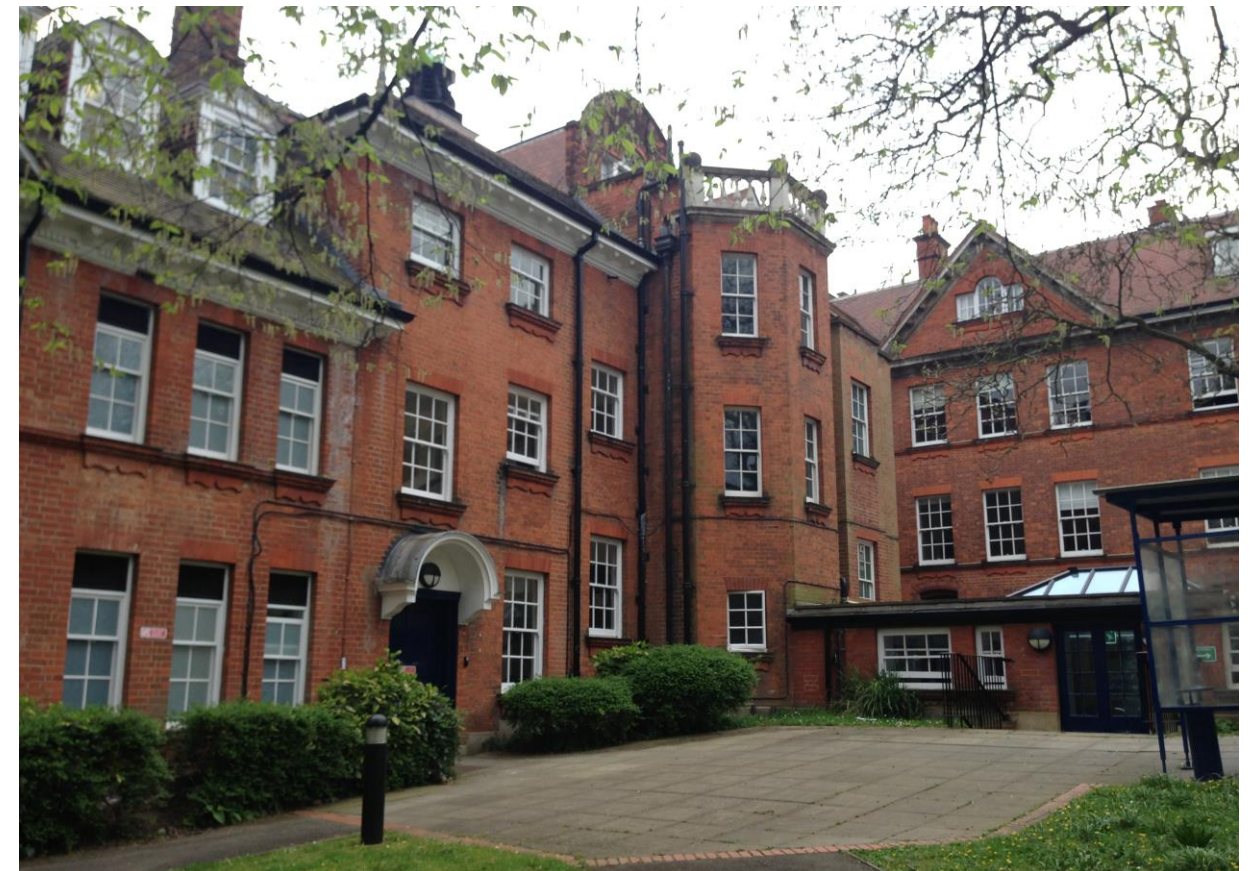
Figure 92. A photograph of the rear elevation of Dudin Brown with the canted bay structure containing the original staircase to the former Skeel Library.

- 3.131 Circulation in Skeel is provided by way of the main central staircase to the rear which is contained within the bay window, and the secondary staircase from the second to the third floor rooms. A balcony space exists above the bay staircase, which is not readily accessed.

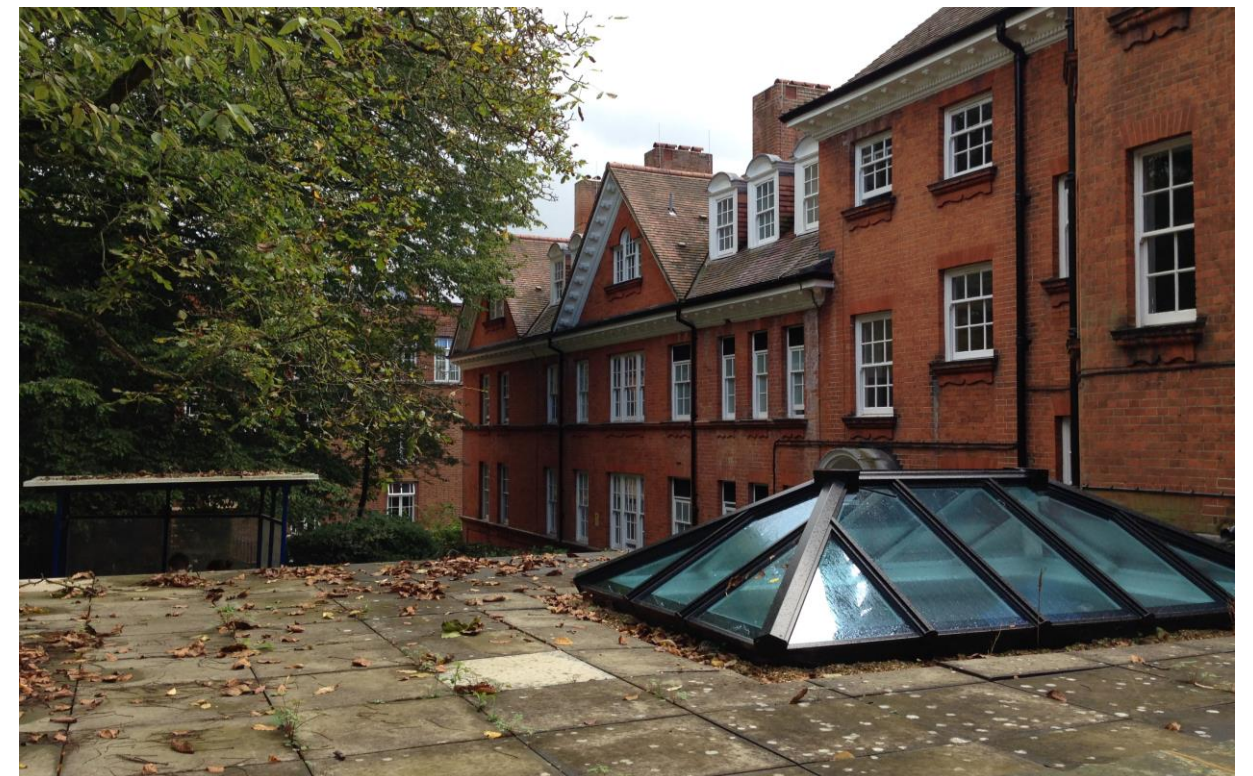
Figure 93. A photograph of the roof of the single storey extension to the rear of Skeel Library and the protruding rooflight.

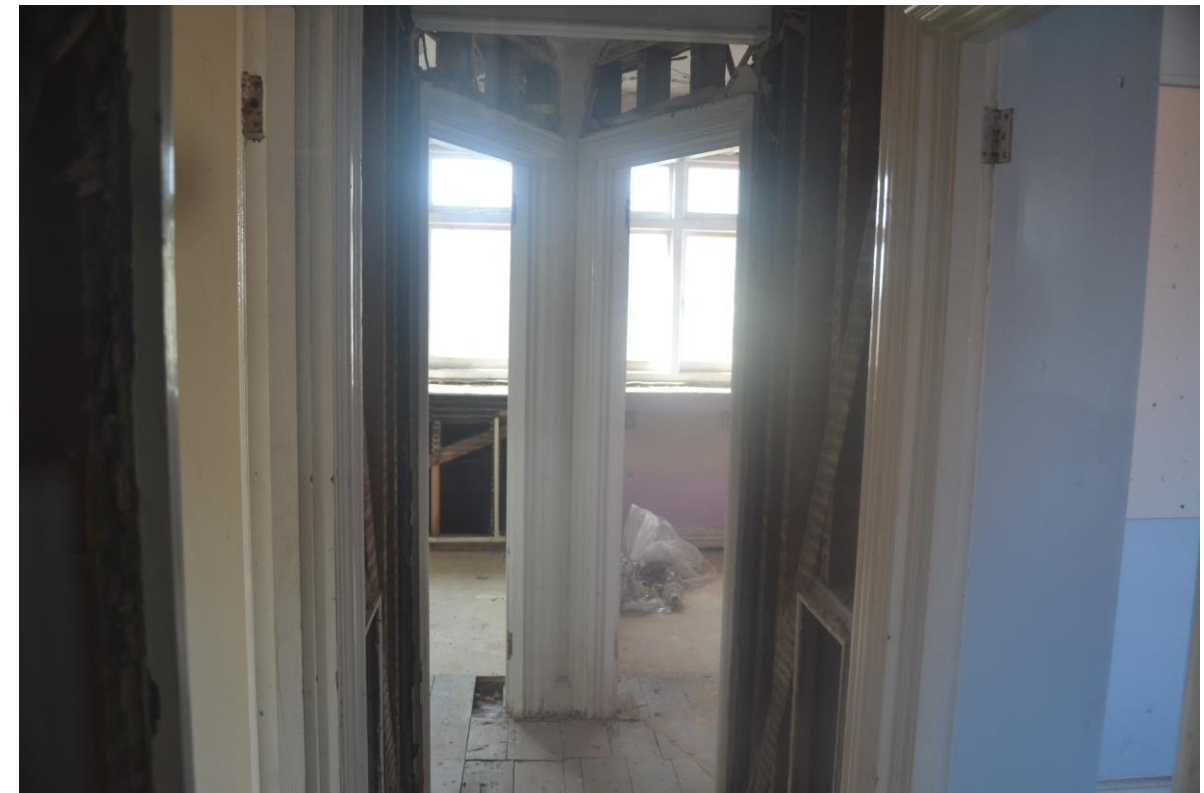
Figure 94. A photograph of the internal partitions at the second floor level.

- 3.130 Above the library space is a further floor known as the 'Crow's Nest' which was most recently used as four student bedrooms. Use of this space was discontinued for safety reasons due to the lack of secondary access/egress. The partitions which divide these rooms in this top floor have been damaged and timbers are exposed. The quality of the interiors at this floor level are poor and in their current condition, detract from the special interest of the listed building.

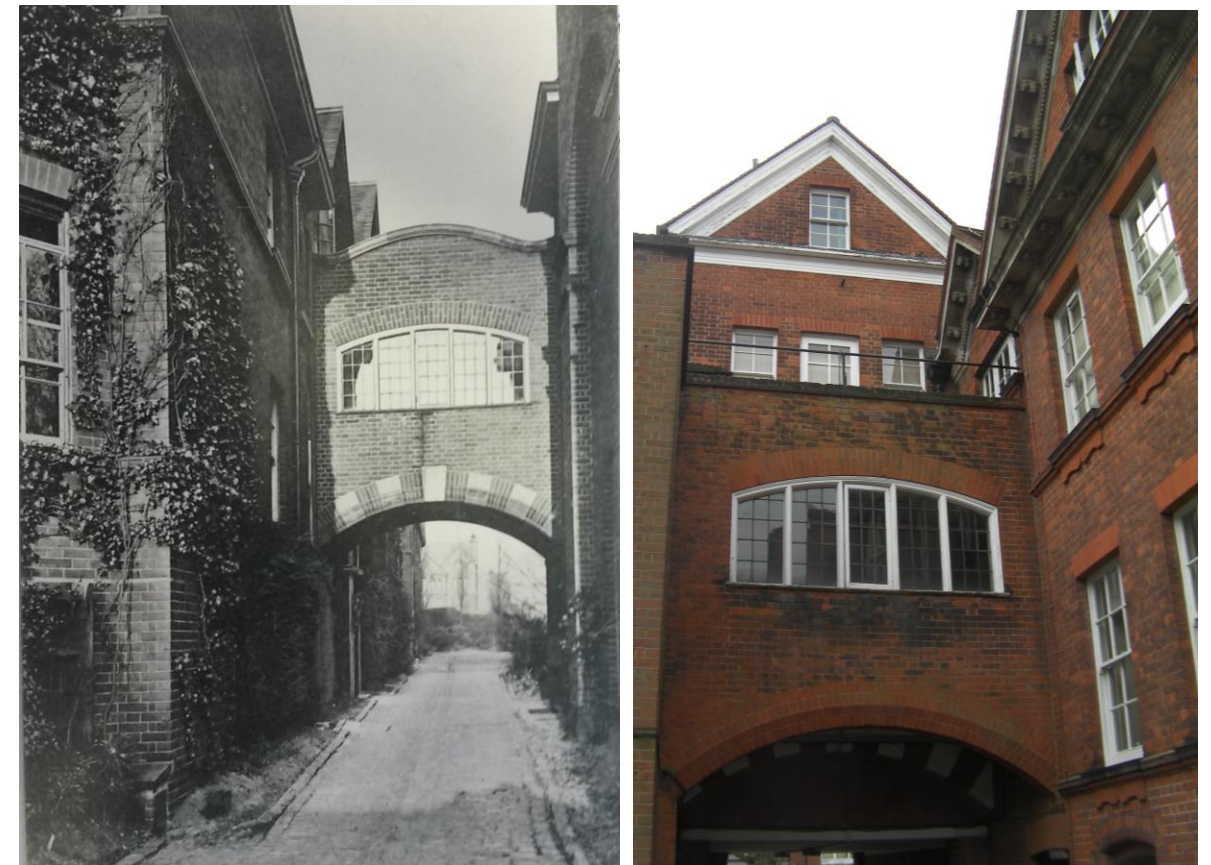
Figure 98. Left: an image of the original bridge link between Skeel Library and Maynard Wing. This photograph is taken prior to the construction of Lady Chapman Hall, and the dwellings on Ferncroft Avenue can be seen in the distance, beyond the boundary of the accommodation premises. Right: the original bridge link behind the 1934 Bay extension.

- 3.121 The original extent of the bridged link between Skeel and Maynard is now obscured by the later extension to the dining wing of Maynard, which was completed at a date after 1934, as shown by comparing the historic maps of 1934-5 and 1953-4 and the proposed site plan for the construction of Lord Cameron Hall, which was drawn up in 1934. This is also labelled on the plan of the College as dating from 1935, shown in Figure 38. This extension served to infill the elevation of the original Maynard Wing (1891) and Skeel Library so that a continuous elevation to Kidderpore Avenue is now read.

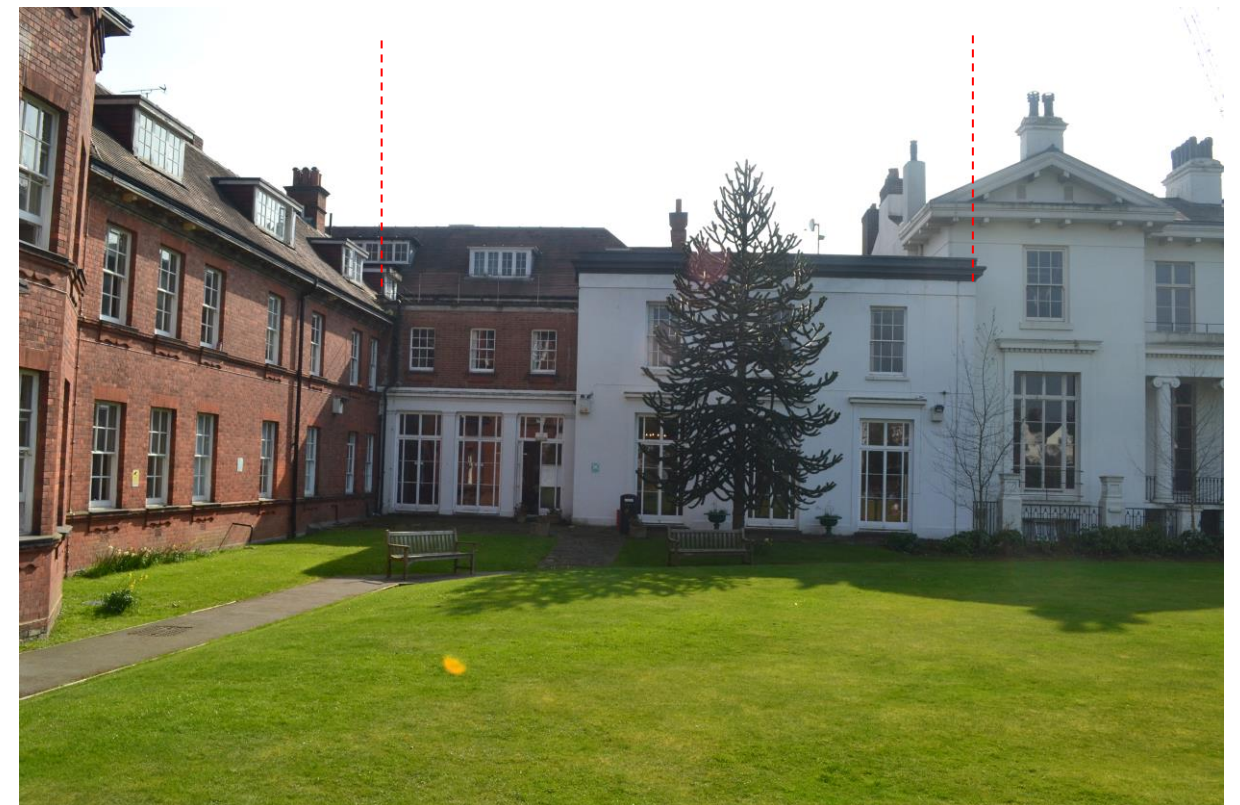
Figure 100 An image of the rear Bay House extension in its context with Kidderpore Hall and the Maynard Wing. The dotted red lines indicate the extent of the Bay House Lounge as seen from the rear from the garden.

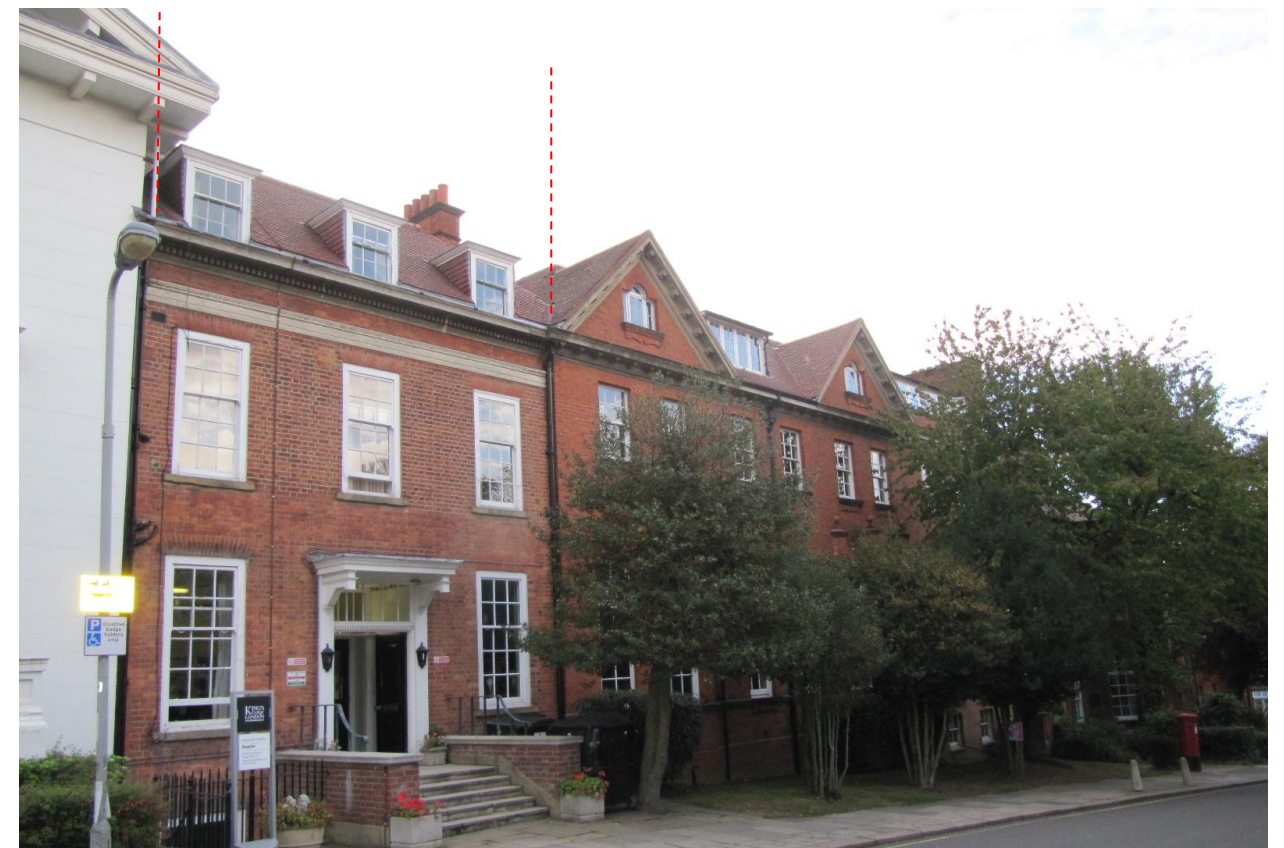
Figure 101. A photograph of the 1921 Bay House extension as seen from Kidderpore Avenue. The red dotted lines are indicative of the extent of the Bay House infill.

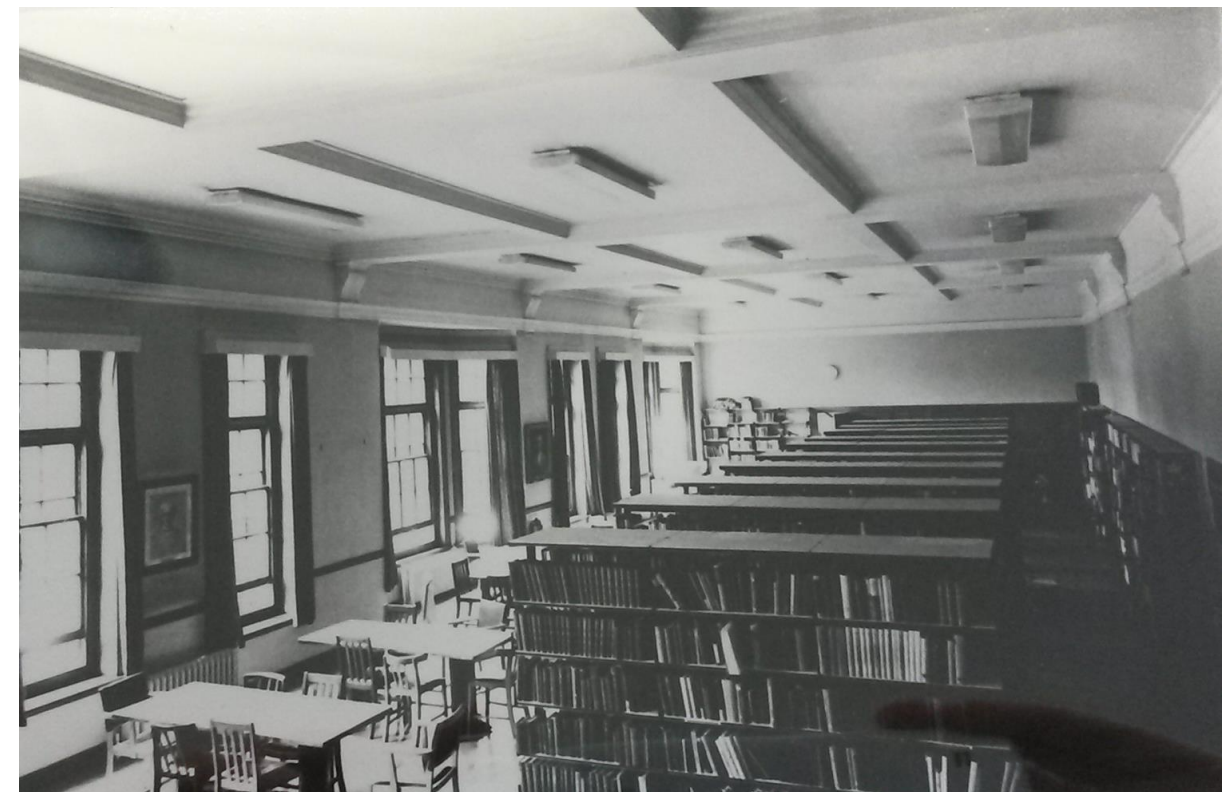
Figure 103. A photograph taken in 1971 of the 'New Reading Room' from the dais- this was formerly known as the Dining Hall.

- 3.140 The new extension completed in 1934 was referred to as the 'Dais' and the new room was to be open plan with a raised platform at one end. The appearance of this interior can be seen in Figure 103, a photograph dating from 1971, which shows Bay House hall was used as a reading room at this time. Prior to this, the space was referred to as a Dining Room, as consistent with the former use of this part of the Maynard Wing.
