Tree Protection and Construction of a rear extension and landscaping

Trees, Construction and Tree Protection – An Impact Assessment and Recommendations

Site: 16 Pakenham Street, London WC1X 0LG

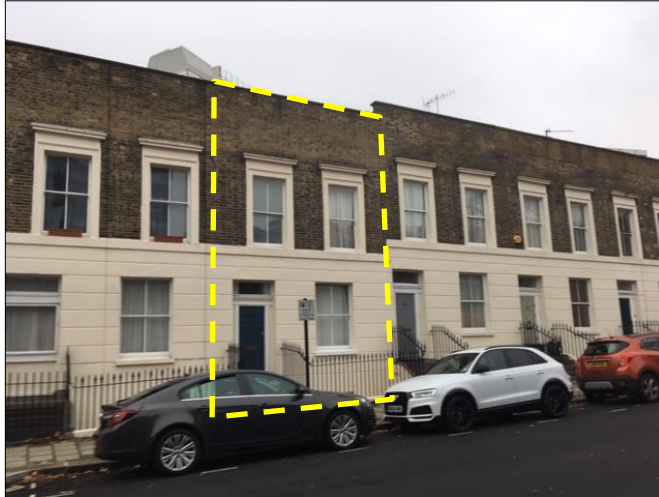
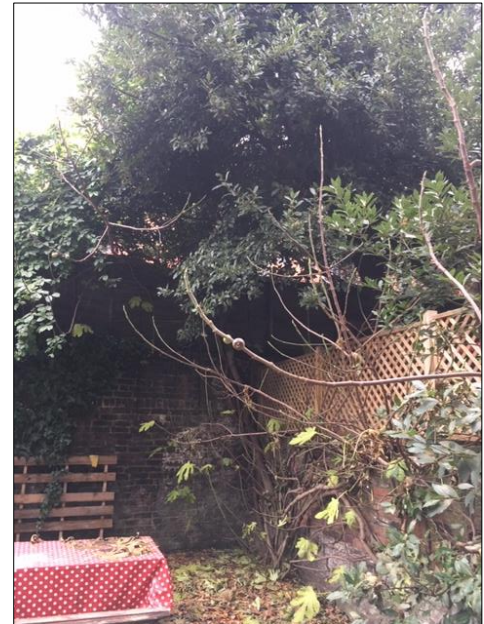
- 2.1 The site comprises a three-storey town house with modest courtyard garden at the rear. A lightwell exists at the front.

Fig.1 16 Pakenham Street (front) and rear - right

- 2.2 The house is adjoined to the north and south by similar, residential terraced buildings already with rear extensions having been constructed. Brick boundary walls separate the rear gardens. Steps lead up to the terraced garden area, which is paved, from lower ground floor level.

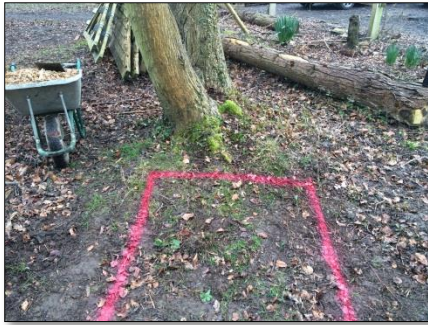
Mark out area to be excavated by manually and set ground protection at the side of the excavation area

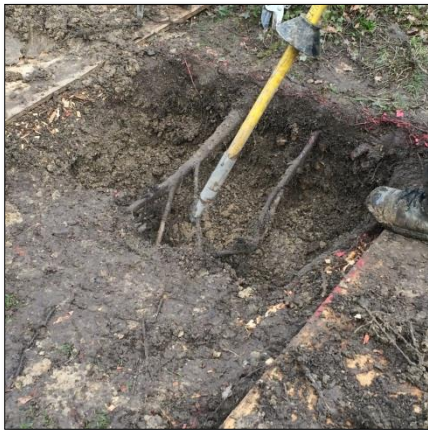
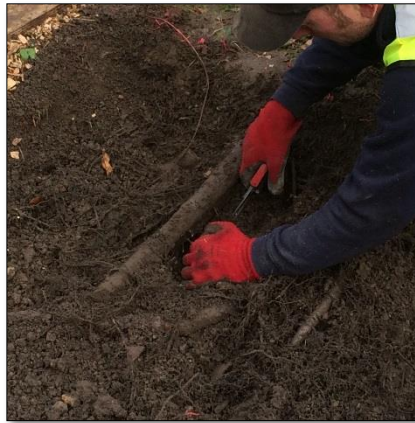
Expose the roots manually and with compressed air as necessary

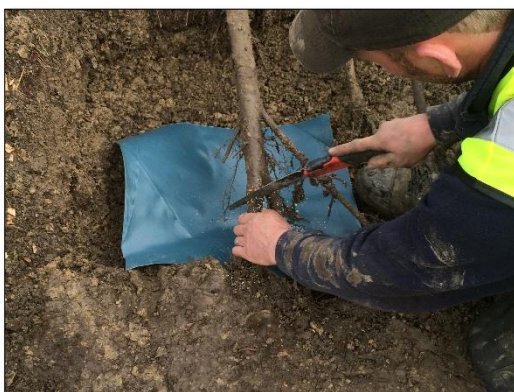
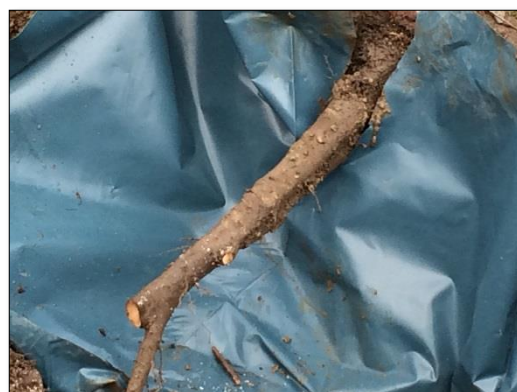
Undertake root pruning (<25mmØ) using sharp pruning tools, avoiding tears or splits and making the pruning cut as small as possible. Roots in excess of 25mmØ may be pruned following arboricultural advice. Line the exposed soil with an impervious liner before protecting any retained roots.

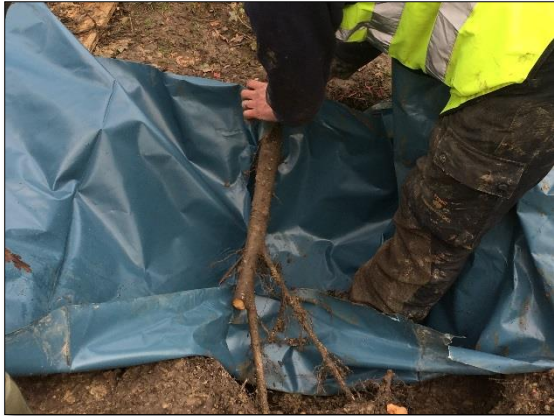
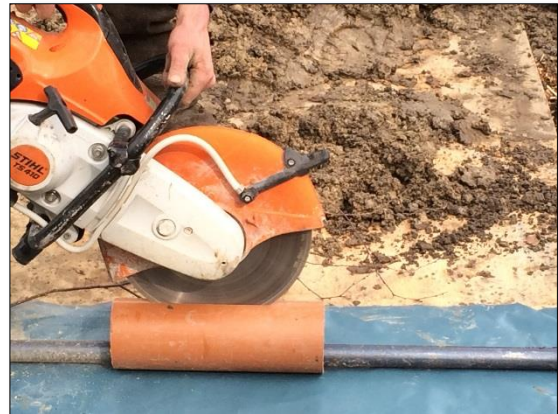
Identify the roots for retention and prepare a void-former (root protection 'sleeve').

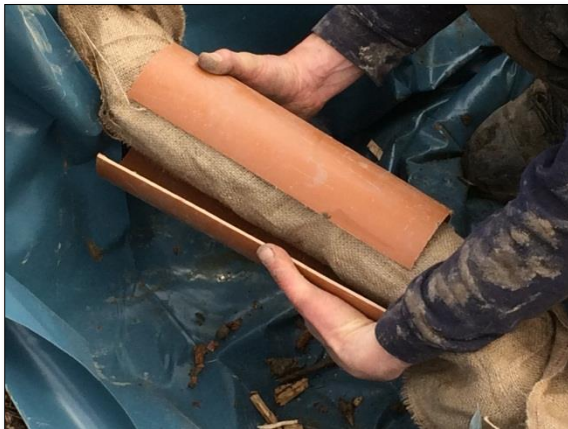
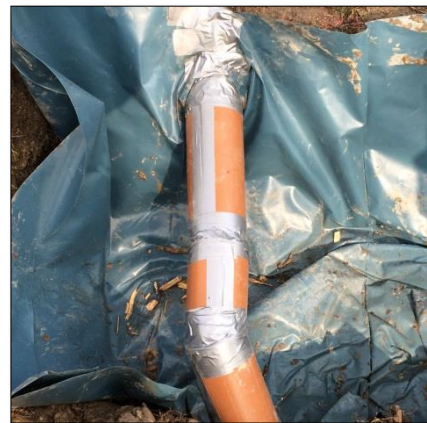
Wrap the identified roots in hessian before fitting the void-former and sealing with duct tape or similar.

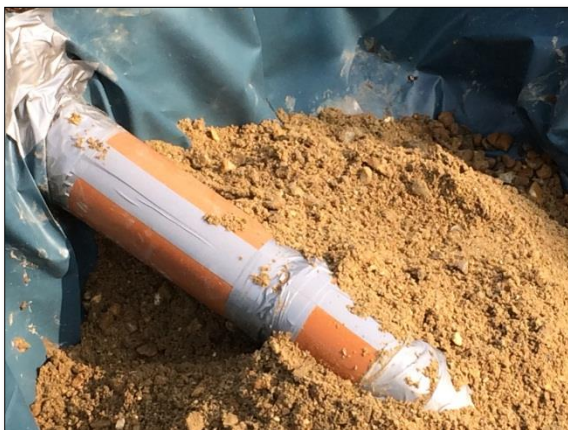
Back-fill the construction area (e.g. footing or base slab) following root protection.

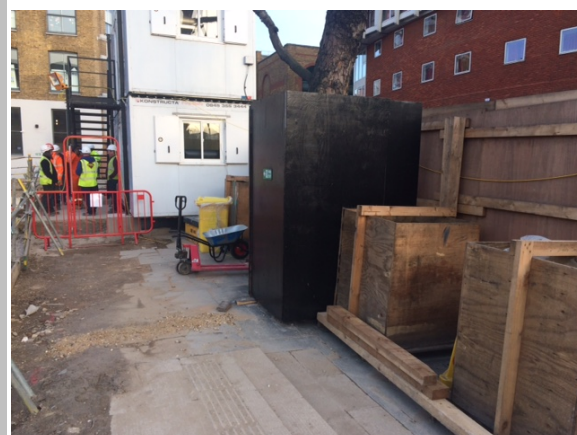
Robust hoarding and temporary concrete ground protection

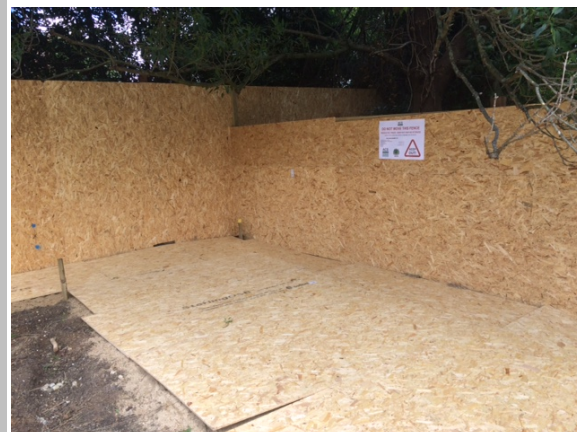
Tree protection Hoarding and ground protection over sharp sand.
