handrail replaced

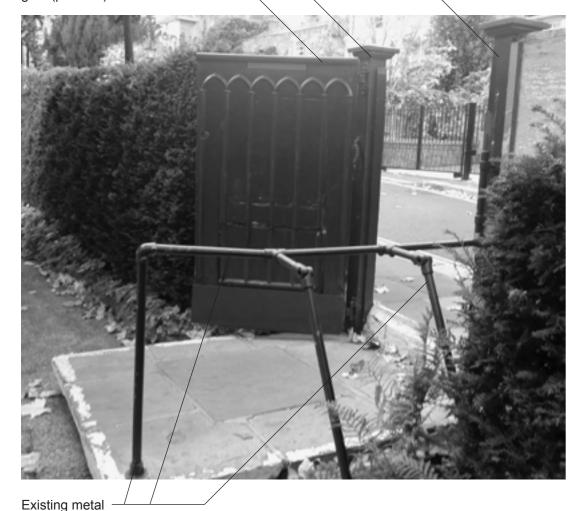
Recessed fixing into post to se details so fit for purpose without visible fixing plate Existing timber post retained Spigot welded into the handrail. Welds ground smooth to allow the hairline joint Flush screw on underside of the handrail Existing step with white line repainted with external 'grip' paint fit for purpose Base cemented into base and base chamfered up Base cast into R.C. base so all fit for purpose

New 60ømm steel handrail galvanised and metallic PPC finished. Colour to match metal gate (bronze). Hairline joints. Galvanised 'drip' holes to lower side only.
