BS 5837 Arboricultural Report

Impact Assessment & Method Statement

**26 Netherhall Gardens
Camden
London
NW3 5TL**

Crown Ref: 09552a

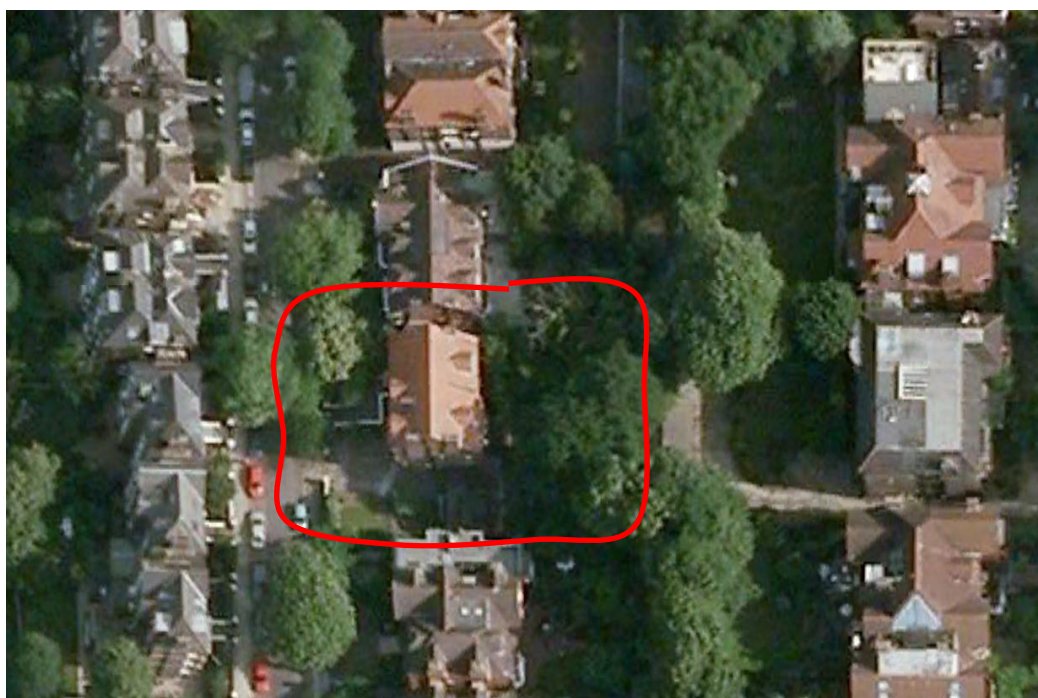
Figure 1 Extent of the survey (image is not current).

- 2.3.1. Our survey covered the area indicated in Figure 1.

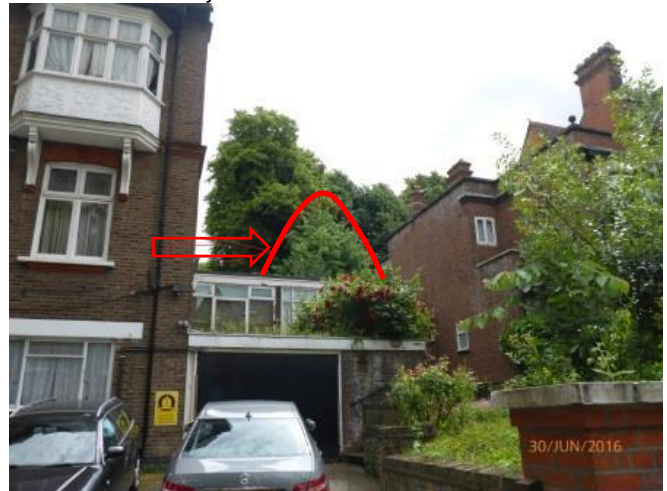
Photo 10. Visibility of T6 to T10 from Netherhall Gardens.

- 5.10.1. In order to facilitate the development, it is proposed to remove five Retention Category C trees which are located internally to the site. These are all small trees and are mostly hidden from public vantage points. Consequently the impact of tree removal on local amenity shall be minimal.
- 5.10.2. No pruning works are required to facilitate the proposal
- 5.10.3. No foundations are proposed within Root Protection Areas.
- 5.10.4. No hard surfacing is proposed in Root Protection Areas.
- 5.10.5. Tree protection measures are specified throughout Section 6 that will ensure no negative impact on retained trees due to construction activity.
- 5.10.6. Adequate space has been allowed between the proposal and all trees to the rear such that no future pressure to overly-prune or remove these trees shall occur as a consequence of the proposal.
