**DEMOLITION BIDBOROUGH STREET ELEVATION** 91102 I:200 @ AI

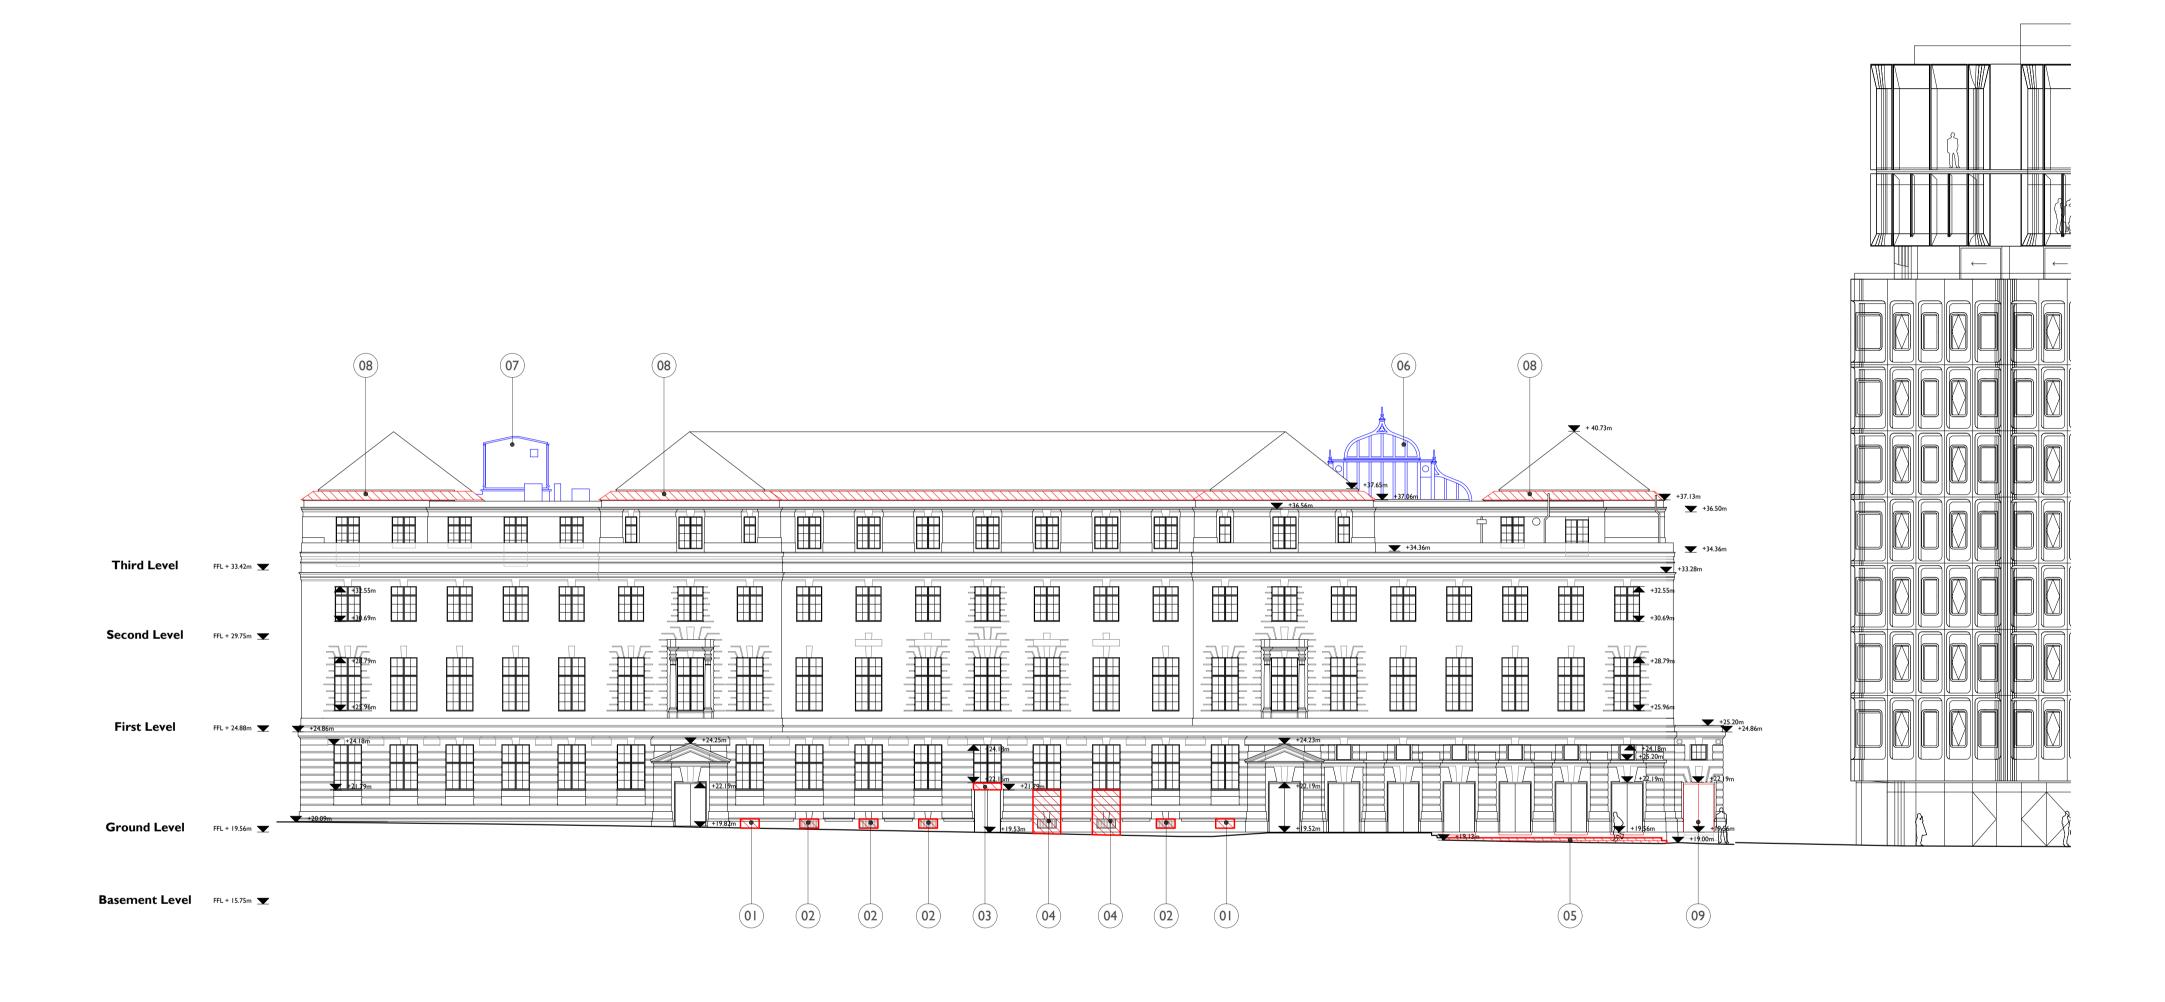
- removed.
- provide for full height opening. 4. Existing window removed and sill lowered to provide full
- height opening. Camden centre removed.
- 6. Existing 1990's conservatory to be removed. 7. Lift motor room removed.
- 8. Bottom 3 courses of slate removed during improvement works to gutters; to be reinstated.
- access from Tonbridge Walk.

1. New openings created at low level in area of stone recess detail and profile to match existing low-level window profiles on Euston Road and Bidborough Street.

3. Existing door, window and lintel above door to be removed to

5. Bidborough street existing stepped ramped arrangement to

9. Side door to prow of building to be removed to allow for the demolition of stepped entrance in order to provide level
