EI.34 Existing Room Elevation 93343 I:25 @ AI

l:25	Scale					
0	500mm	lm	1.5m	2m	2.5 m	
S5 P00	18 Apr 2019	ОВ	NS			
ISSUE	DATE	DRAWN	CHECKED		DESCRIPTION	
DRAWING TITLE Int Elevations - E1.34 Proposed Internal Conservation Repairs						
DRAWING NO.			CTH-PUR-MB-01-DR-A-93343			
REVISION		S5 P	S5 P00			
SIZE 8	& SCALE	AIL	1:25			
DRAWING STATUS		JS S5 SI	S5 SUITABLE FOR PLANNING			
CLIENT		Lend	llease			
PROJE	ст	Cam	den Town Hall			
JOB NUMBER		2386	64	PL	JRCELL

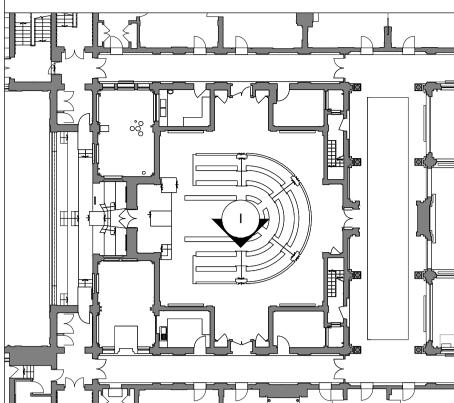
FB FB Floor Box - Indicative location of proposed floor box. Cabling to be fed from below; openings located on site. Floor boxes to include bespoke joinery lid to allow for integration into heritage floor finishes Floor Box - Indicative location of proposed floor box.

Area of structural opening - refer to (91)000 series drawings for dimensions

Section of timber panelling to be carefully removed for installation of electrical cabling from below. To be kept secure during works and reinstated following electrical \checkmark installation. Maximum extents of removal shown - on site confirmation of panel division required Item of removal - Original Fabric

Existing undercut to doors used for exhaust air transfer to corridors

- Overhead 300mm wide opening to ceiling for high level concealed cable distribution make good after installation
- Overhead - Whole bay of vaulted ceiling to be removed for cabling distribution and reinstated
- High level opening in wall for services distribution
