ISSUE	DATE	DRAWN	CHECKED	DESCRIPTION
<b>DRAWING TITLE</b>	Int Elevations - EI.34 Proposed Internal Conservation Repairs			
<b>DRAWING NO.</b>	CTH-PUR-MB-01-DR-A-93346			
<b>REVISION</b>	S5 P00			
<b>SIZE &amp; SCALE</b>	A1L 1:25			
<b>DRAWING STATUS</b>	S5 SUITABLE FOR PLANNING

<b>PROJECT</b>	Camden Town Hall	
<b>JOB NUMBER</b>	238664

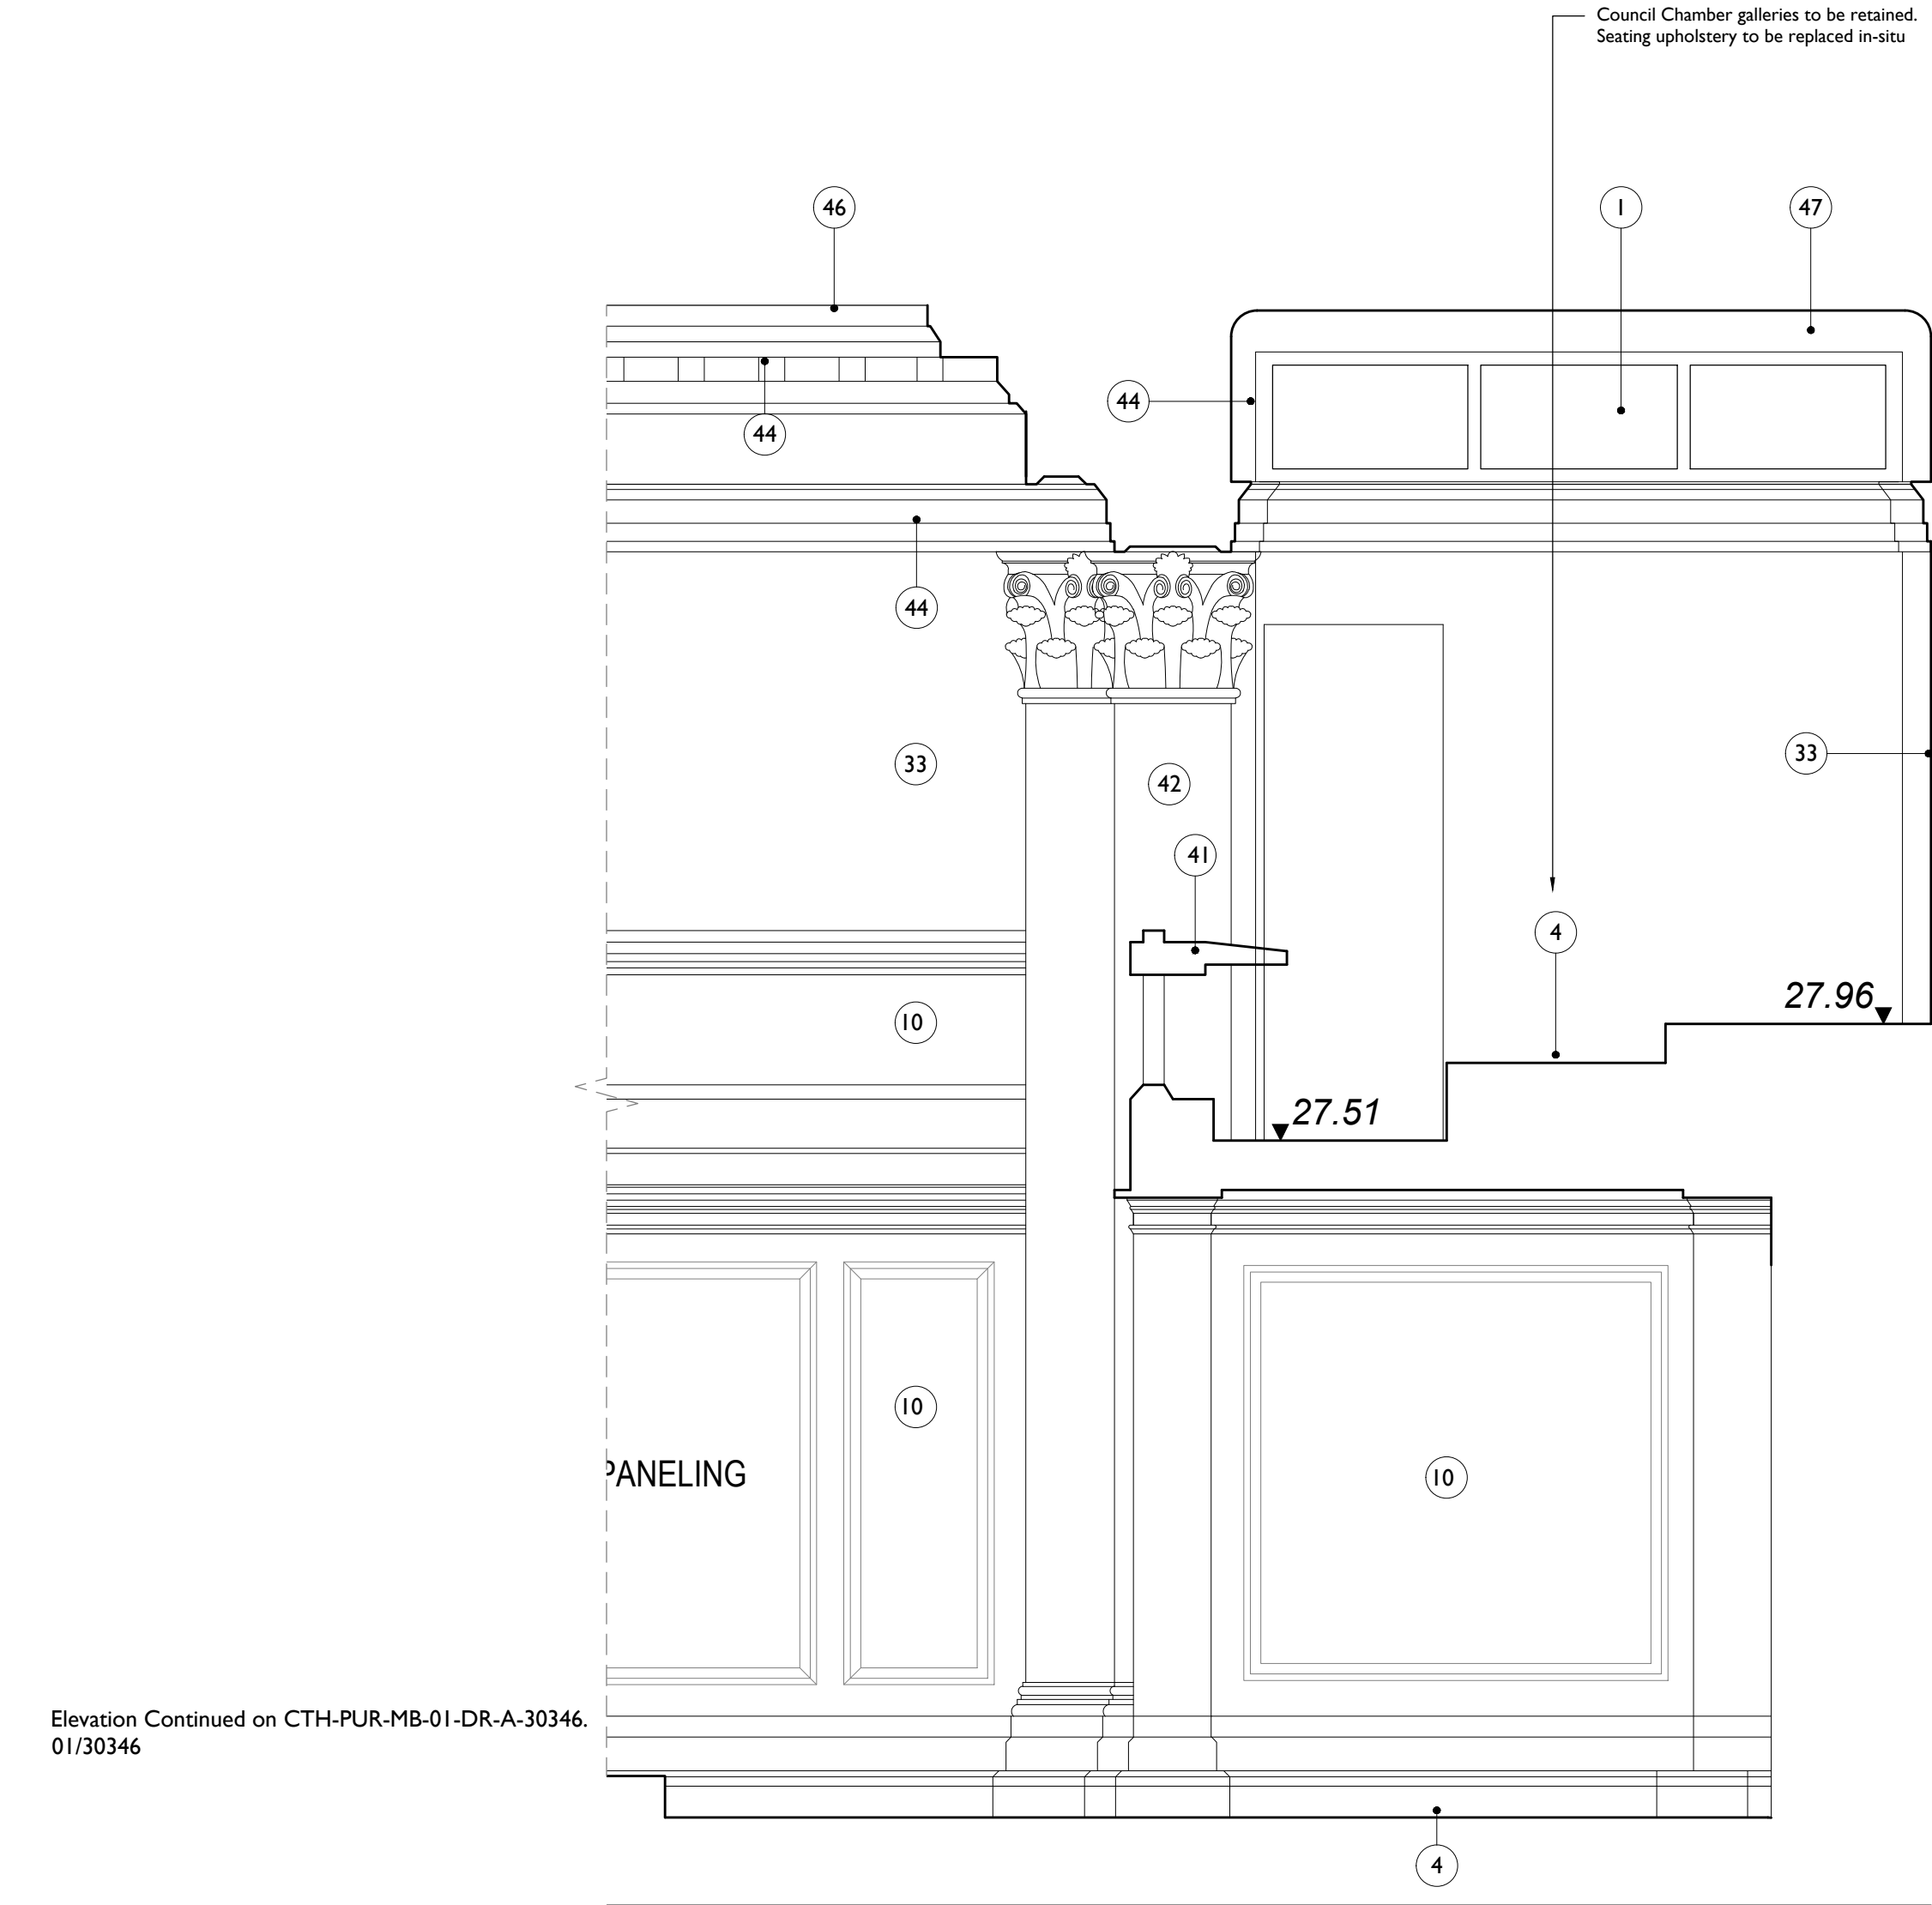
**1**  
93346

**EI.34 Existing Room Elevation**  
**1:25 @ A1**

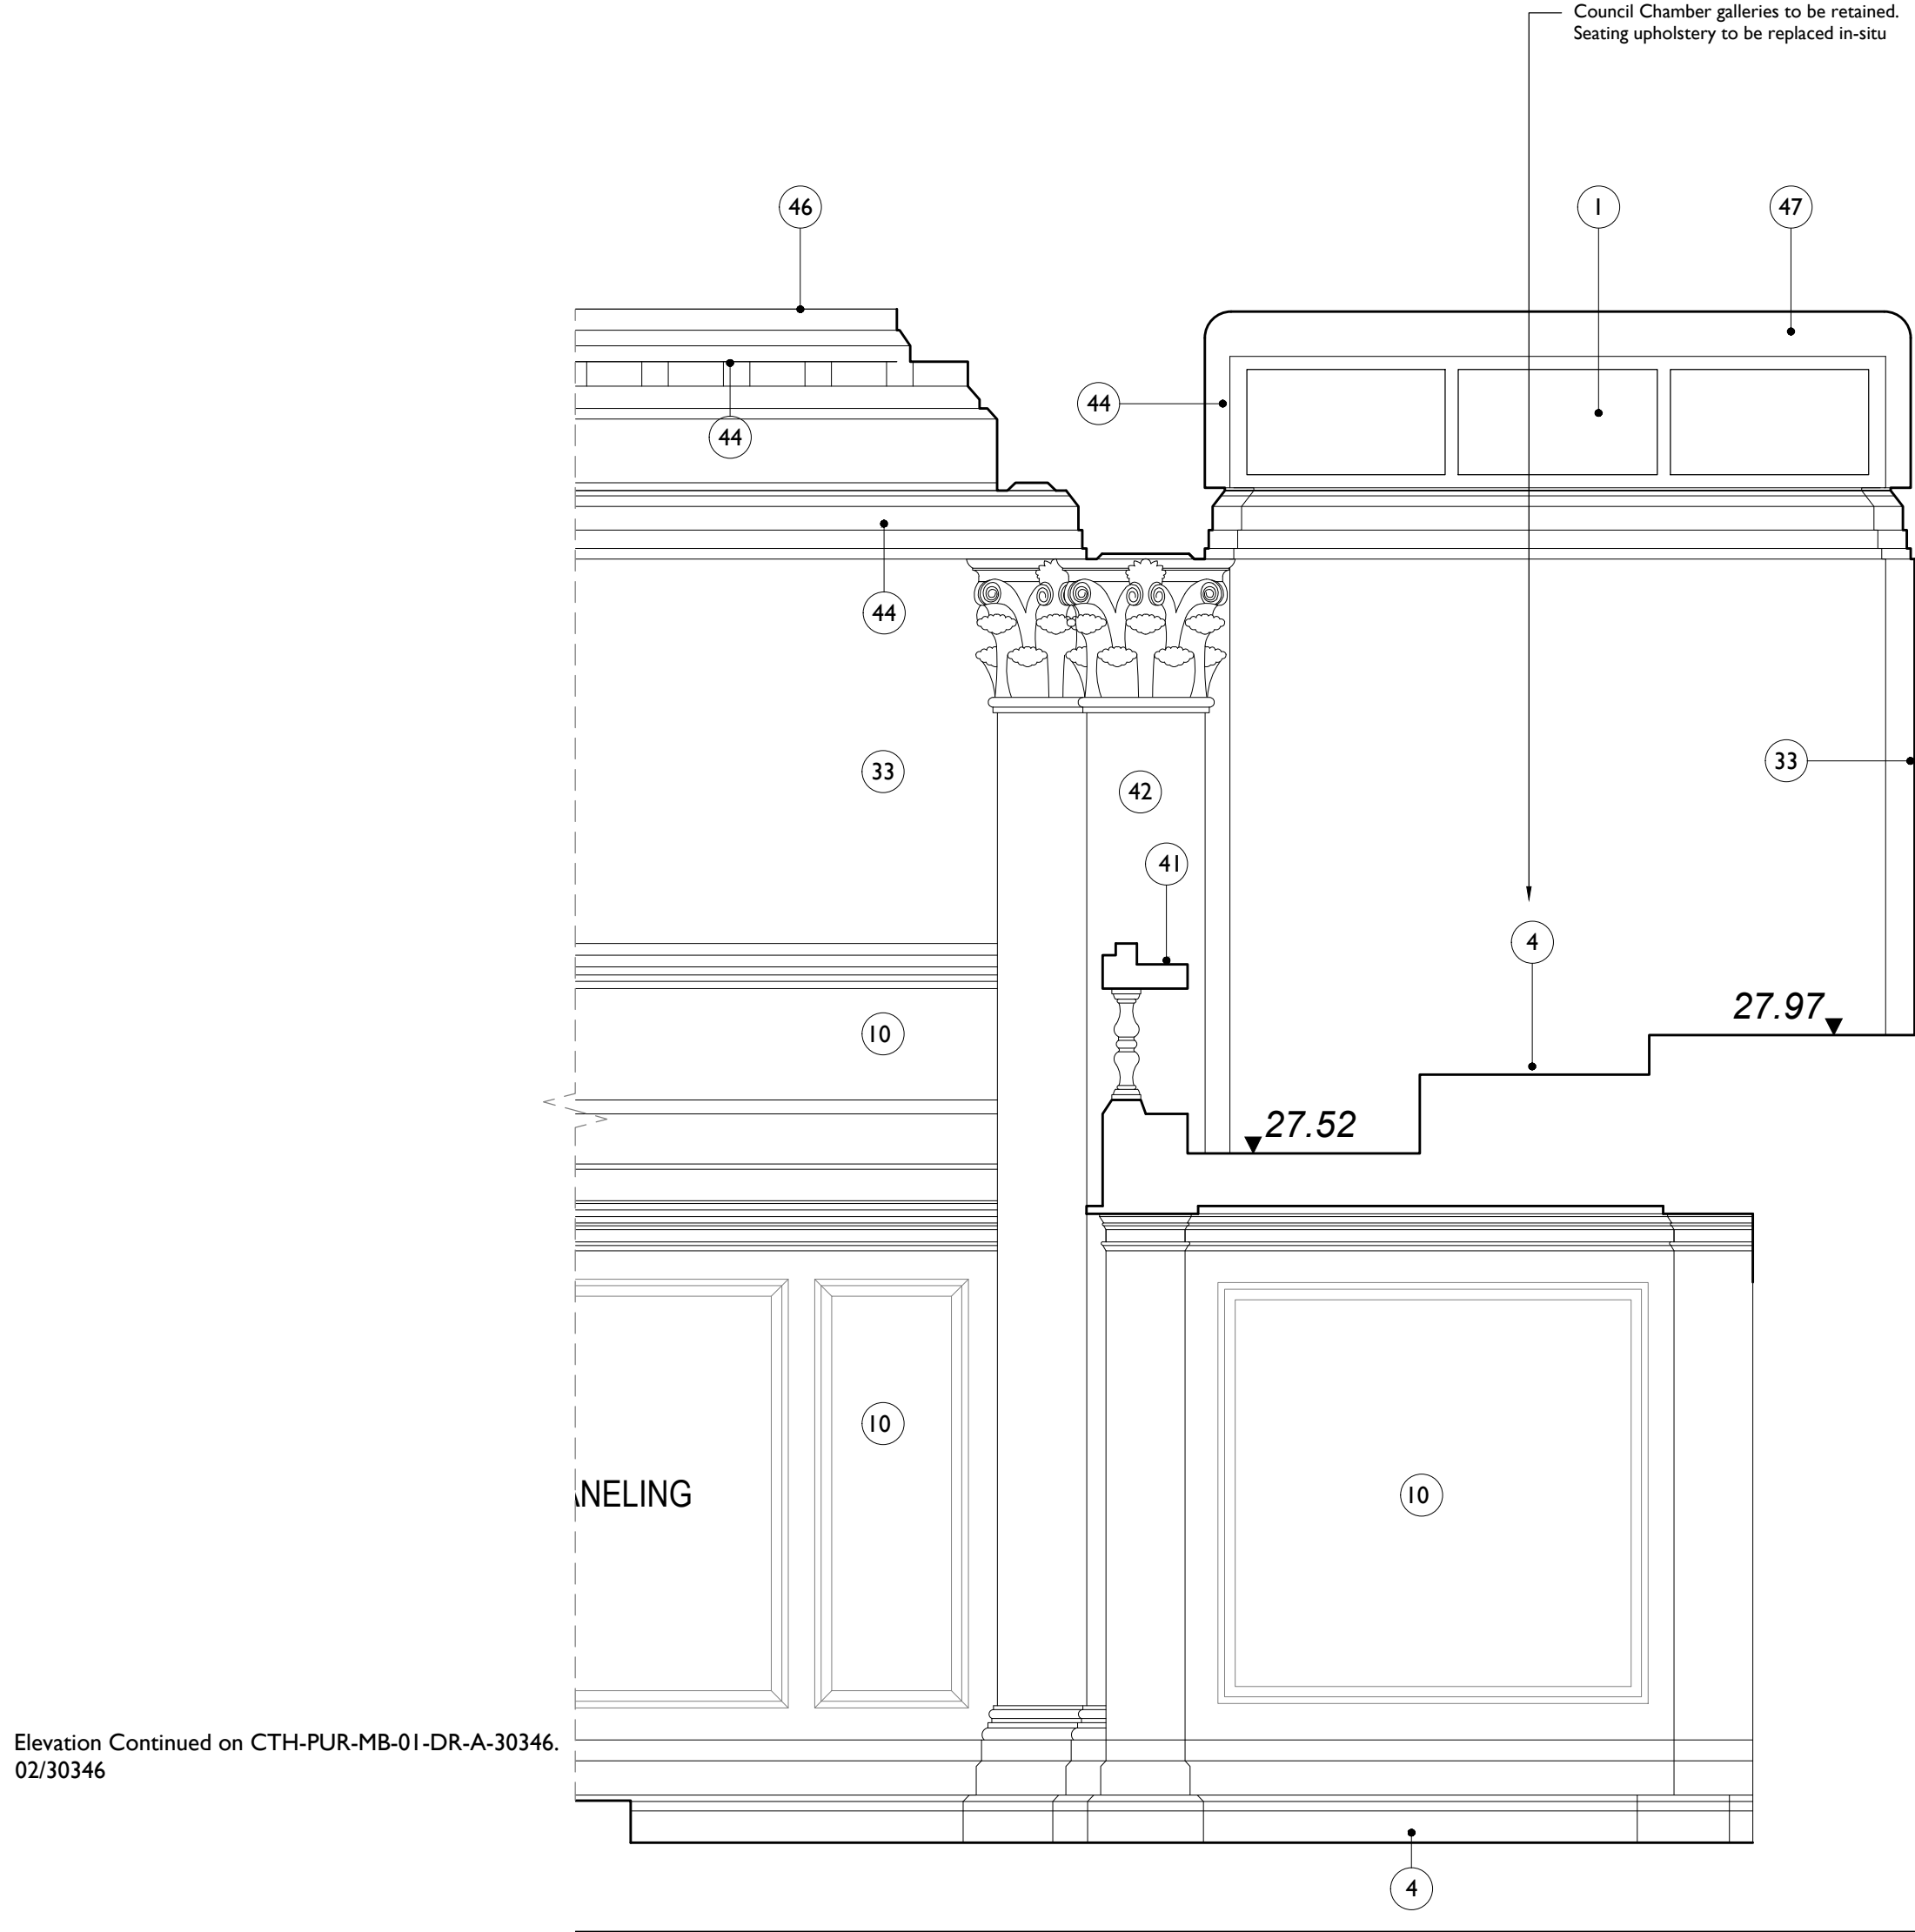
**2**  
93346

**EI.34 Existing Room Elevation**  
**1:25 @ A1**
