ISSUE	DATE	DRAWN	CHECKED	DESCRIPTION
DRAWING TITLE	Int Elevations - EI.40 Proposed Internal Conservation Repairs			
DRAWING NO.	CTH-PUR-MB-01-DR-A-93408			
REVISION	SS P00			
SIZE & SCALE	A1L 1:25			
DRAWING STATUS	SS SUITABLE FOR PLANNING

CLIENT Lendlease
PROJECT Camden Town Hall
JOB NUMBER 238664

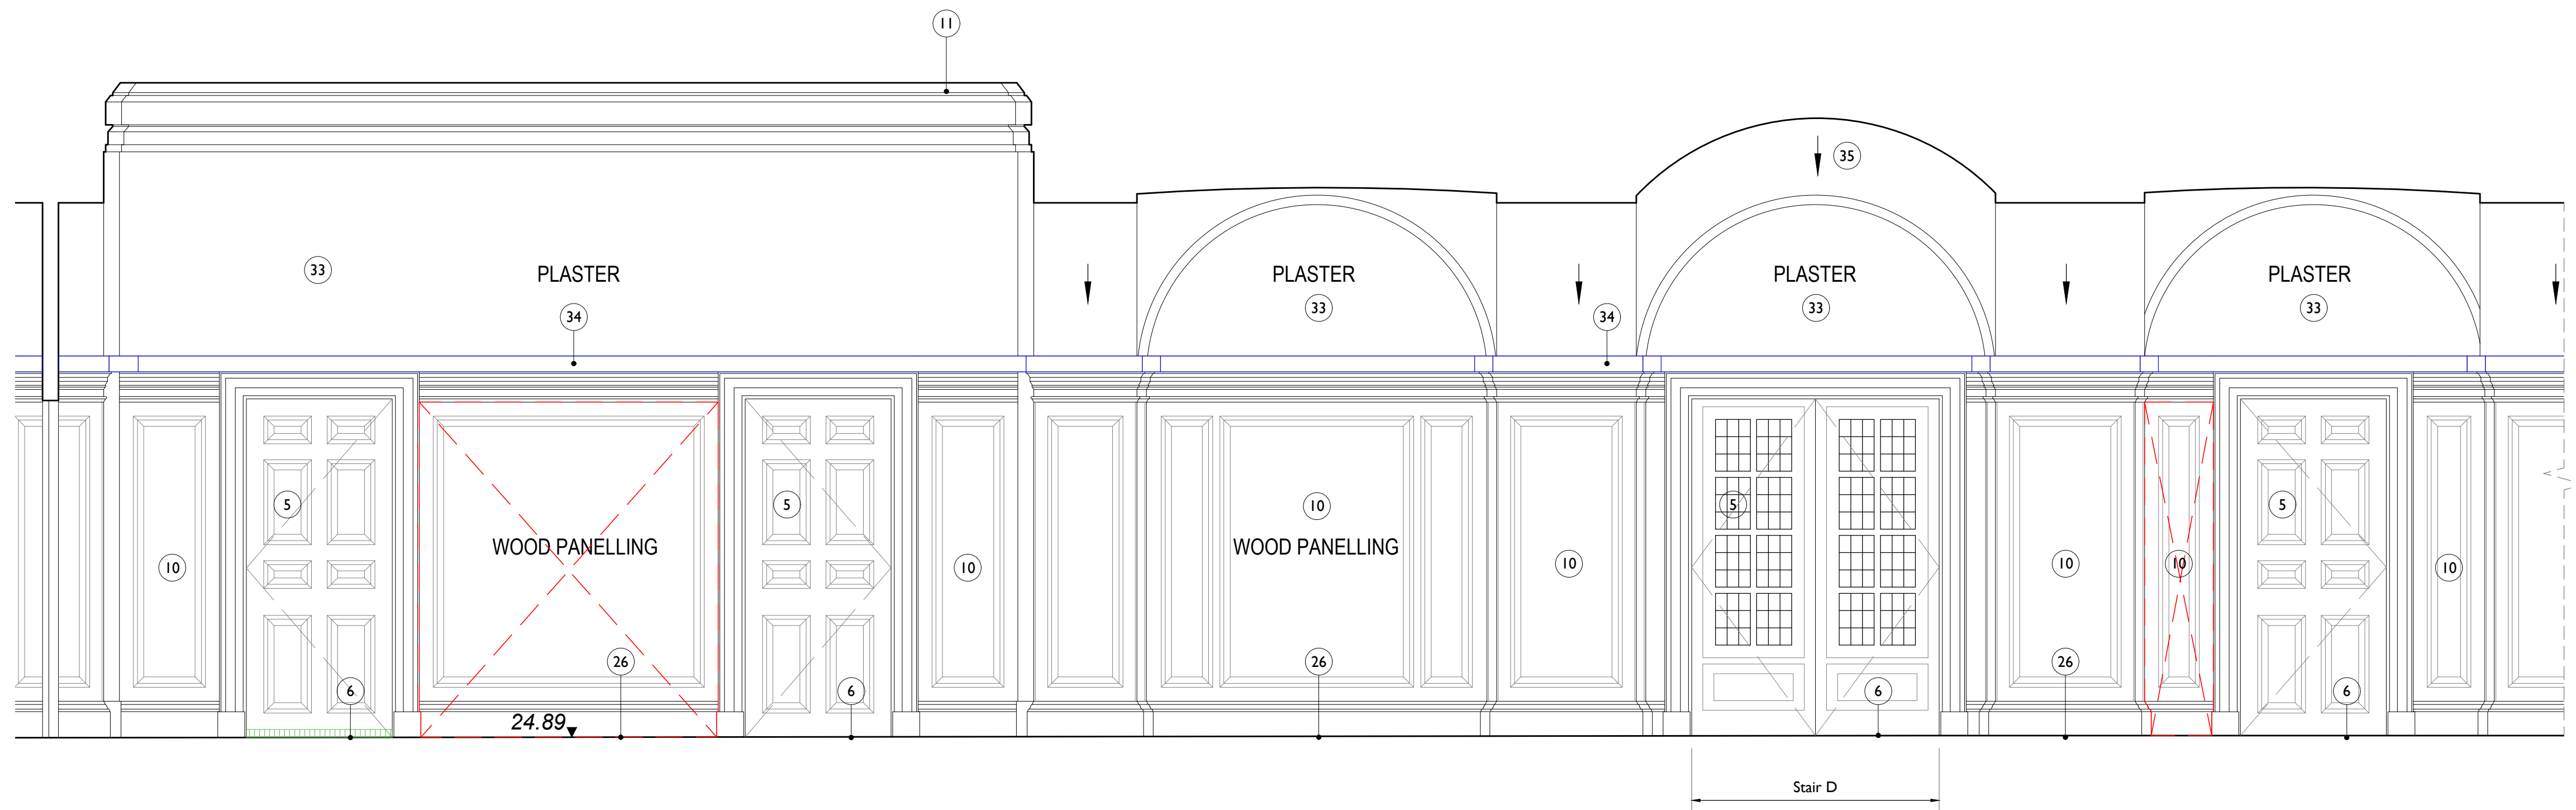
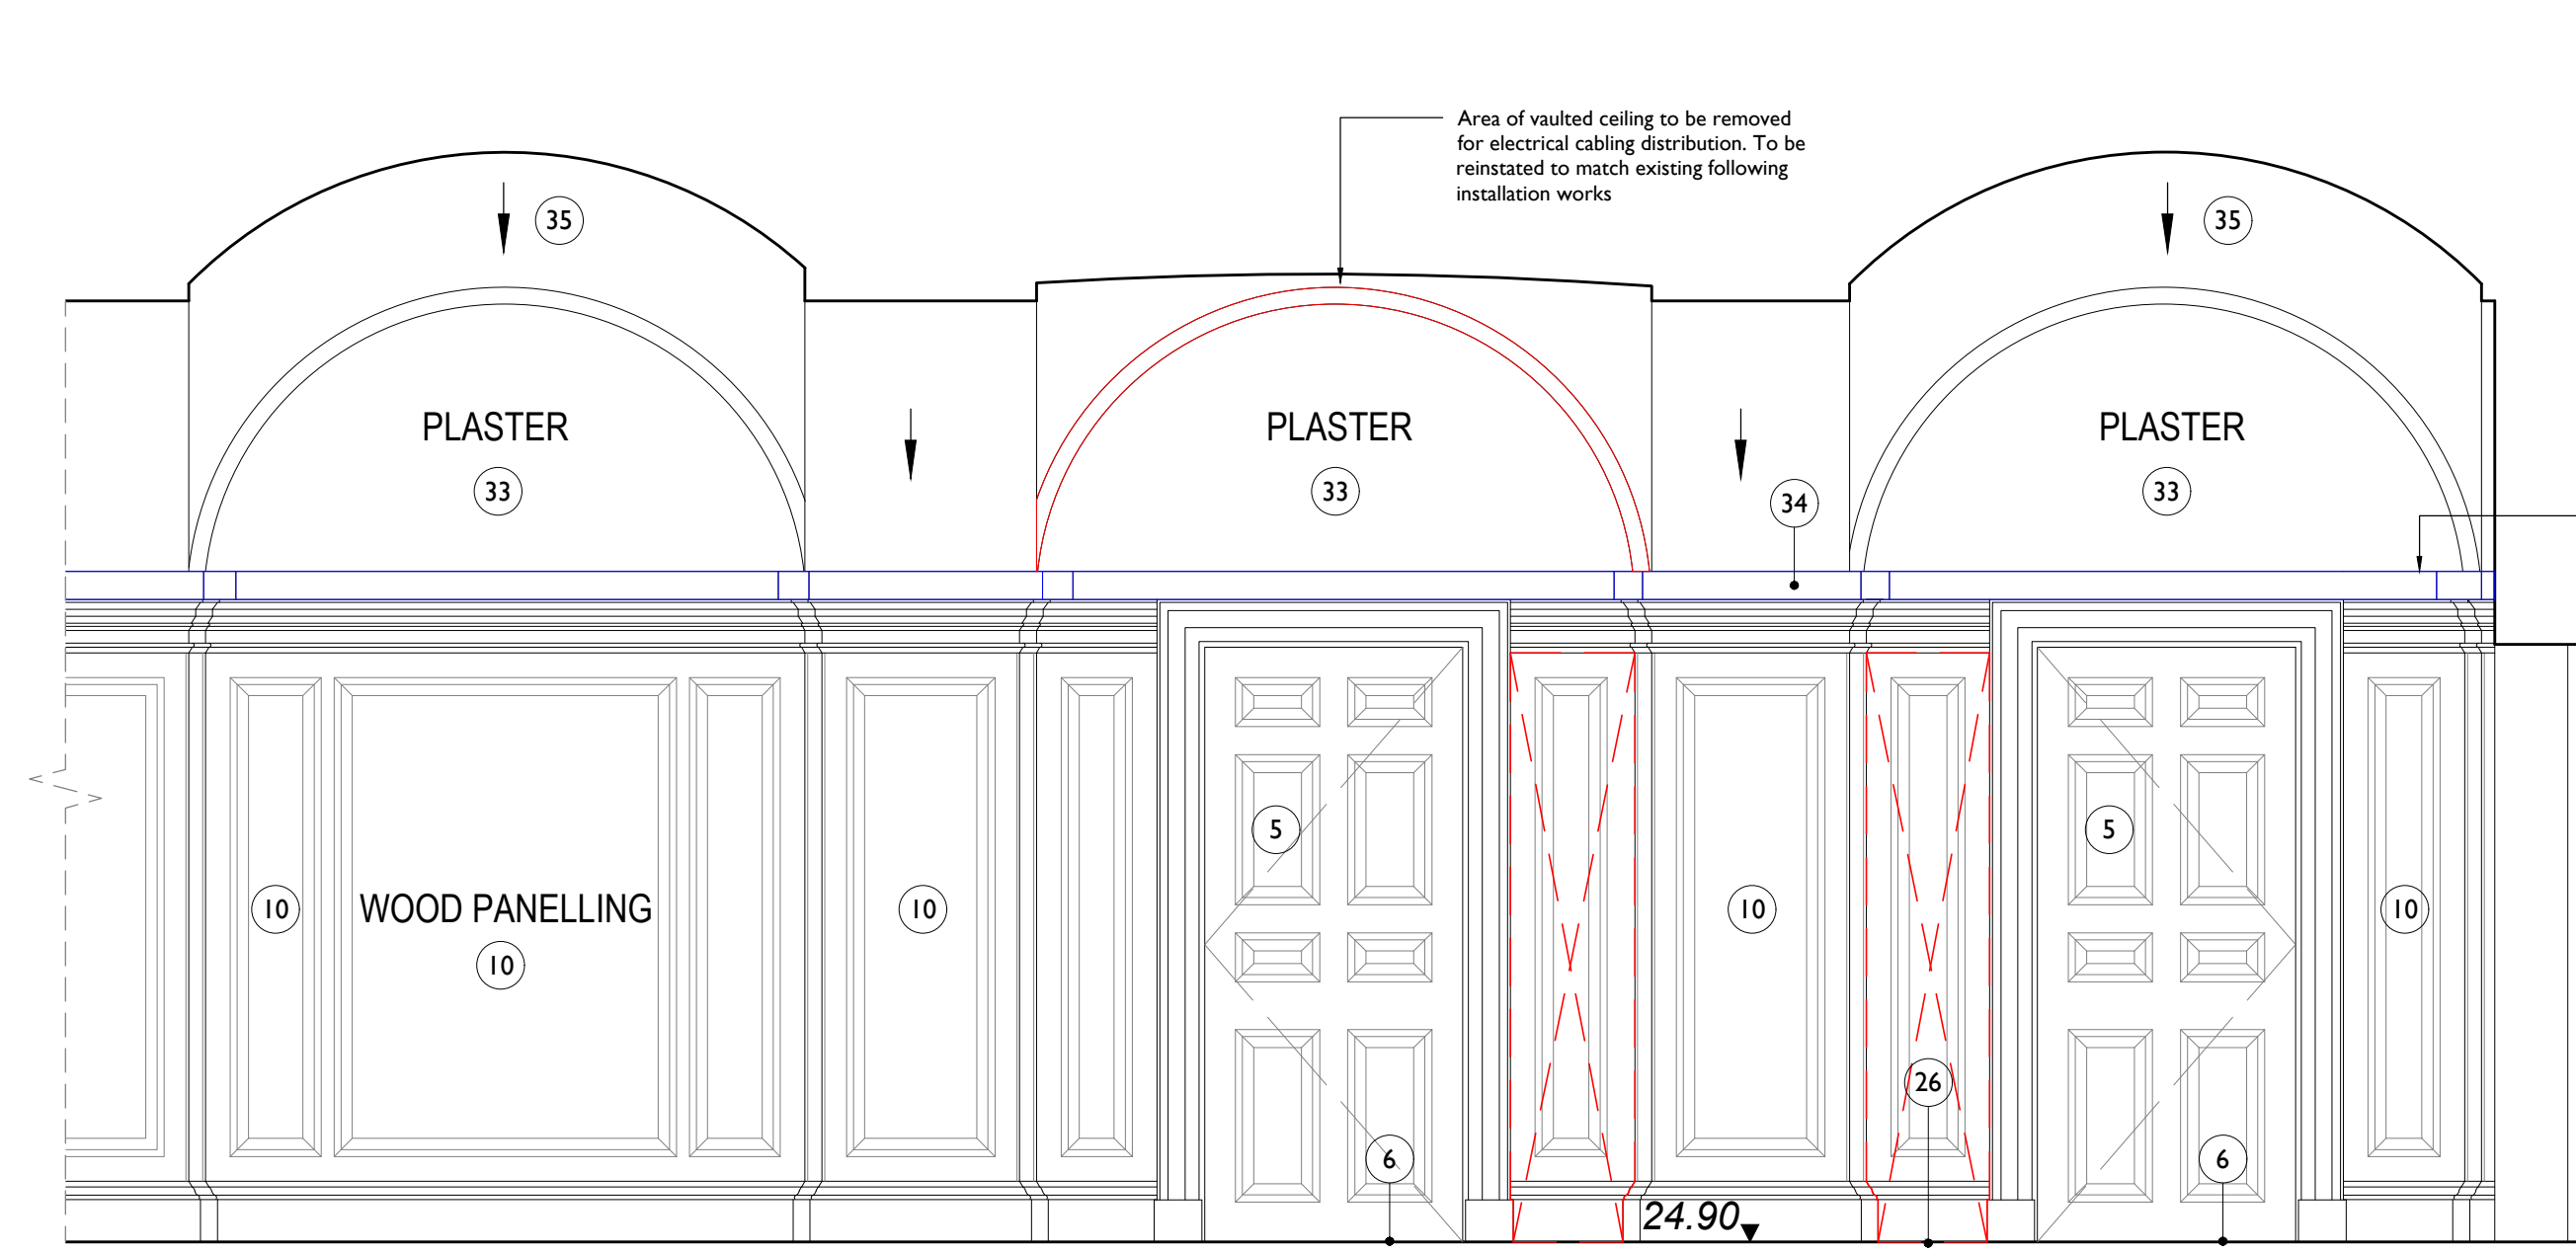
Existing white plastic trunking to be removed and cabling stripped out. To be replaced with sensitively integrated concealed lighting and cabling containment
