| ISSUE | DATE | DRAWN | CHECKED | DESCRIPTION |
|---|--|---|---|---|
| <b>DRAWING TITLE</b> | Int Elevations - EG.70<br>Proposed Internal Conservation Repairs | | | |
| <b>DRAWING NO.</b> | CTH-PUR-MB-G0-DR-A-93074 | | | |

**PROJECT** Camden Town Hall

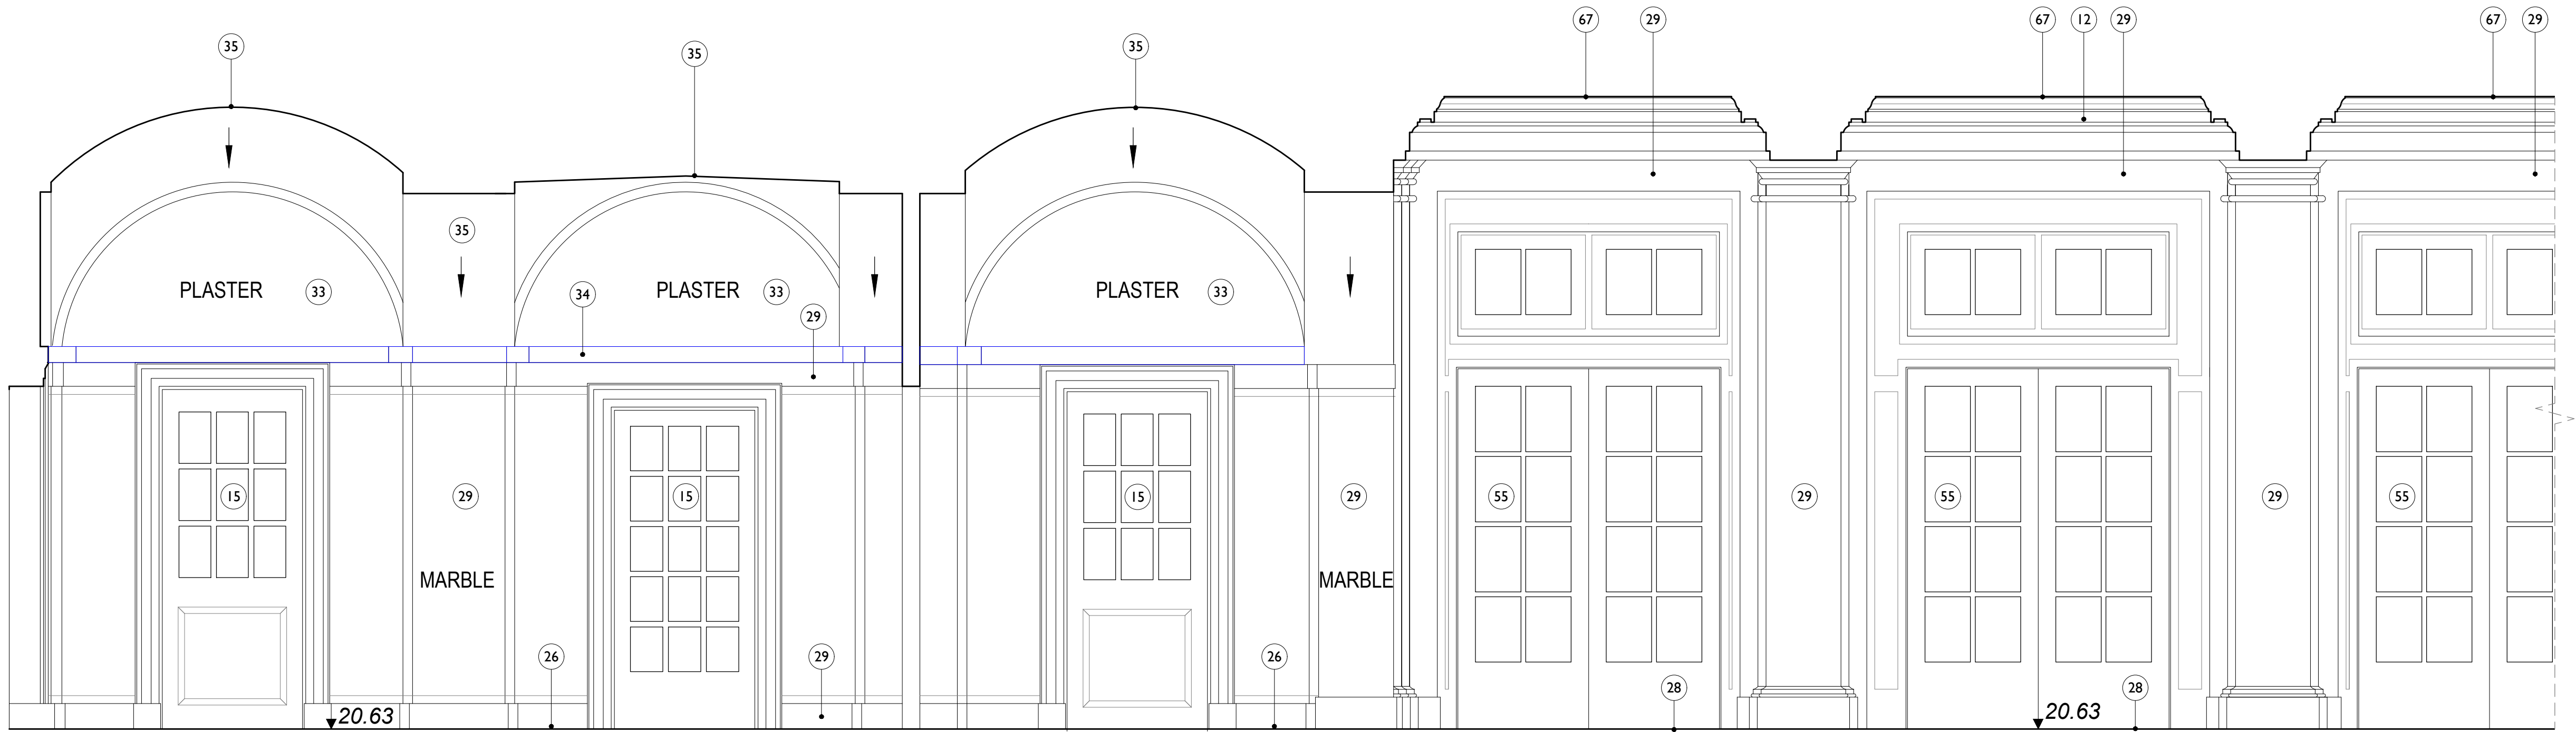
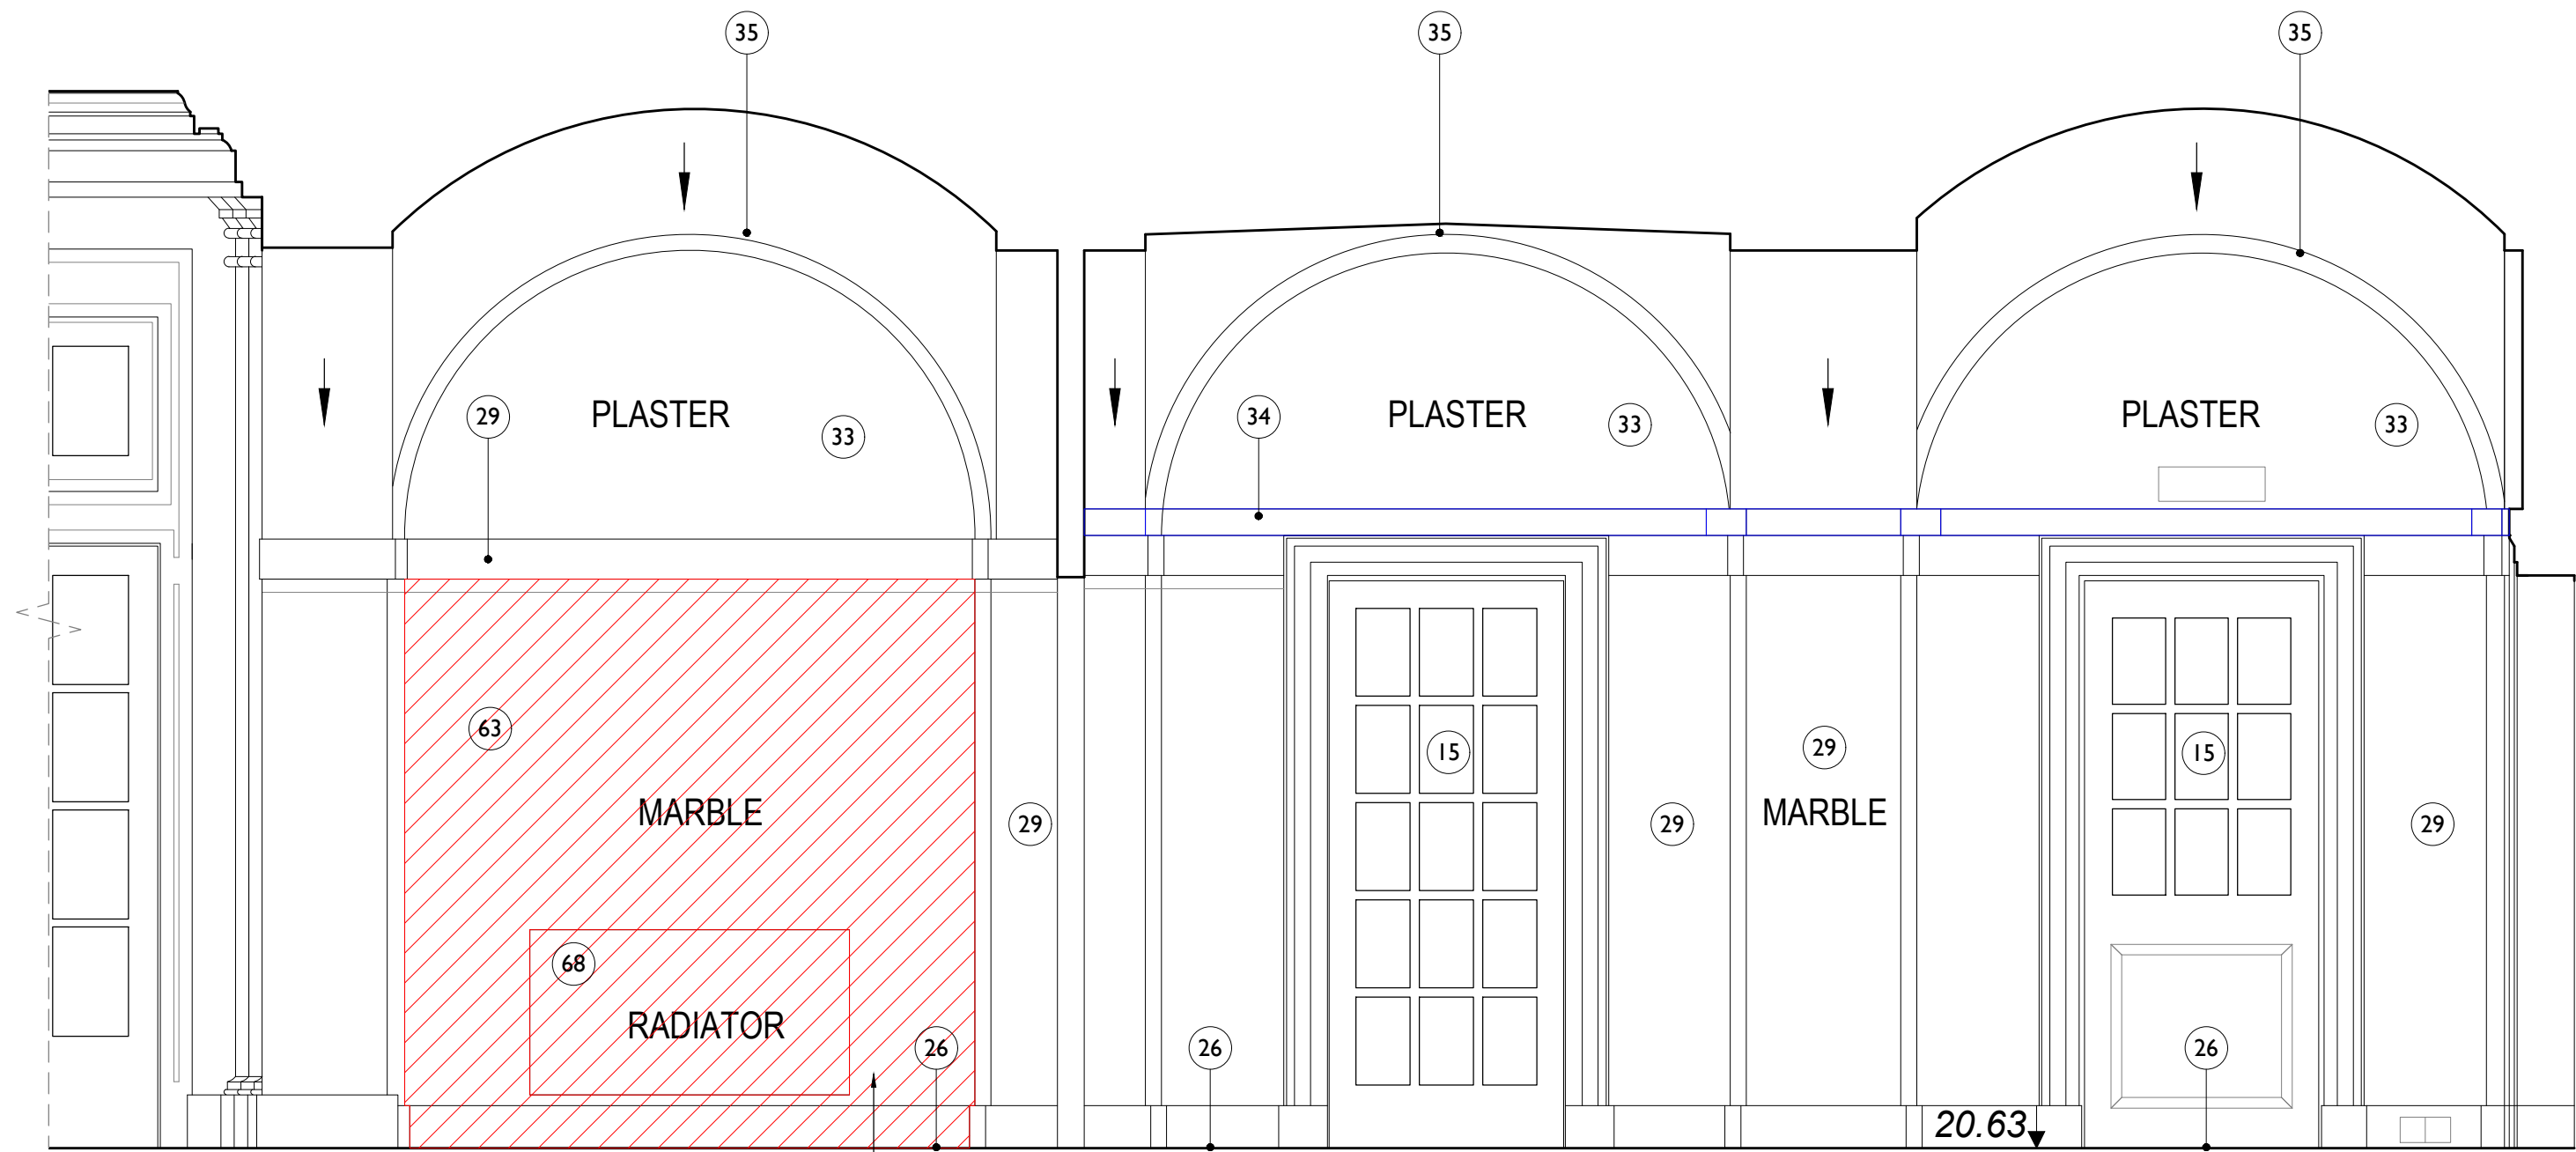
Extent of new opening into  
reception with new  
timber/stone lining to reveal  
to distinguish modern  
intervention
