<b>DRAWING TITLE</b>	Int Elevations - EG.70 Proposed Internal Conservation Repairs			
----------------------	--	--	--	--

<b>DRAWING NO.</b>	CTH-PUR-MB-G0-DR-A-93078			
--------------------	--------------------------	--	--	--

<b>DRAWING STATUS</b>	SS SUITABLE FOR PLANNING			
-----------------------	--------------------------	--	--	--

<b>PROJECT</b>	Camden Town Hall			
----------------	------------------	--	--	--

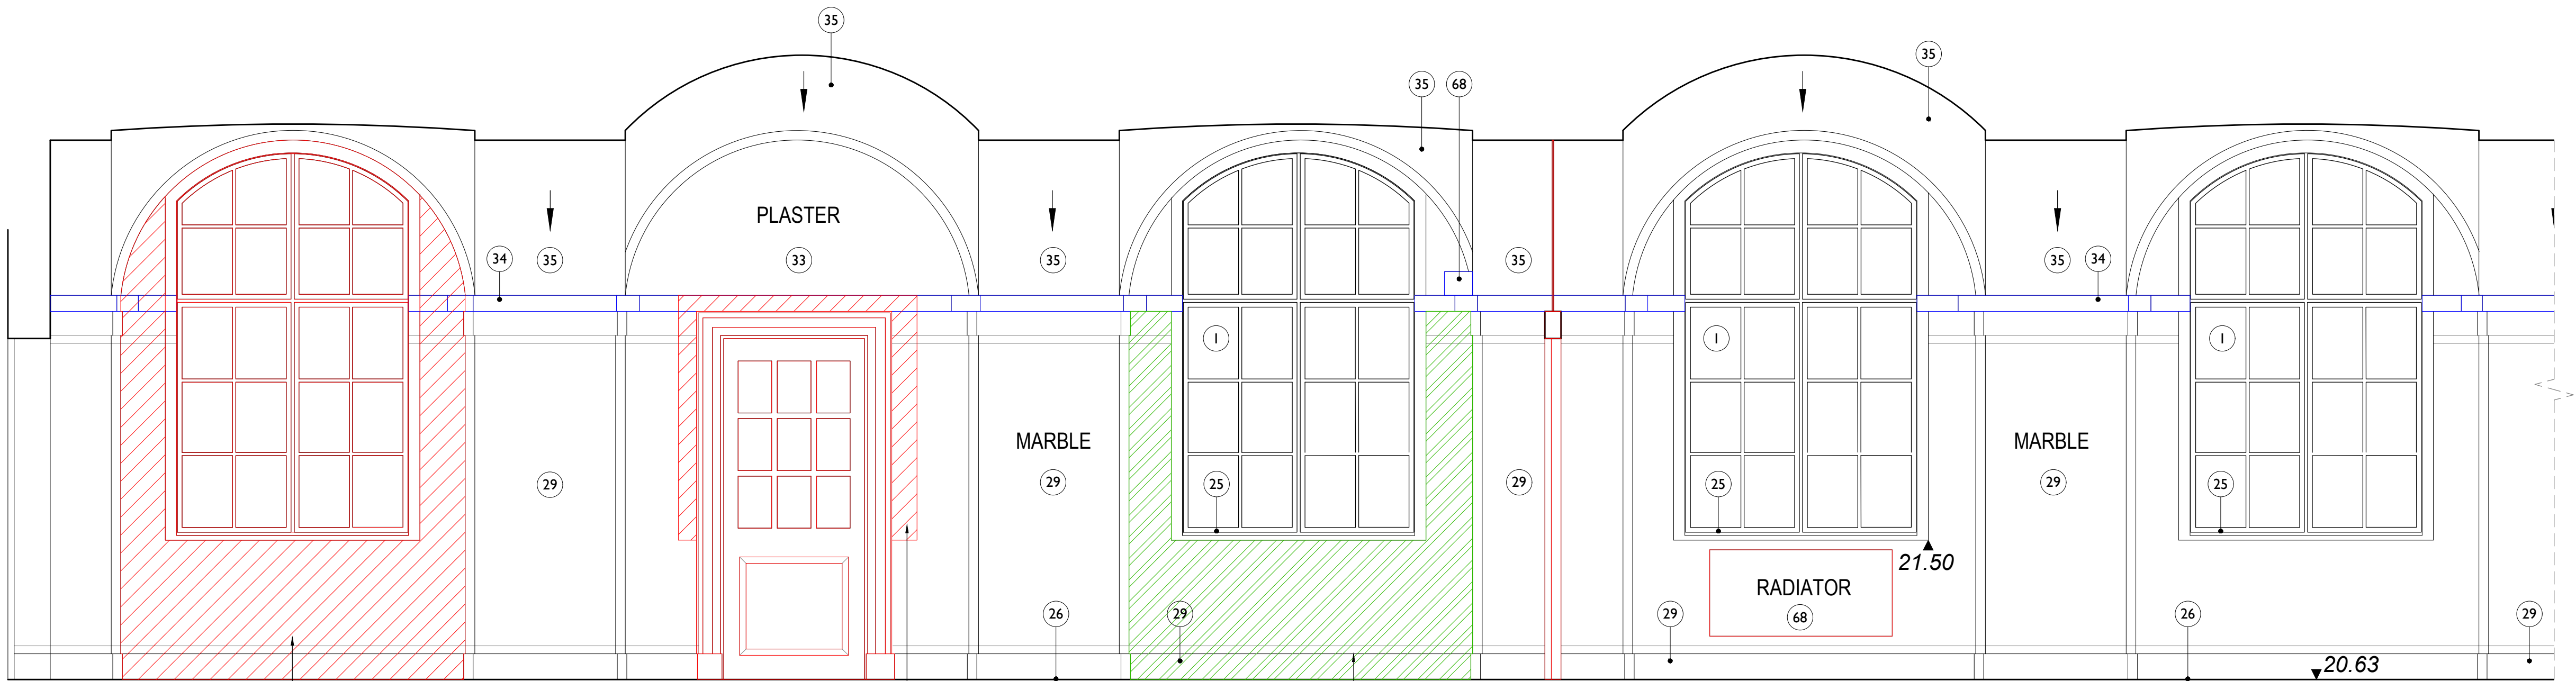
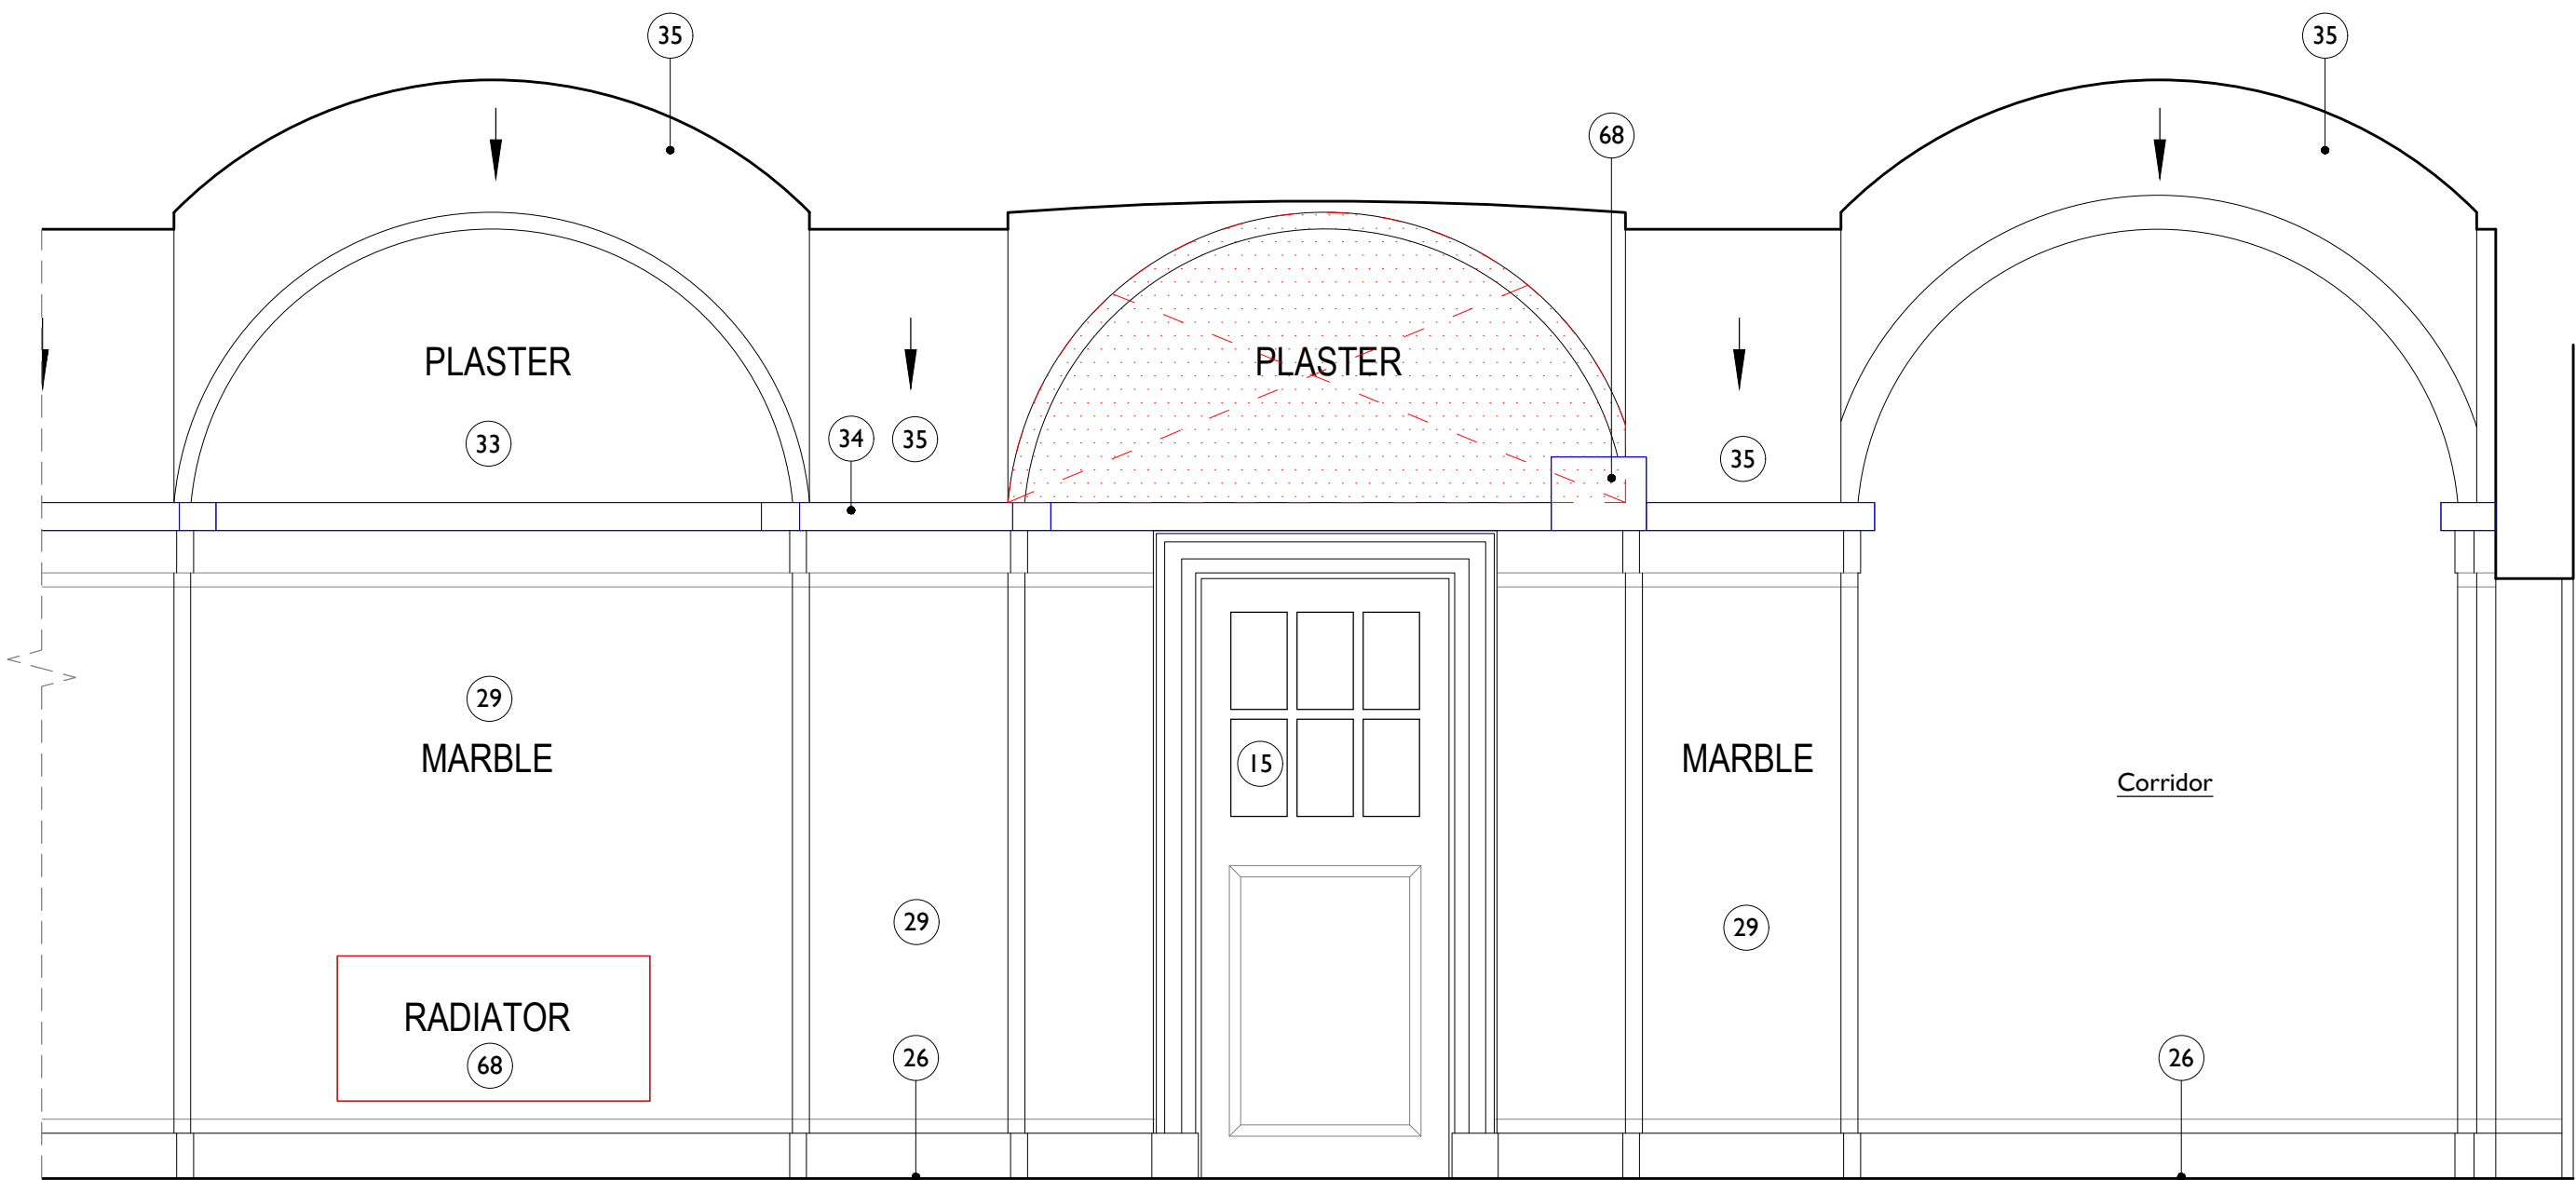
**I**  
**93708**  
**EG.70 Existing Room Elevation**  
**1:25 @ A1**

Window and fabric proposed to be removed to accommodate wedding lobby

Door proposed to be removed and opening increased to accommodate new internal window to wedding lobby

Area of severe damage
