| ISSUE | DATE | DRAWN | CHECKED | DESCRIPTION |
|---|---|---|---|---|
| DRAWING TITLE | Plan - EI.25, EI.26 & EI.22 Proposed Internal Conservation Repairs | | | |
| DRAWING NO. | CTH-PUR-MB-01-DR-A-93261 | | | |

| PROJECT | Camden Town Hall | |

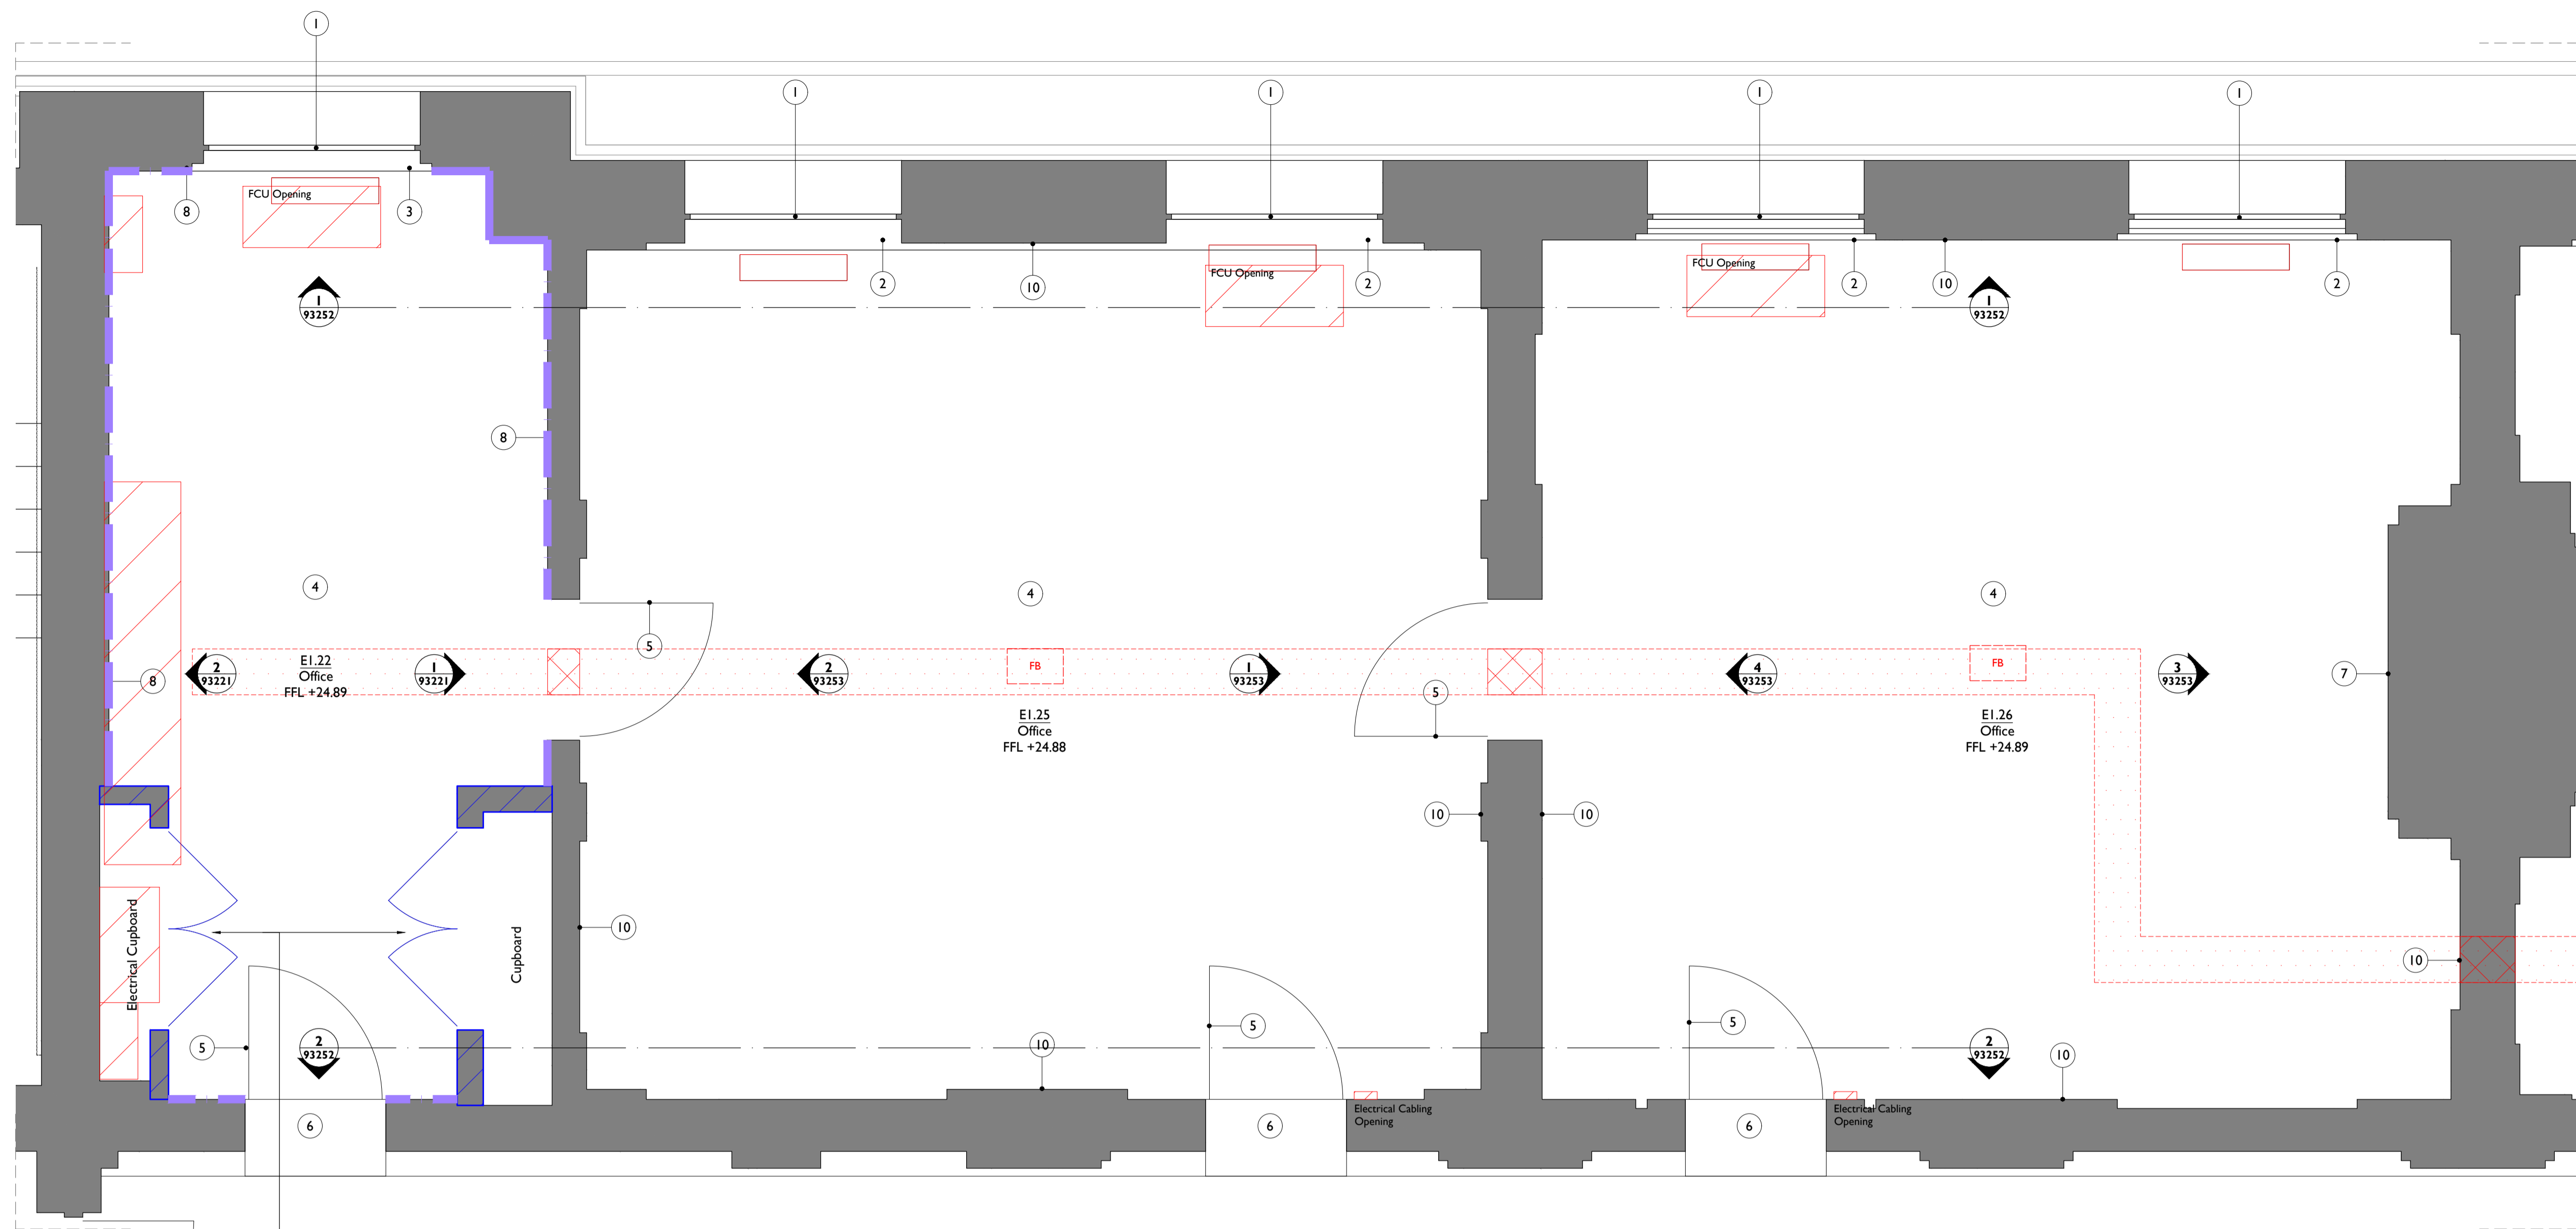
I EI.25, EI.26 & EI.22 Existing Room Plan
 93251 1:25 @ A1

Timber cupboards removed to allow services installation and minimise the impact on adjacent rooms which are more historically significant spaces
