Project: St Giles Circus
 Drawing title: Heritage Buildings Nos. 21-25 Denmark Street Proposed South Elevation

1793 PL016-08 Rev. P5

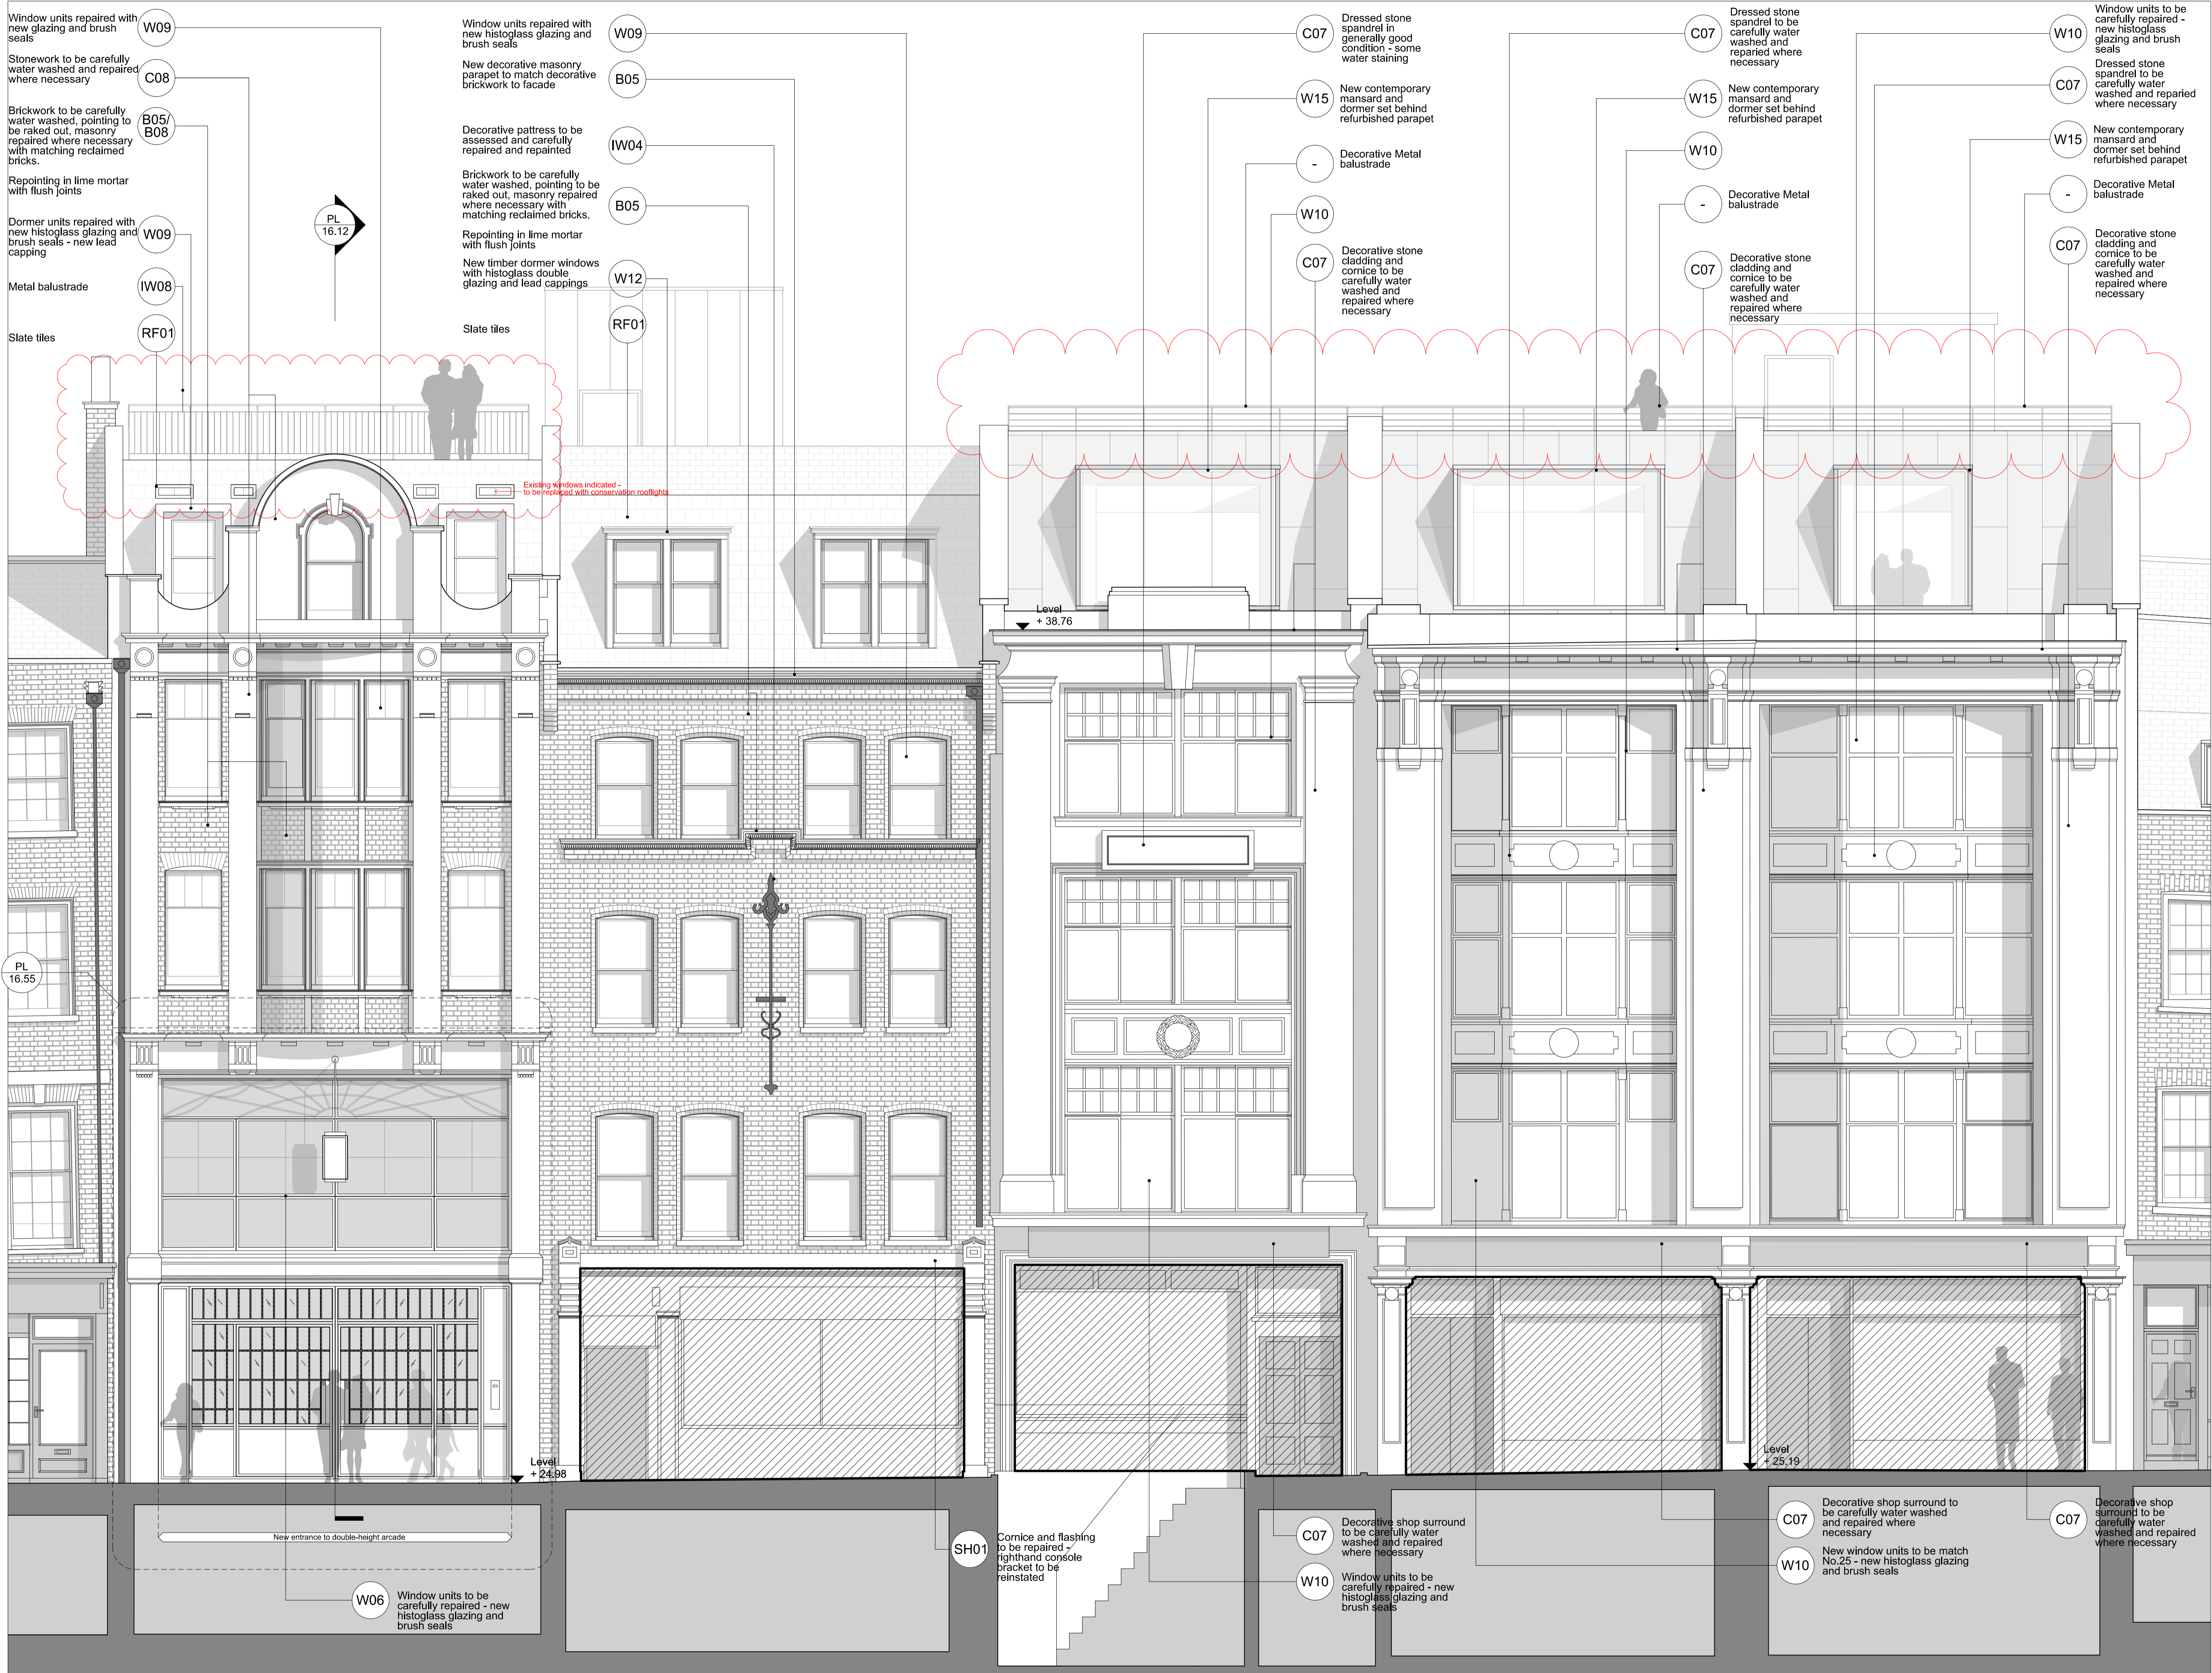
Window units repaired with new glazing and brush seals
 Stonework to be carefully water washed and repaired where necessary
 Brickwork to be carefully water washed, pointing to be raked out, masonry repaired where necessary with matching reclaimed bricks
 Repointing in lime mortar with flush joints
 Dormer units repaired with new histoglass glazing and brush seals - new lead capping
 Metal balustrade
 Slate tiles

Window units repaired with new histoglass glazing and brush seals
 New decorative masonry parapet to match decorative brickwork to facade
 Decorative patters to be assessed and carefully repaired and repainted
 Brickwork to be carefully water washed, pointing to be raked out, masonry repaired where necessary with matching reclaimed bricks
 Repointing in lime mortar with flush joints
 New timber dormer windows with histoglass double glazing and lead cappings
 Slate tiles

Dressed stone spandrel in generally good condition - some water staining
 New contemporary mansard and dormer set behind refurbished parapet
 Decorative Metal balustrade
 Decorative stone cladding and cornice to be carefully water washed and repaired where necessary
 Dressed stone spandrel to be carefully water washed and repaired where necessary
 New contemporary mansard and dormer set behind refurbished parapet
 Decorative Metal balustrade
 Decorative stone cladding and cornice to be carefully water washed and repaired where necessary
 Window units to be carefully repaired - new histoglass glazing and brush seals
 Dressed stone spandrel to be carefully water washed and repaired where necessary
 New contemporary mansard and dormer set behind refurbished parapet
 Decorative Metal balustrade
 Decorative stone cladding and cornice to be carefully water washed and repaired where necessary
