Symmetrys Ltd
Structural Engineers

BASEMENT IMPACT ASSESSMENT

43 Hillfield Road
London
NW6 1QD

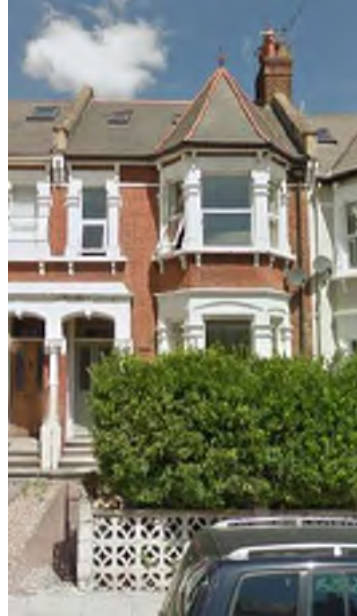
Figure 1: Front Elevation

1.1.2. The current site arrangement is a four storey terraced house with an existing lower ground floor under part of the footprint of the house. The existing structure is load bearing masonry with timber floors spanning from front to back of the house.

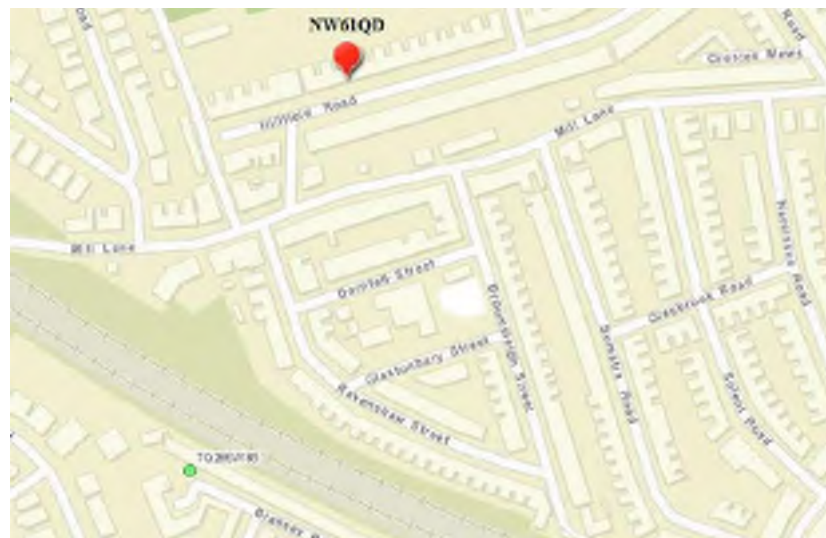
Figure 4: Extract of BGS map

3.2.1. The *British Geology Survey (BGS) map* of the area indicates that the site is underlain by hard blue clay as per the borehole results of TQ28SW85 in the South of the site, see Figure 4.

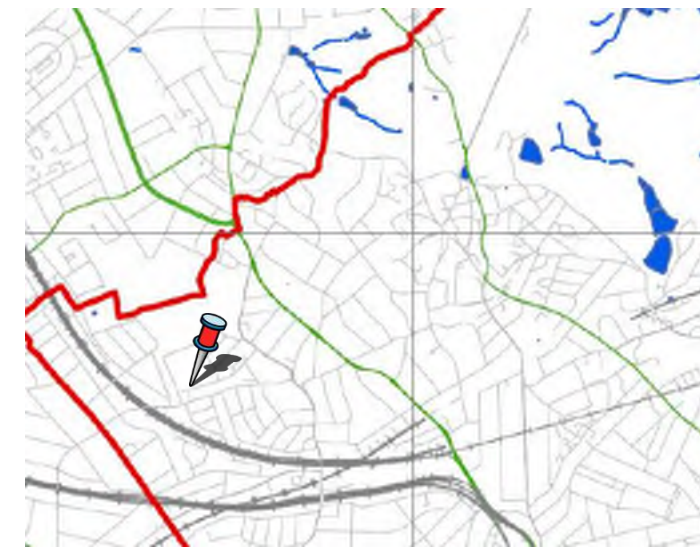
Figure 5: Extract of Camden Surface Water Features map

3.4.1. The site is located at two kilometres from the closest surface water features in Hampstead Heath, see Figure 5.

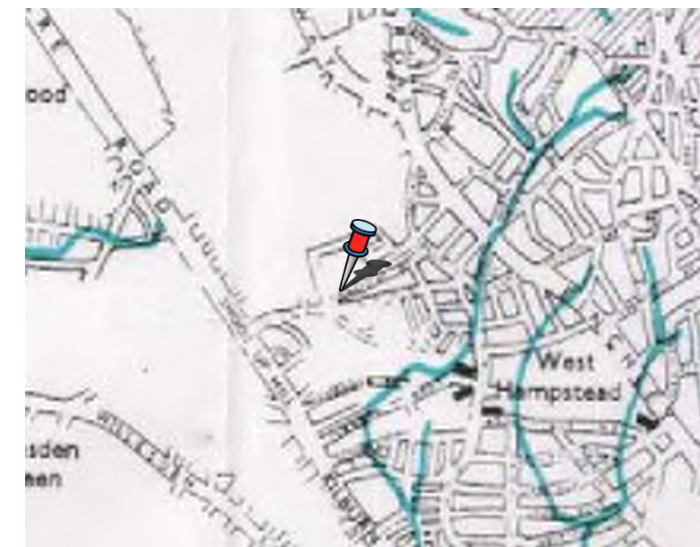
Figure 6: Extract of the "Lost Rivers of London" from Nicholas Barton

3.4.2. The site is located at 500 metres distance from the Westbourne historical watercourse. This is a significant distance therefore it is unlikely to have any impact on the local hydrology, see Figure 6.

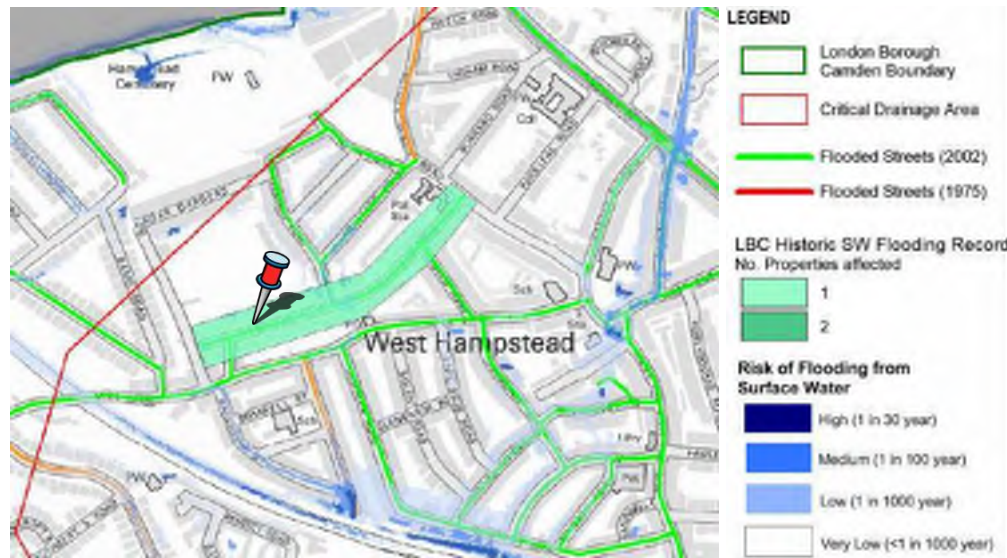
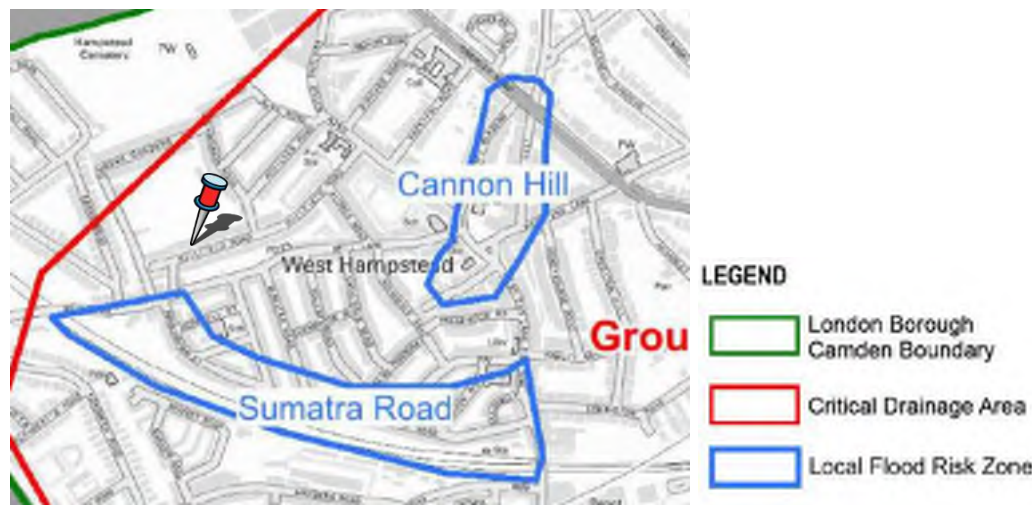
3.4.6. The site is classified is not located in a Local Flood Risk Zone and is at low risk of surface water flooding, see Figure 7 and 8.

Figure 7: Extract of URS map "Updated Flood Maps for Surface Water Flooding"

Figure 8: Extract of URS Map "Critical Drainage Area / Local Flood Risk Zones"

3.4.7. The site is within a Critical Drainage Area.

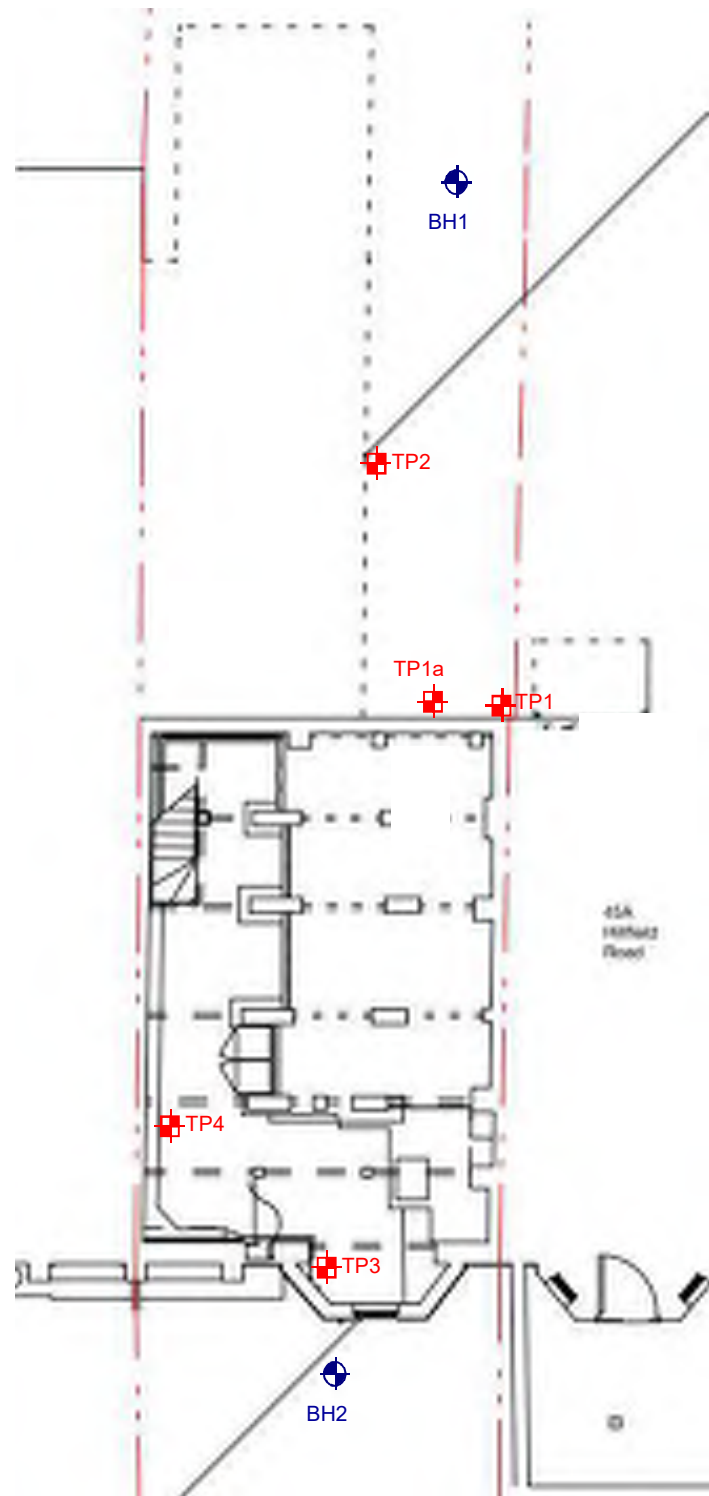
Figure Number: Figure 2

The ground investigation works were undertaken between 27th and 30th July 2018 and comprised the progression of 1No. continuous flight auger borehole and 1No. dynamic (windowless) sampler borehole to depths of 8.00m bgl and 5no. hand excavated trial pits to try and expose existing building foundations, with sampling of soil for laboratory testing (see **Figure 2**).

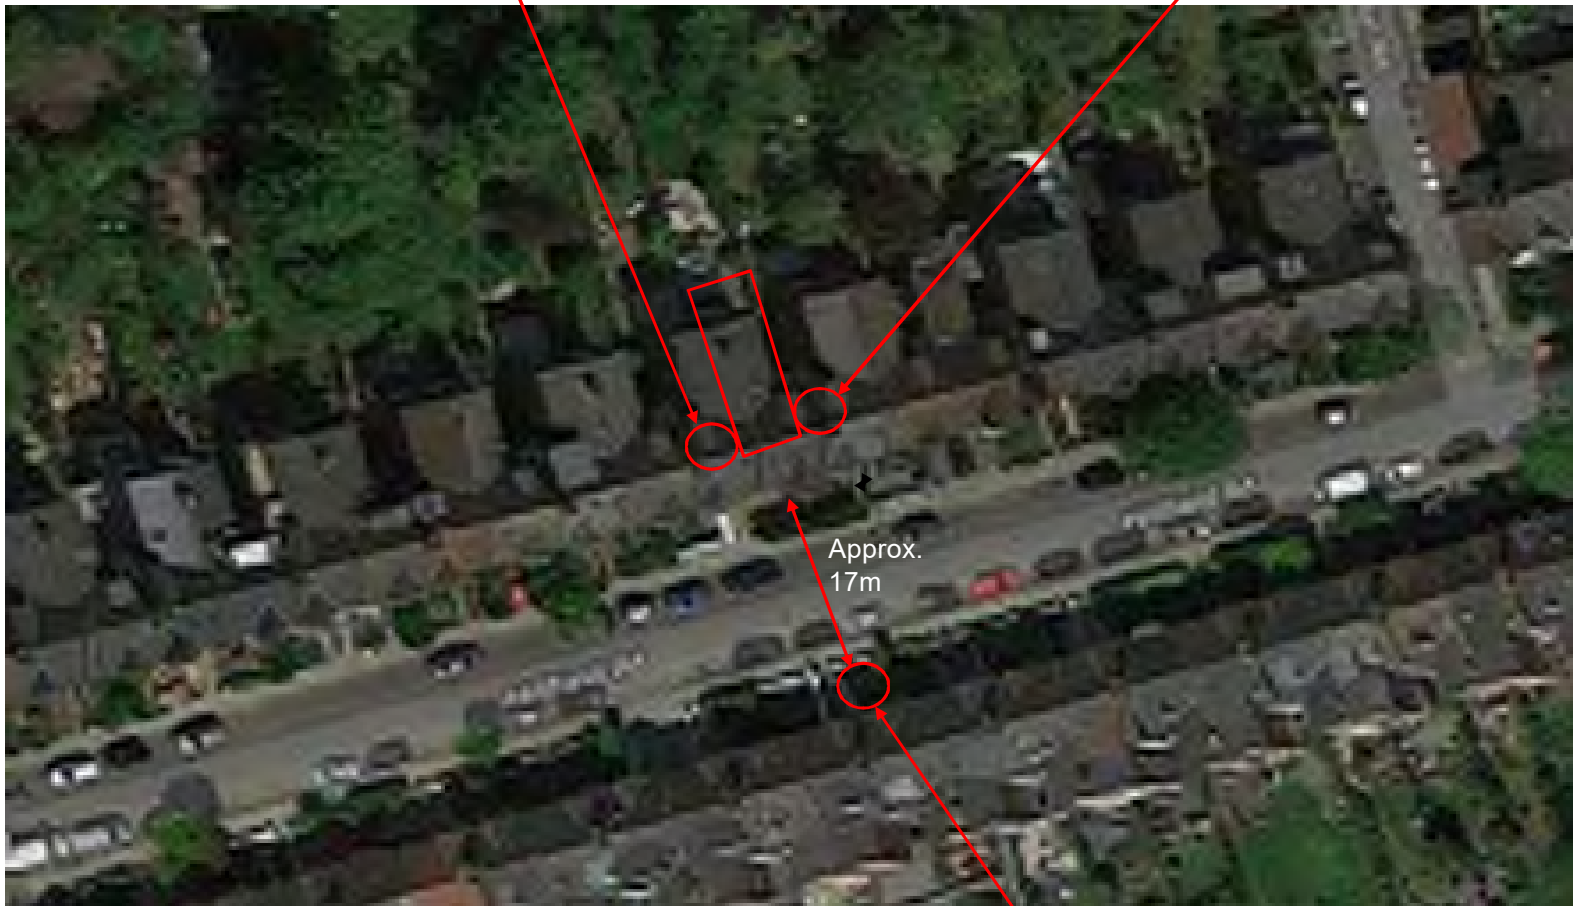
Figure Number: Figure 3

45 Hillfield Road
(existing
basement)

34 Hillfield Road
(existing
basement)

The site is located on a relatively flat lying residential road with an existing basement in the neighbouring property (see Plates 5 to 7).

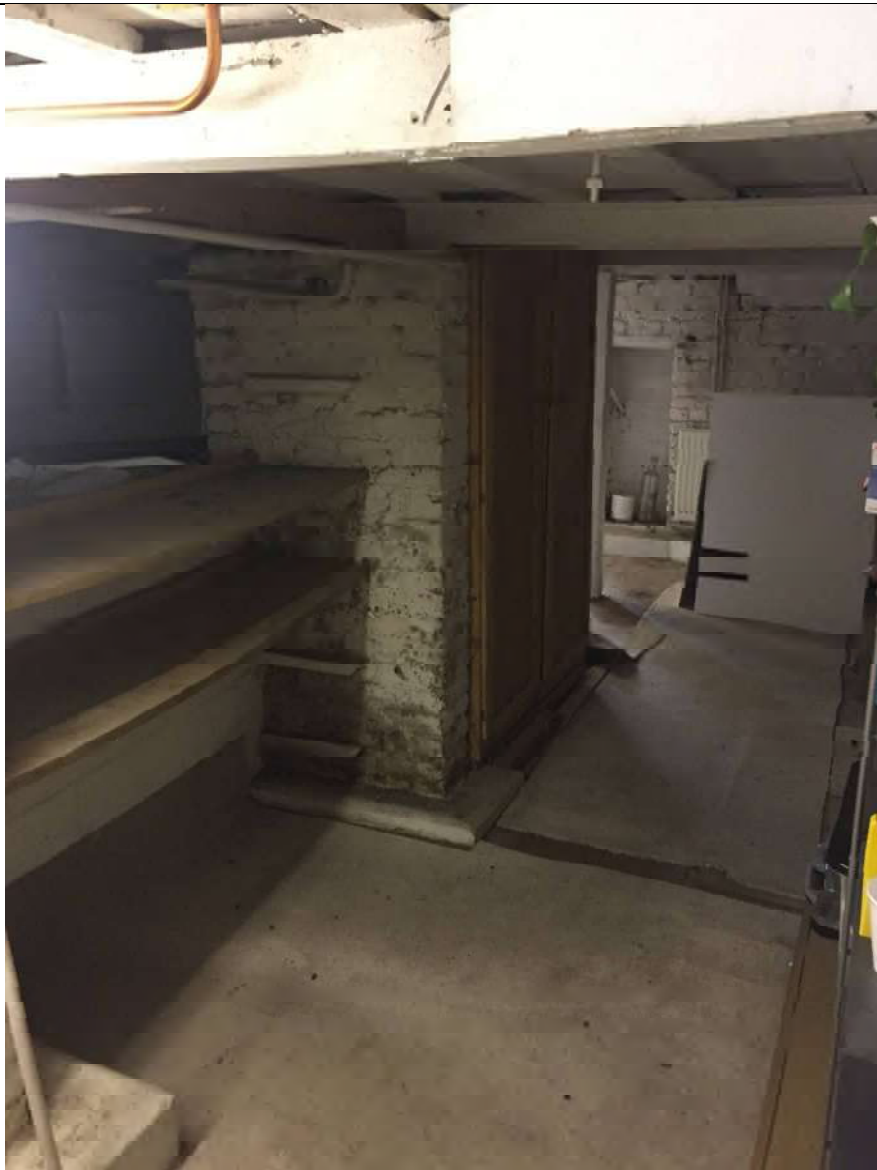
Plate 3: Existing cellar/basement.

The site currently comprises the lower ground floor flat of a three storey (including roof) residential terrace property with an existing partial basement/cellar (see Plates 1 to 4).

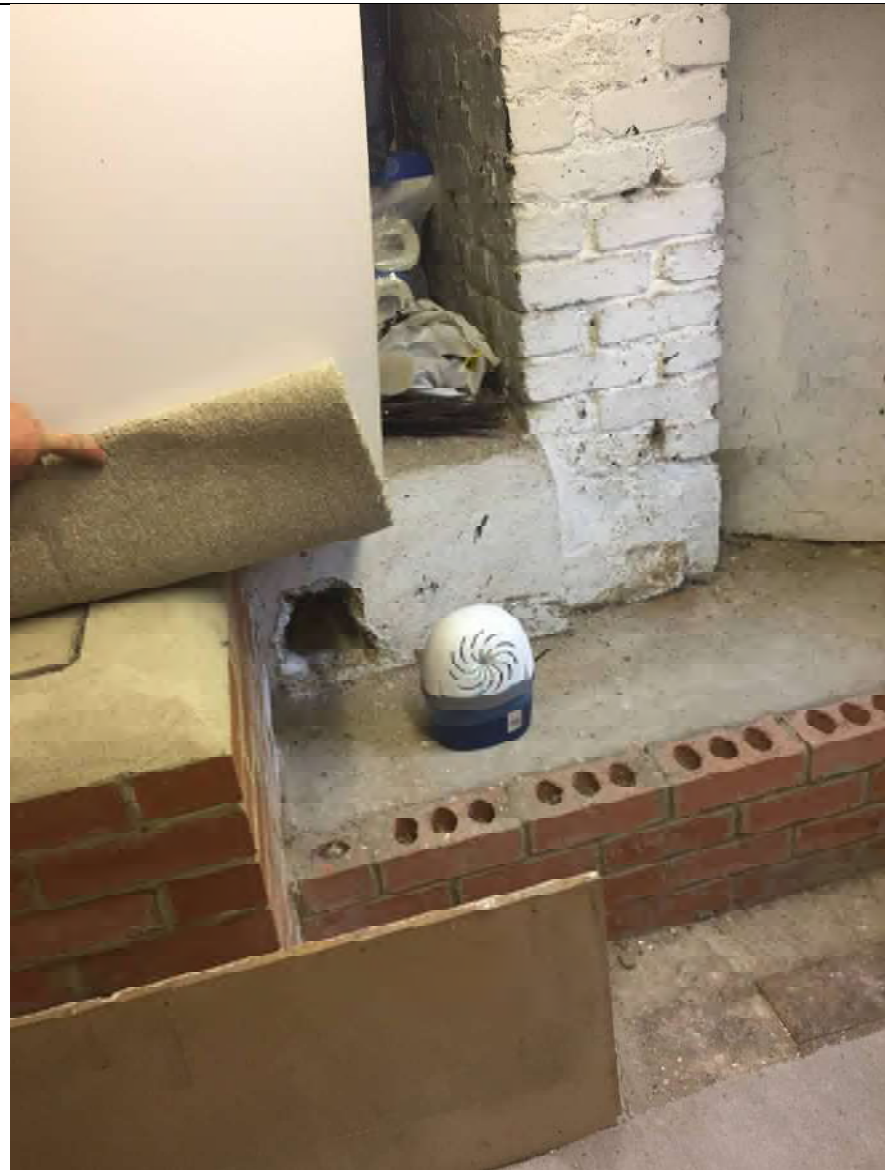
Plate 4: Drain cover within existing basement/cellar.

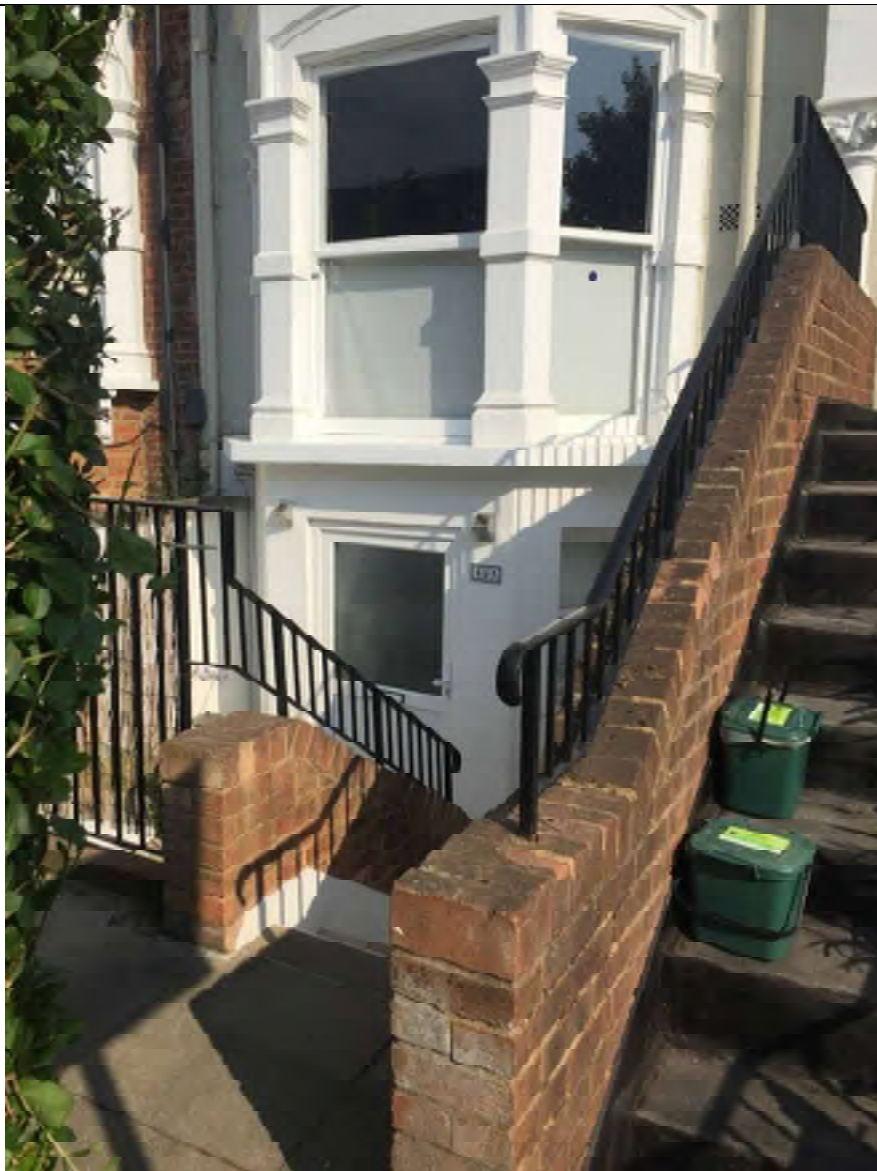
Plate 5: Existing basement in neighbouring property (no. 45).

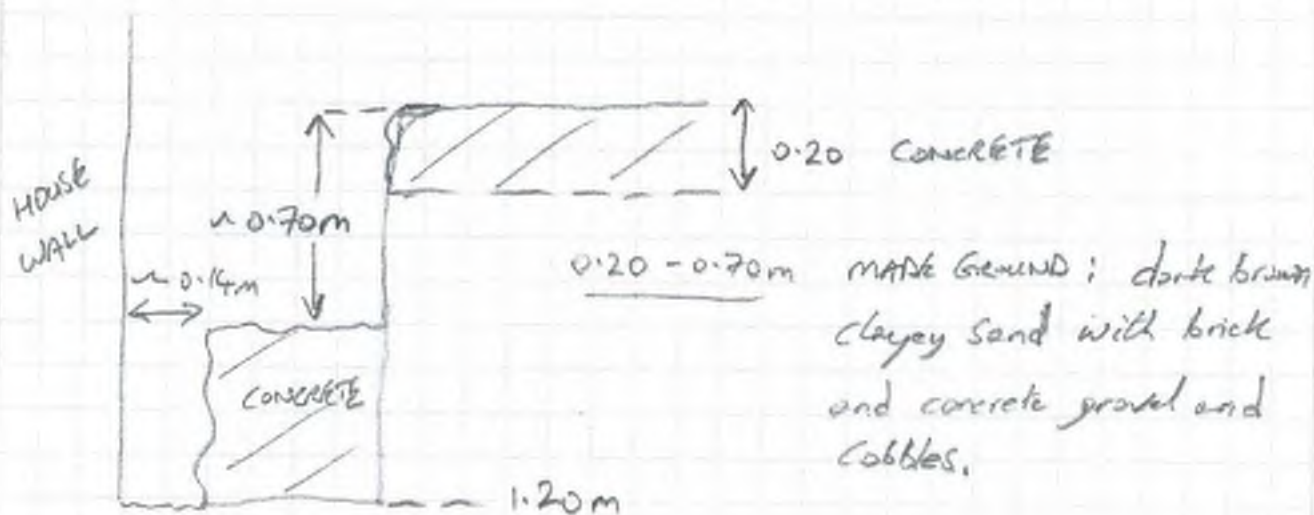
TP1A

NOTE: Unable to progress due to concrete.

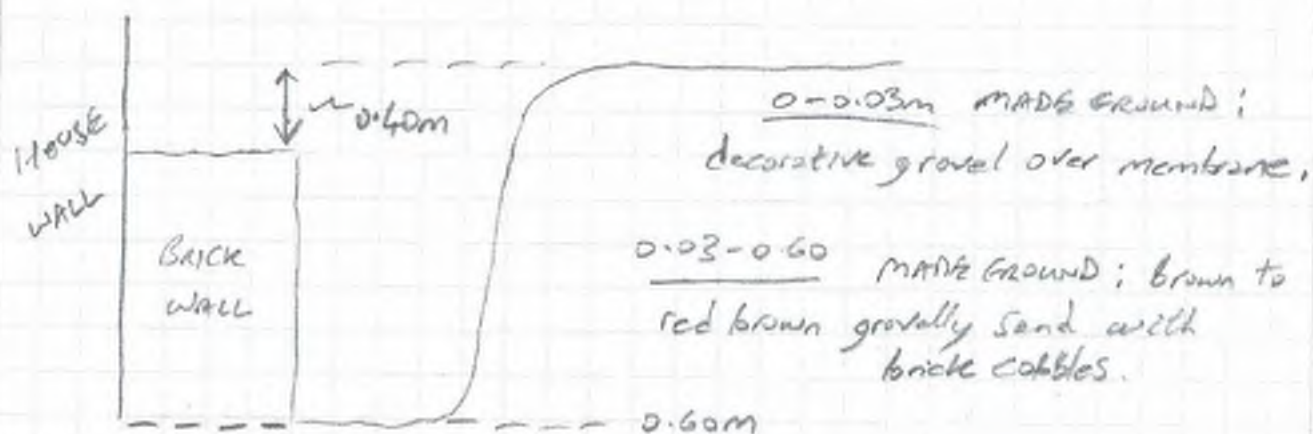
TP1B

NOTE: Unable to progress due to brick wall - possibly associated with existing basement/cellar.

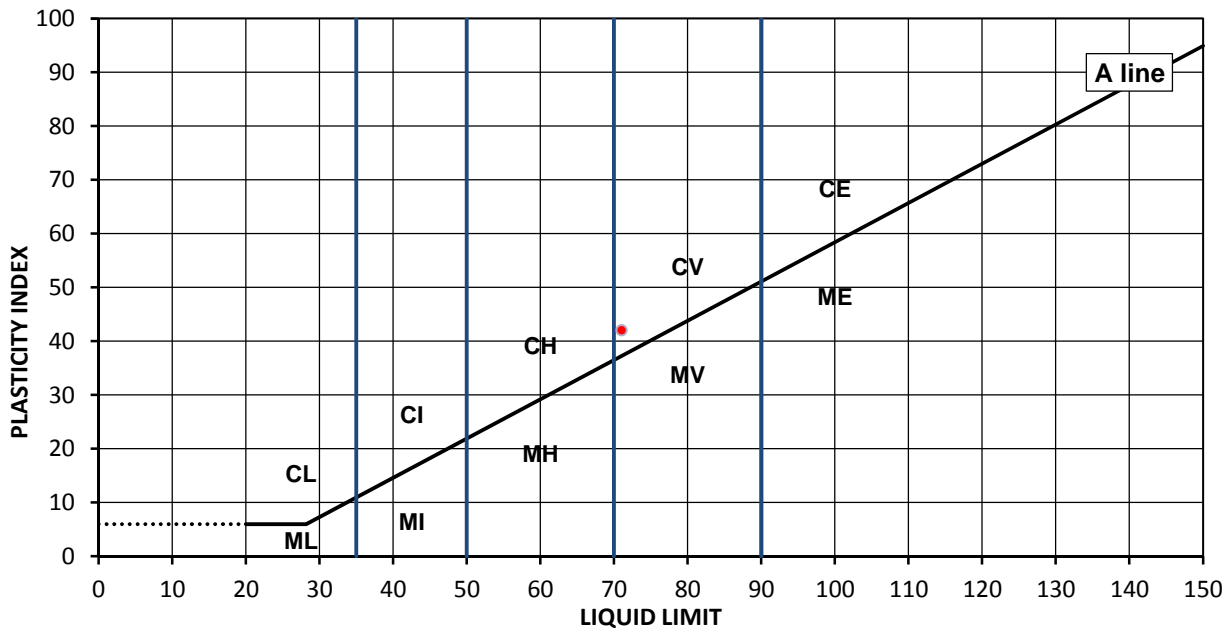
| As Received Moisture Content [%] | Liquid Limit [%] | Plastic Limit [%] | Plasticity Index [%] | % Passing 425µm BS Test Sieve |
|---|---|---|---|---|
| 30 | 71 | 29 | 42 | 100 |

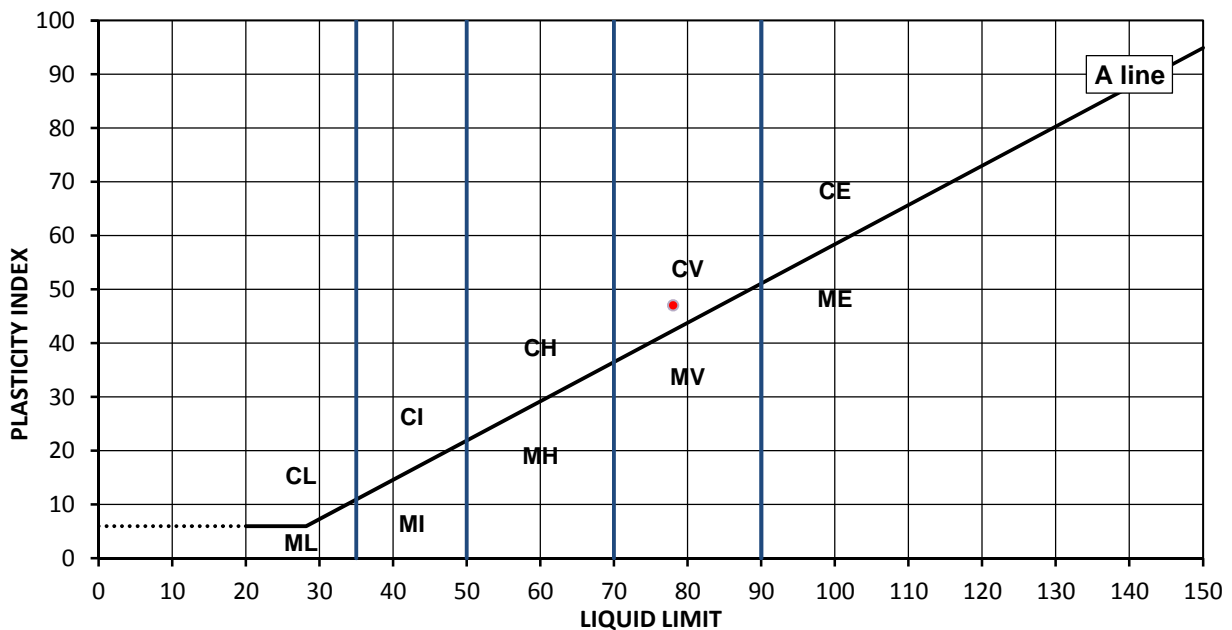
| As Received Moisture Content [%] | Liquid Limit [%] | Plastic Limit [%] | Plasticity Index [%] | % Passing 425µm BS Test Sieve |
|---|---|---|---|---|
| 31 | 78 | 31 | 47 | 100 |

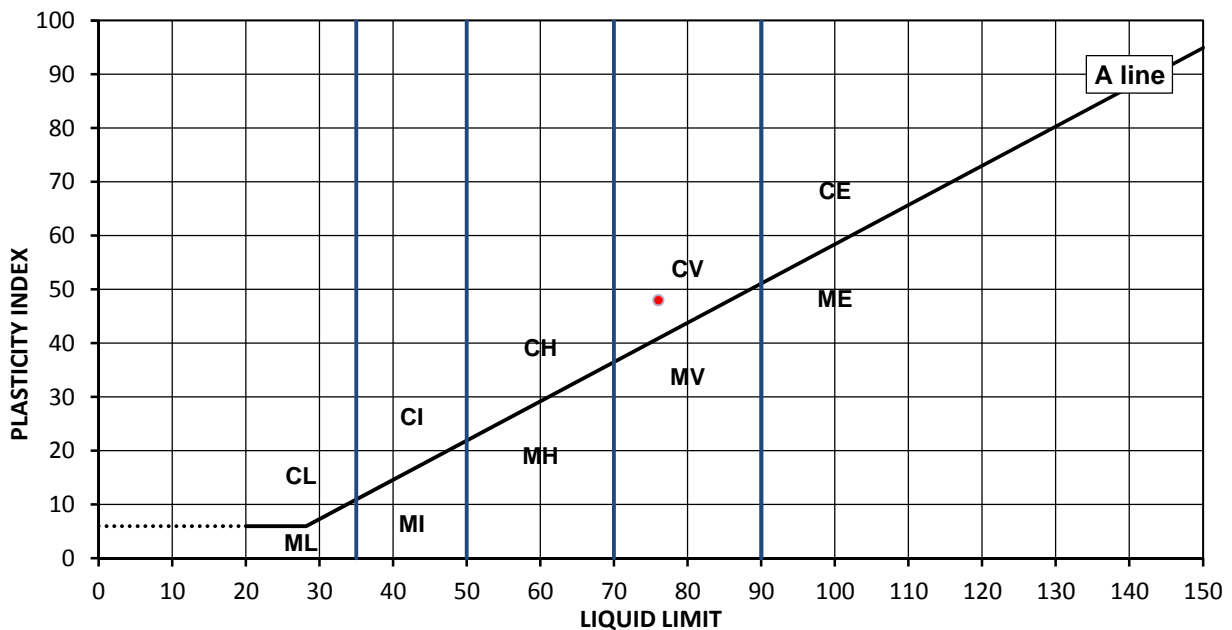
| As Received Moisture Content [%] | Liquid Limit [%] | Plastic Limit [%] | Plasticity Index [%] | % Passing 425µm BS Test Sieve |
|---|---|---|---|---|
| 33 | 76 | 28 | 48 | 100 |

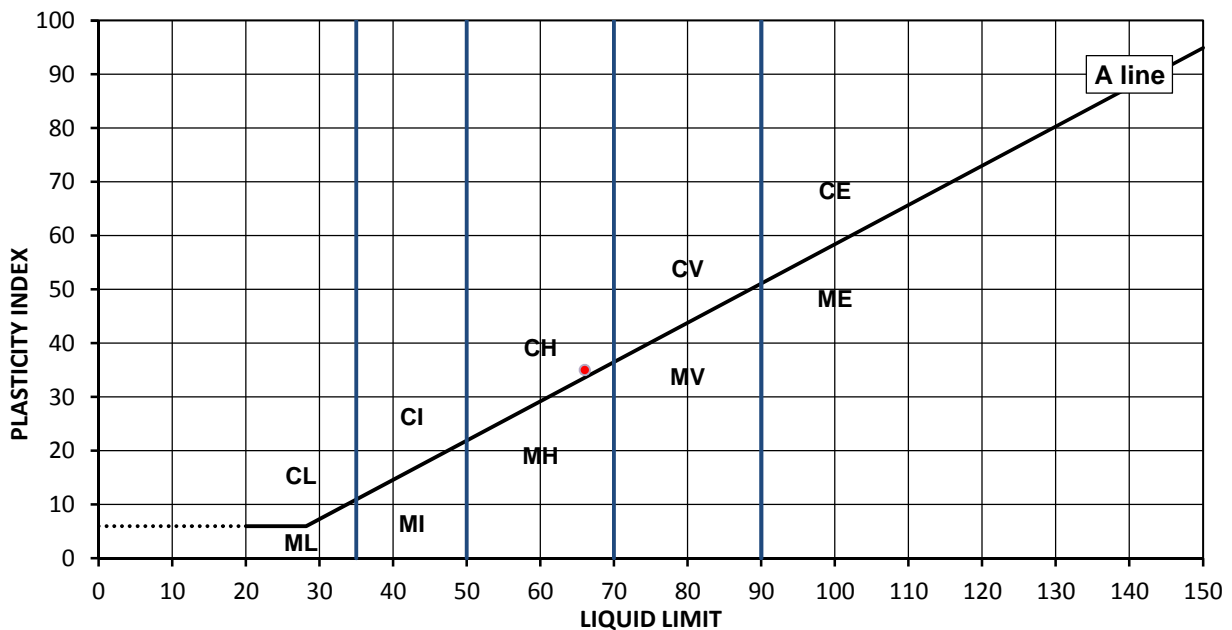
| As Received Moisture Content [%] | Liquid Limit [%] | Plastic Limit [%] | Plasticity Index [%] | % Passing 425µm BS Test Sieve |
|---|---|---|---|---|
| 31 | 66 | 31 | 35 | 100 |

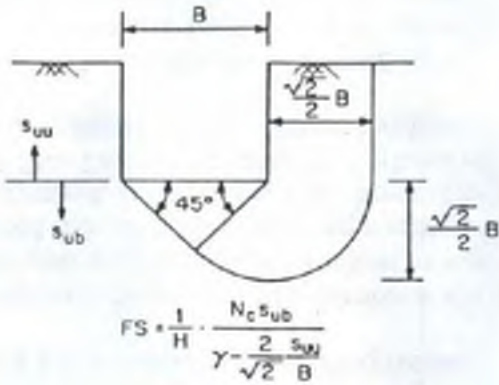
| FoS | 9.0 | Factor of Safety against Bottom Heave (after Terzaghi, 1943) |

Terzaghi's Method to assess Factor of Safety against Bottom Heave (Fig. 6.2 in CIRIA C760).
