Symmetrys Ltd
Structural Engineers

BASEMENT IMPACT ASSESSMENT

43 Hillfield Road
London
NW6 1QD

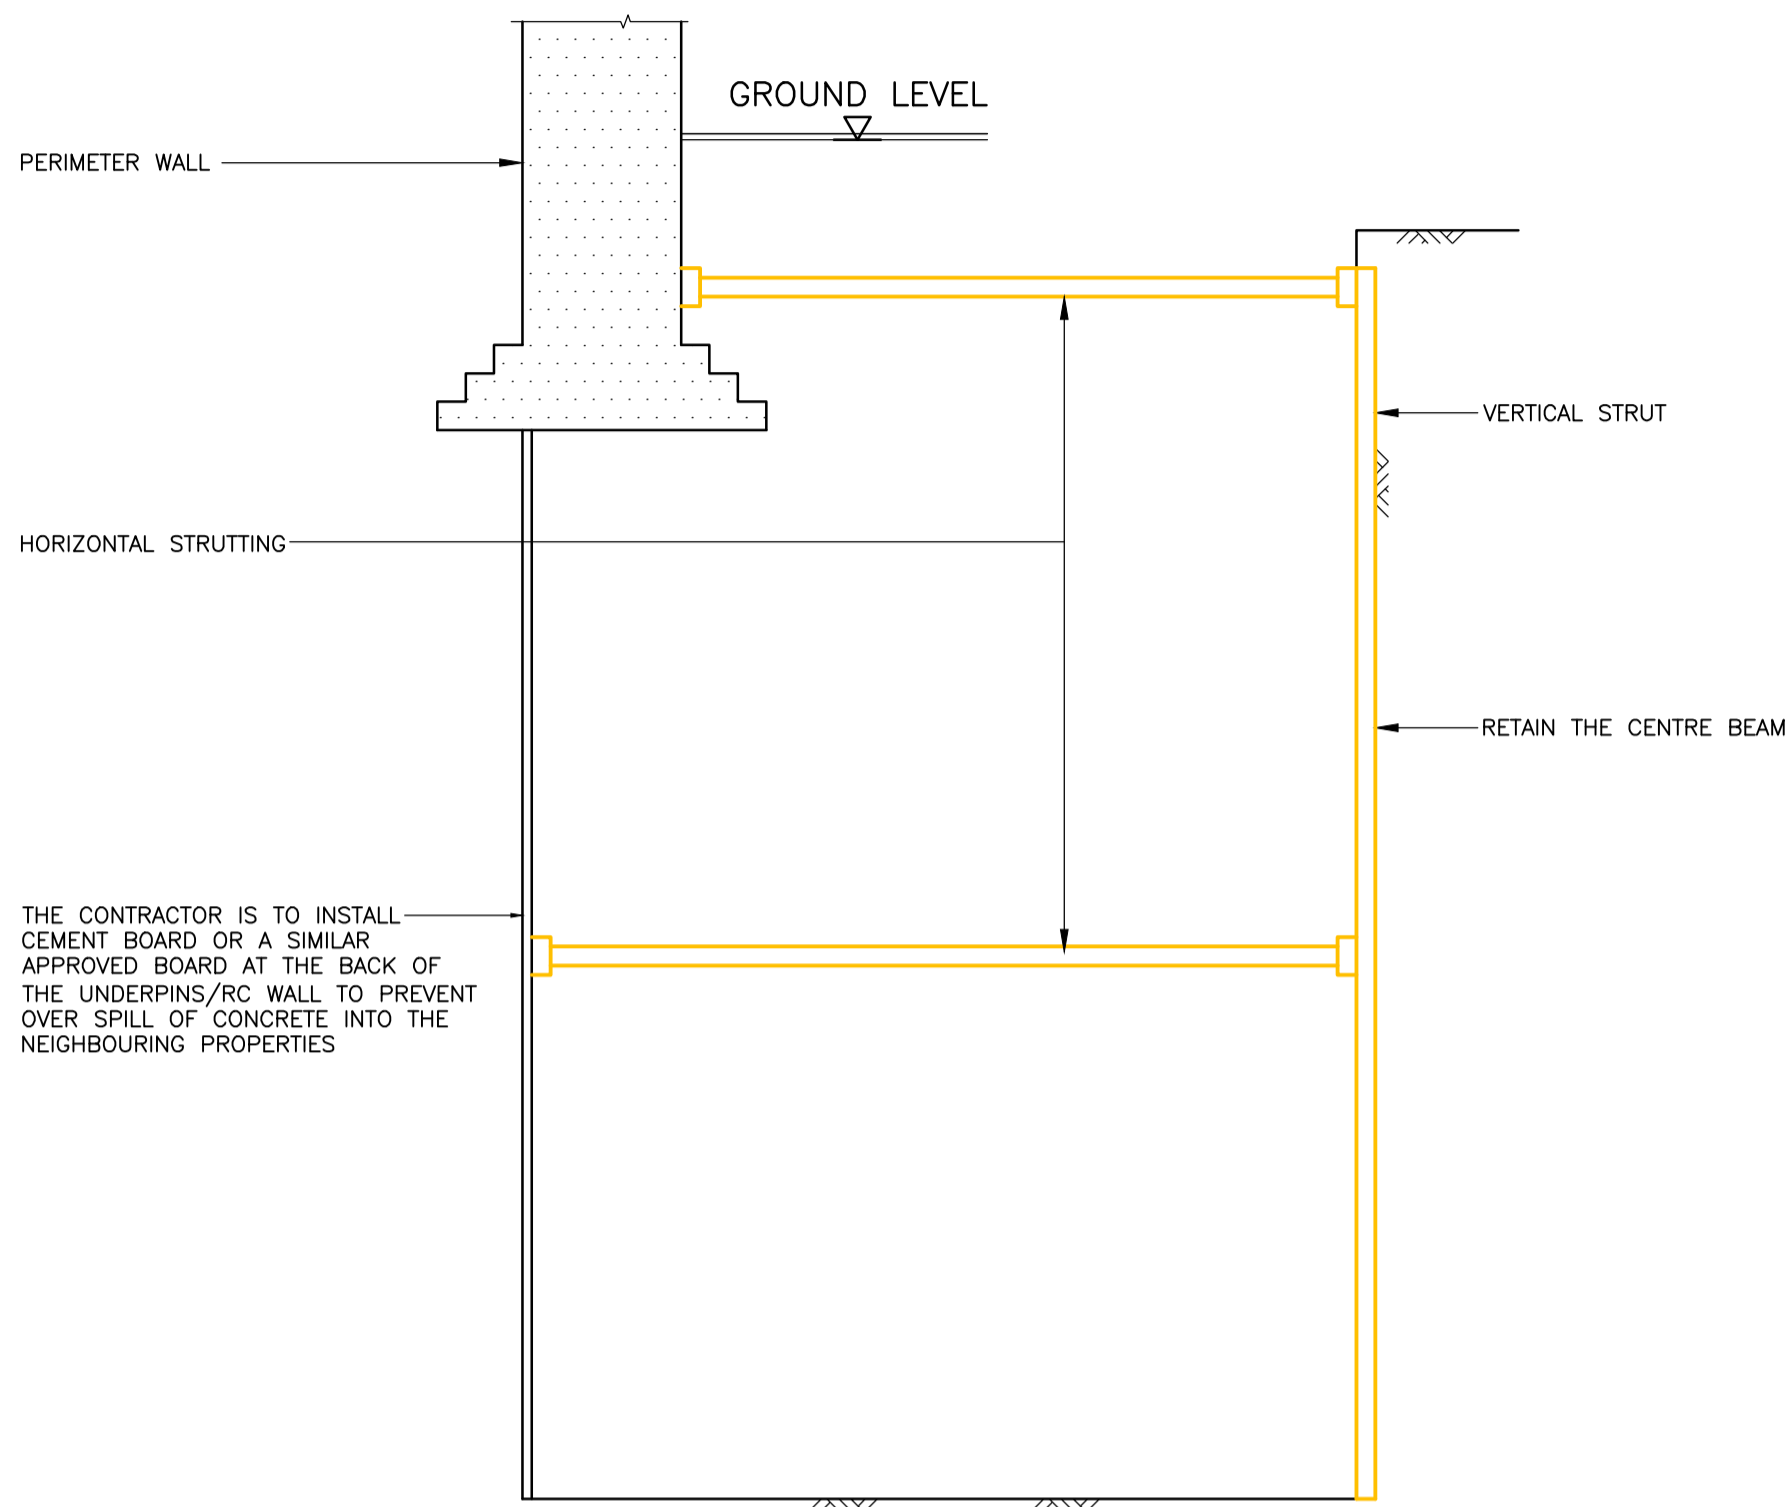
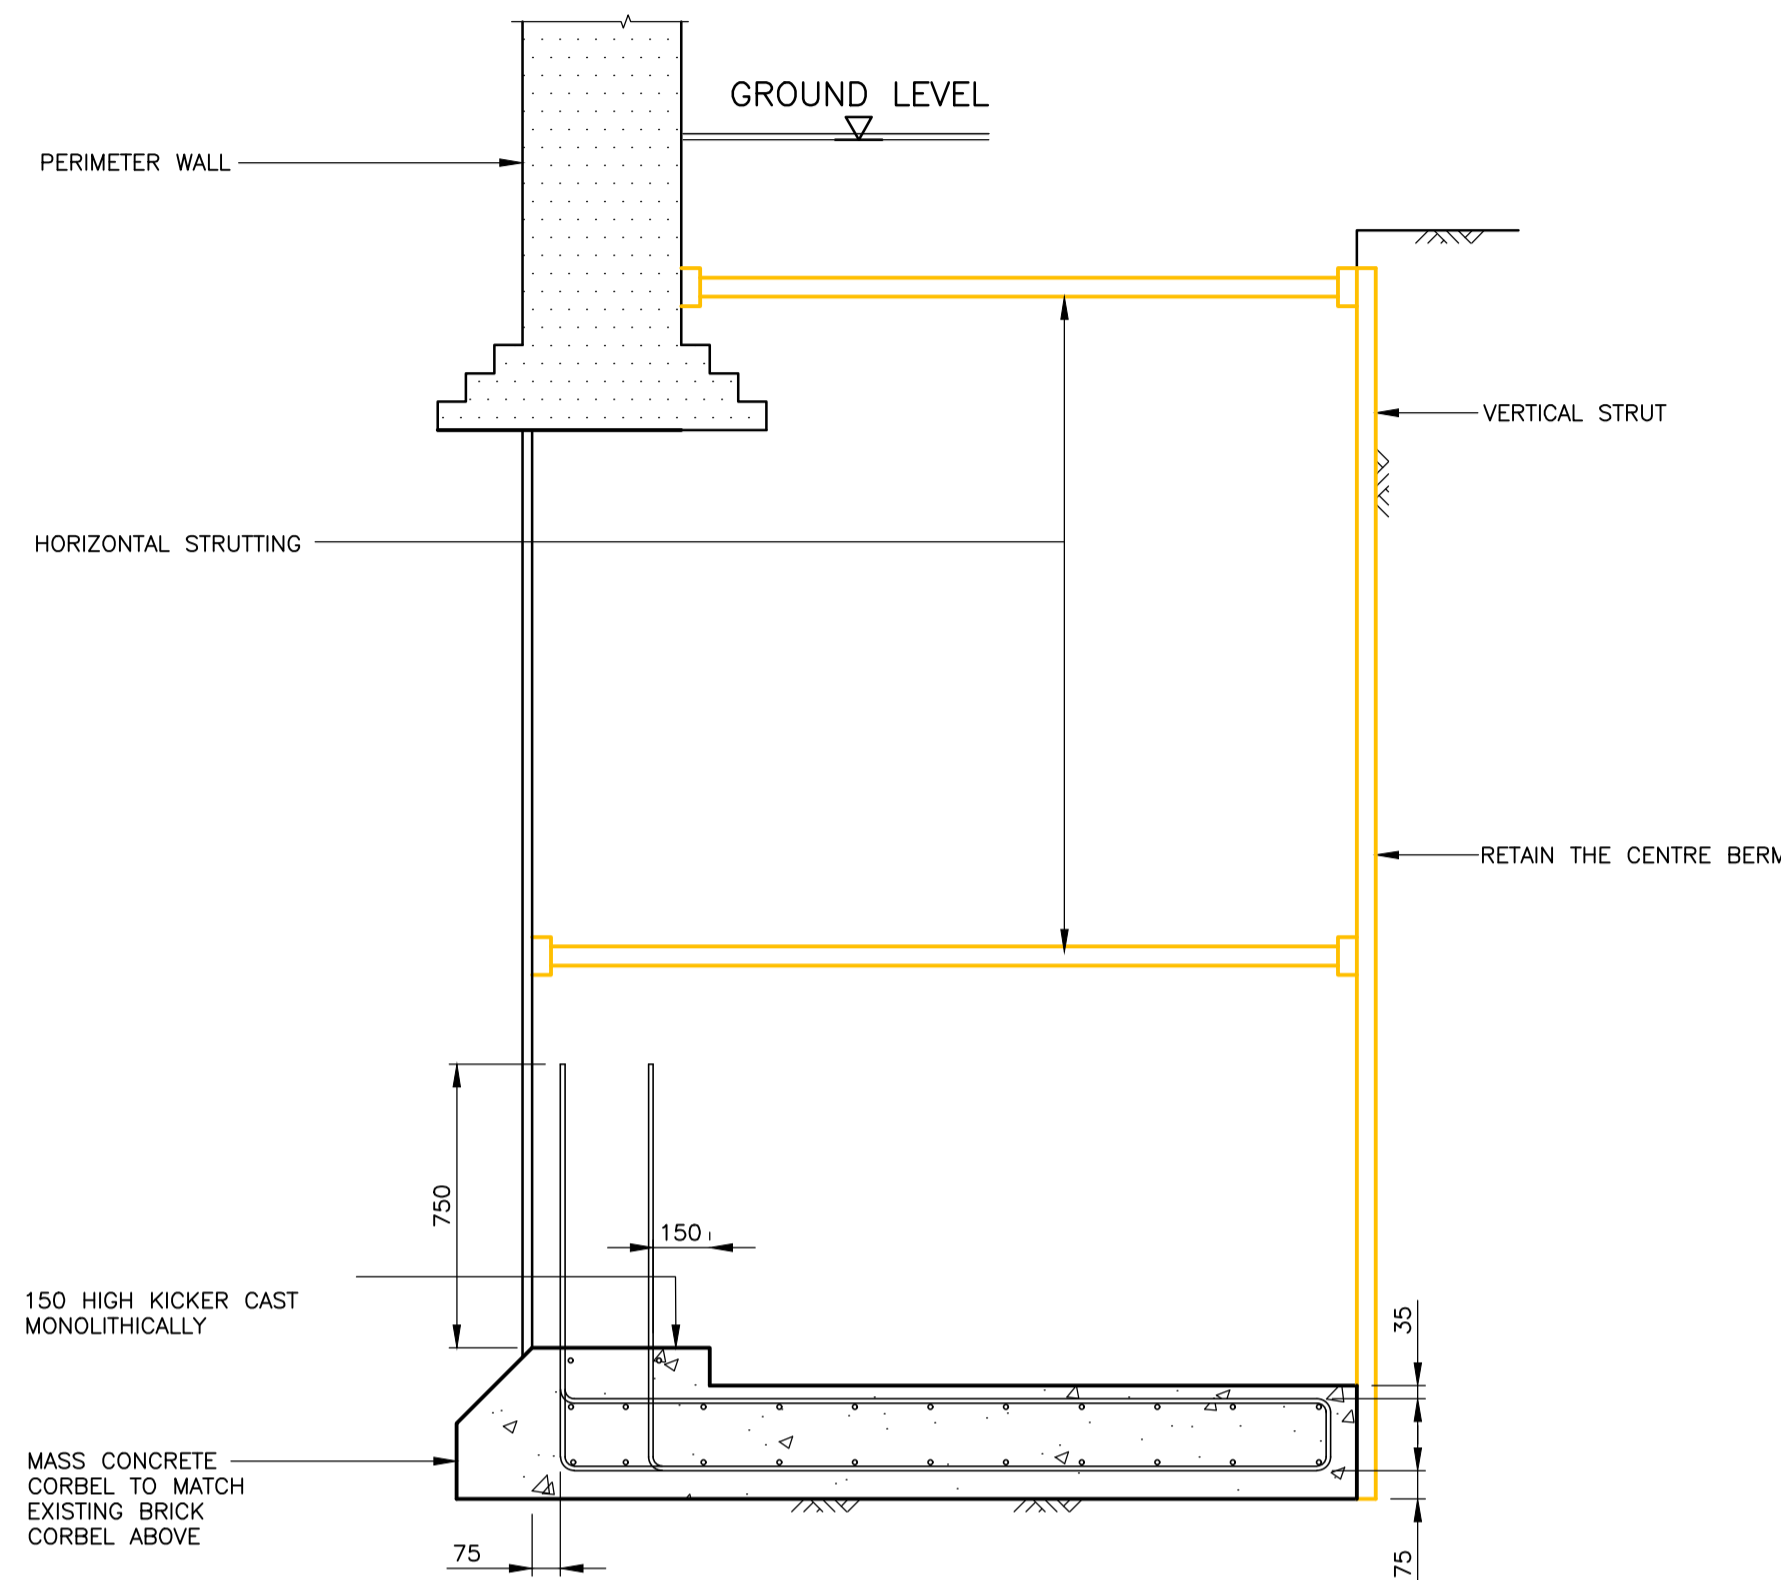
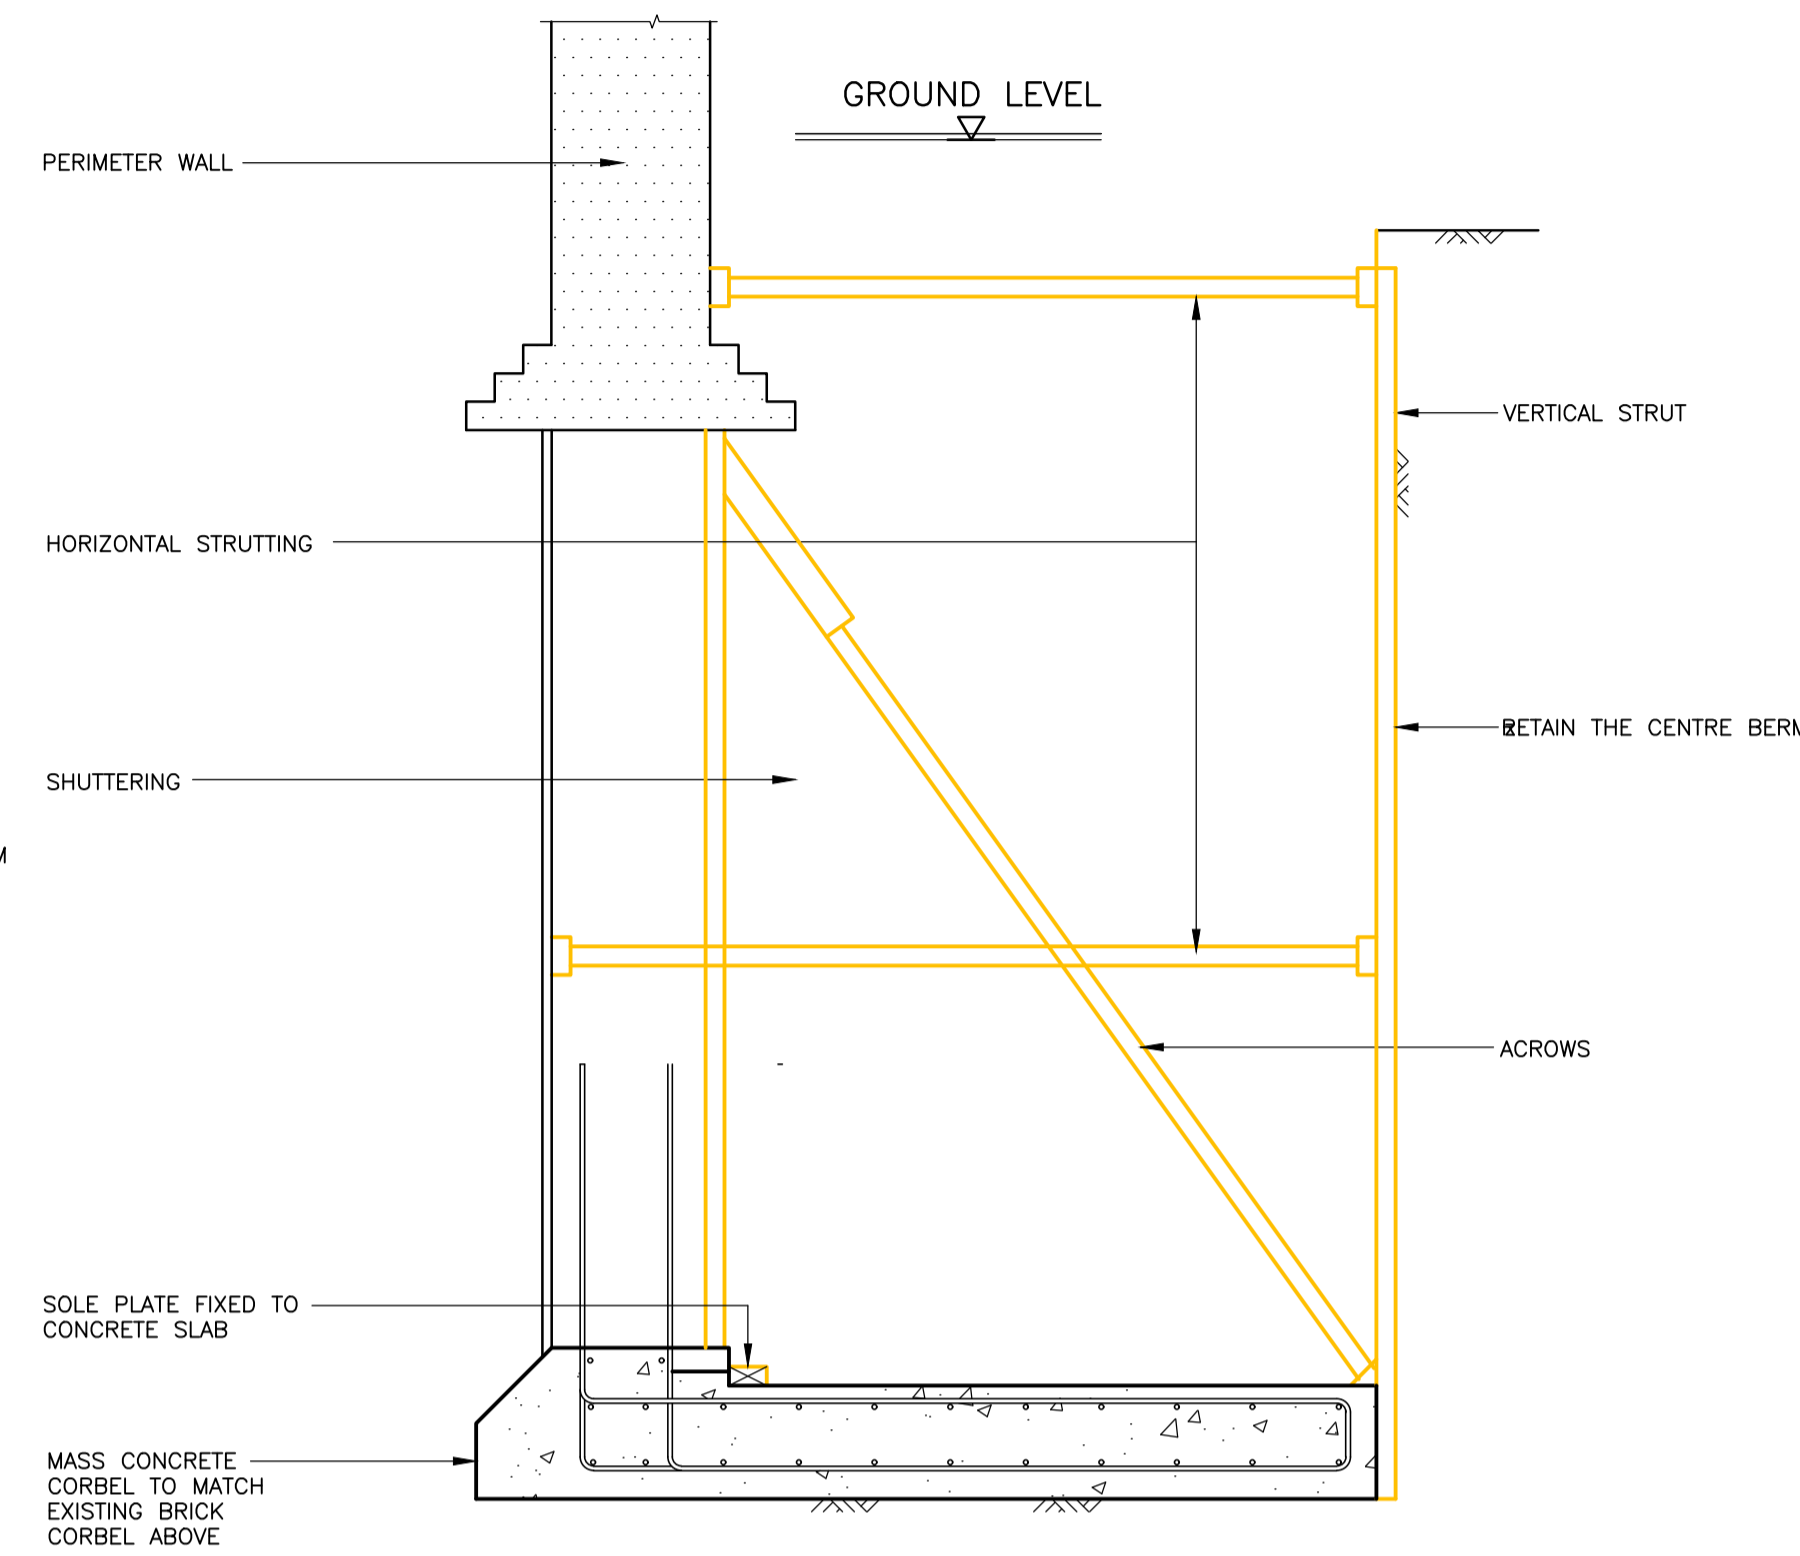
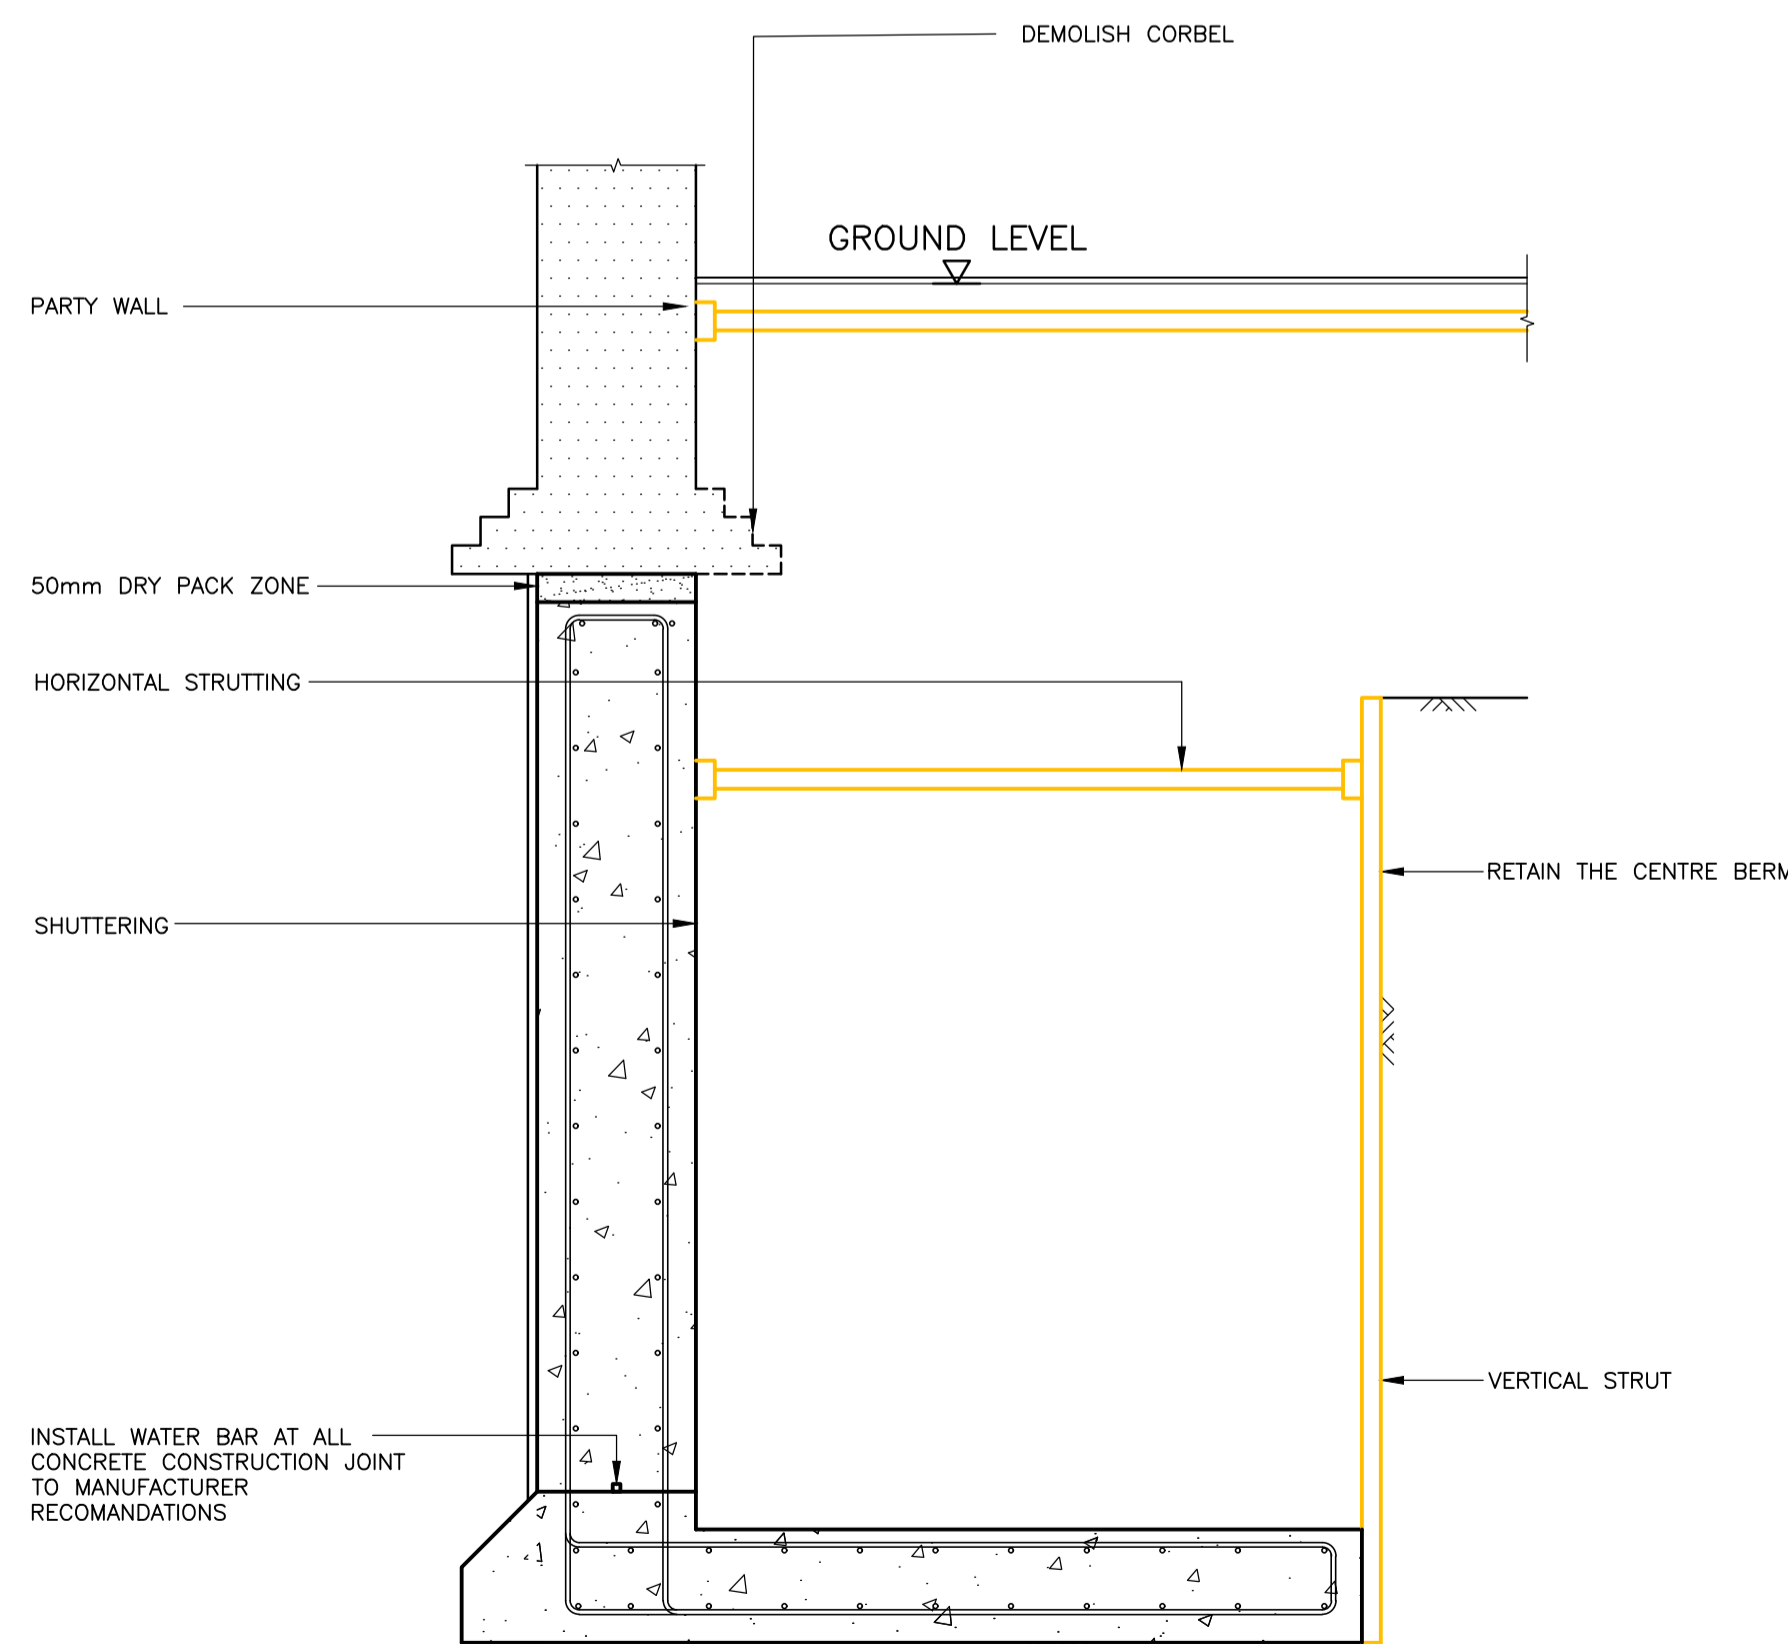
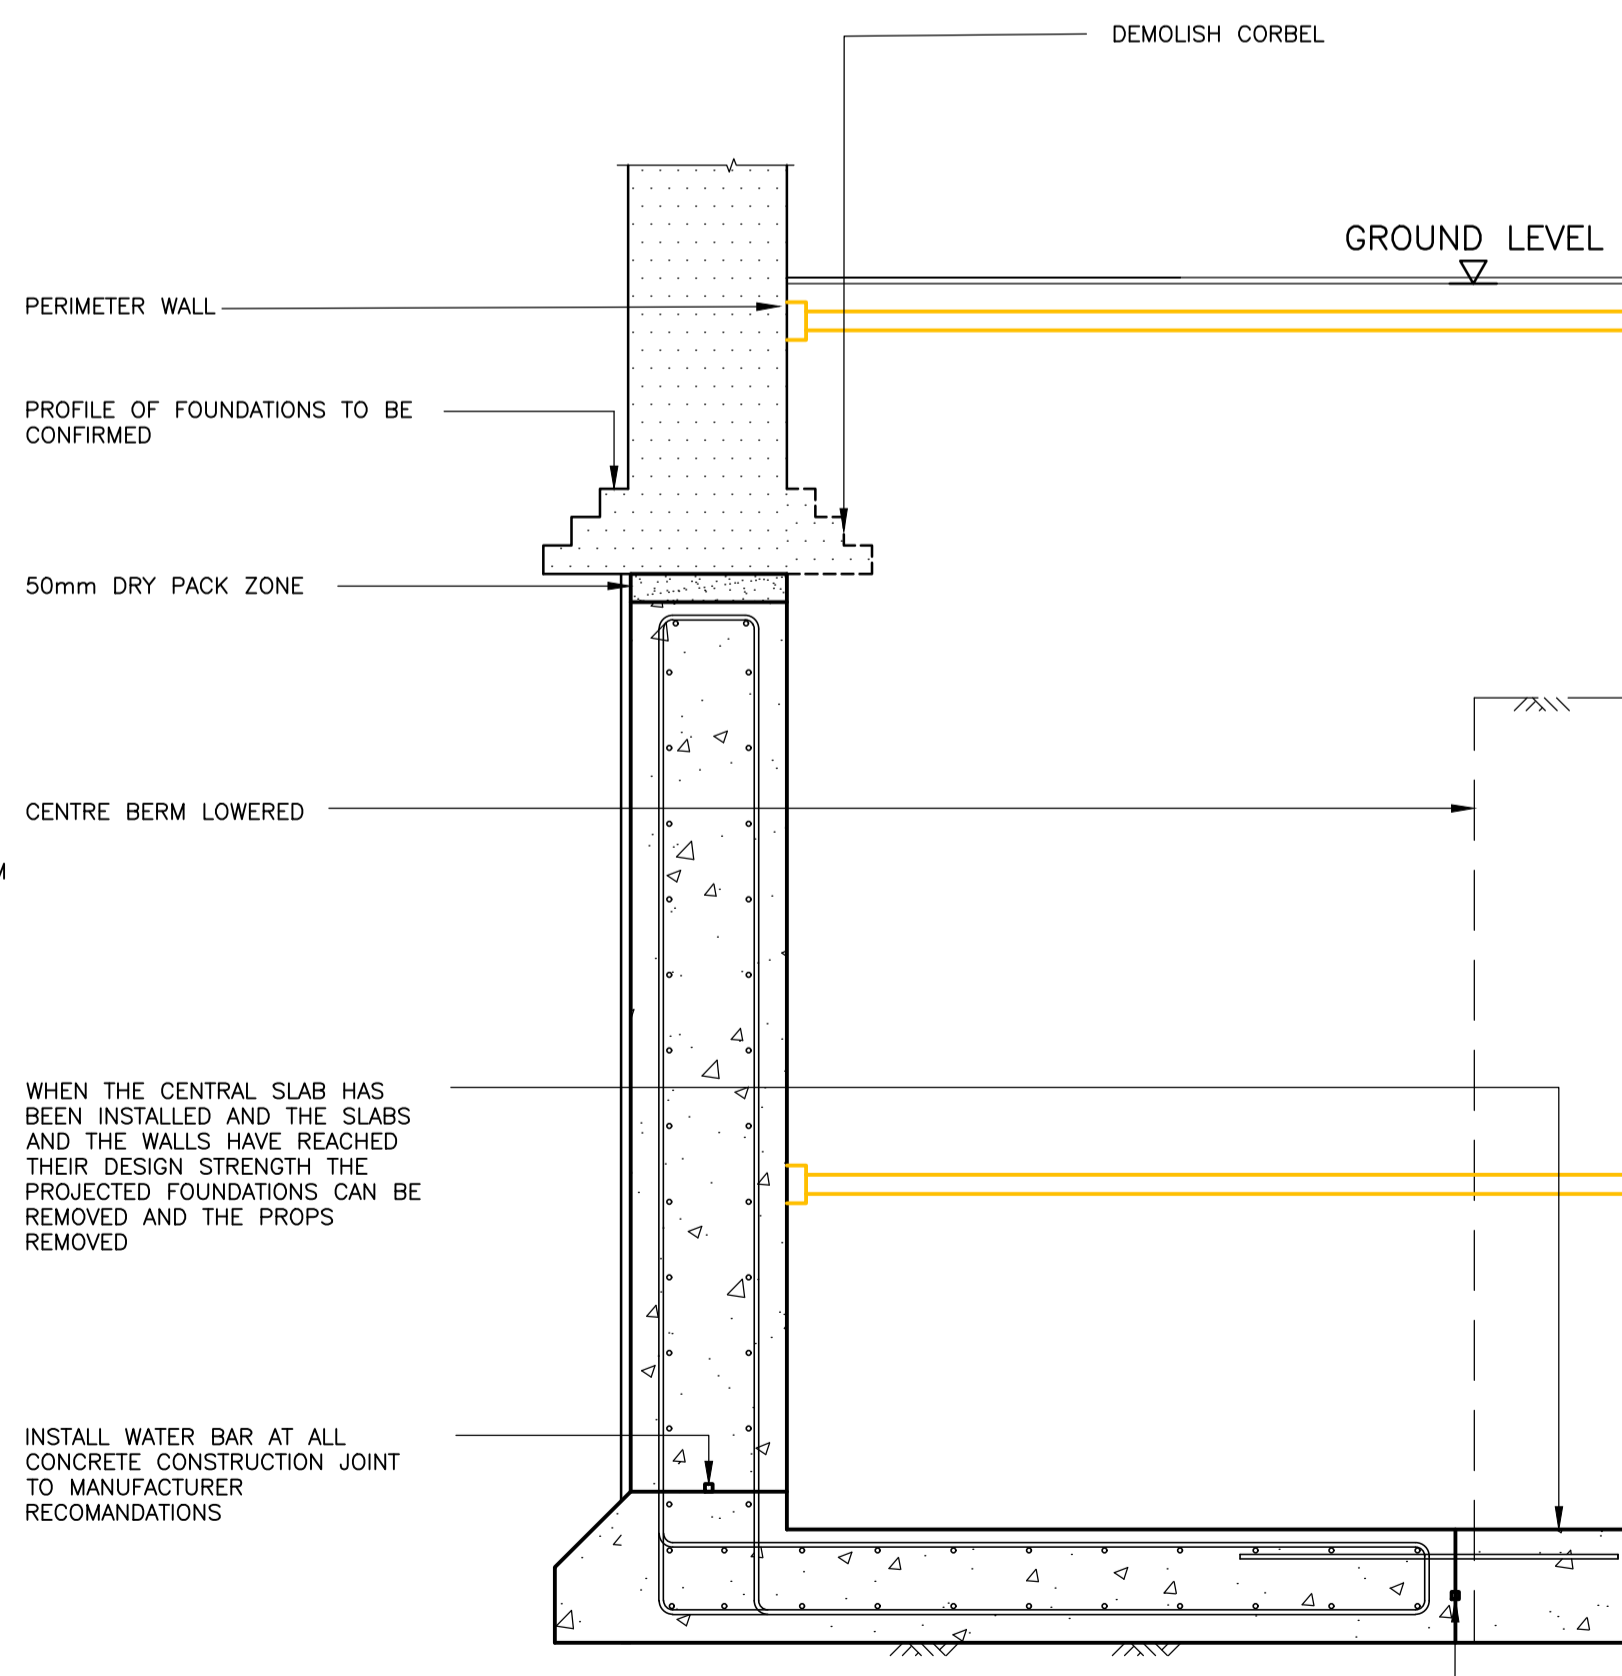
NOTE:
UNDERPINS TO BE DOWELLED INTO EACH OTHER WITH
6No. MIN H20 DOWELS WITH 400mm MIN. EMBEDMENT

SEQUENCE 1
1:20

SEQUENCE 2
1:20

SEQUENCE 3
1:20

SEQUENCE 4
1:20

SEQUENCE 5
1:20

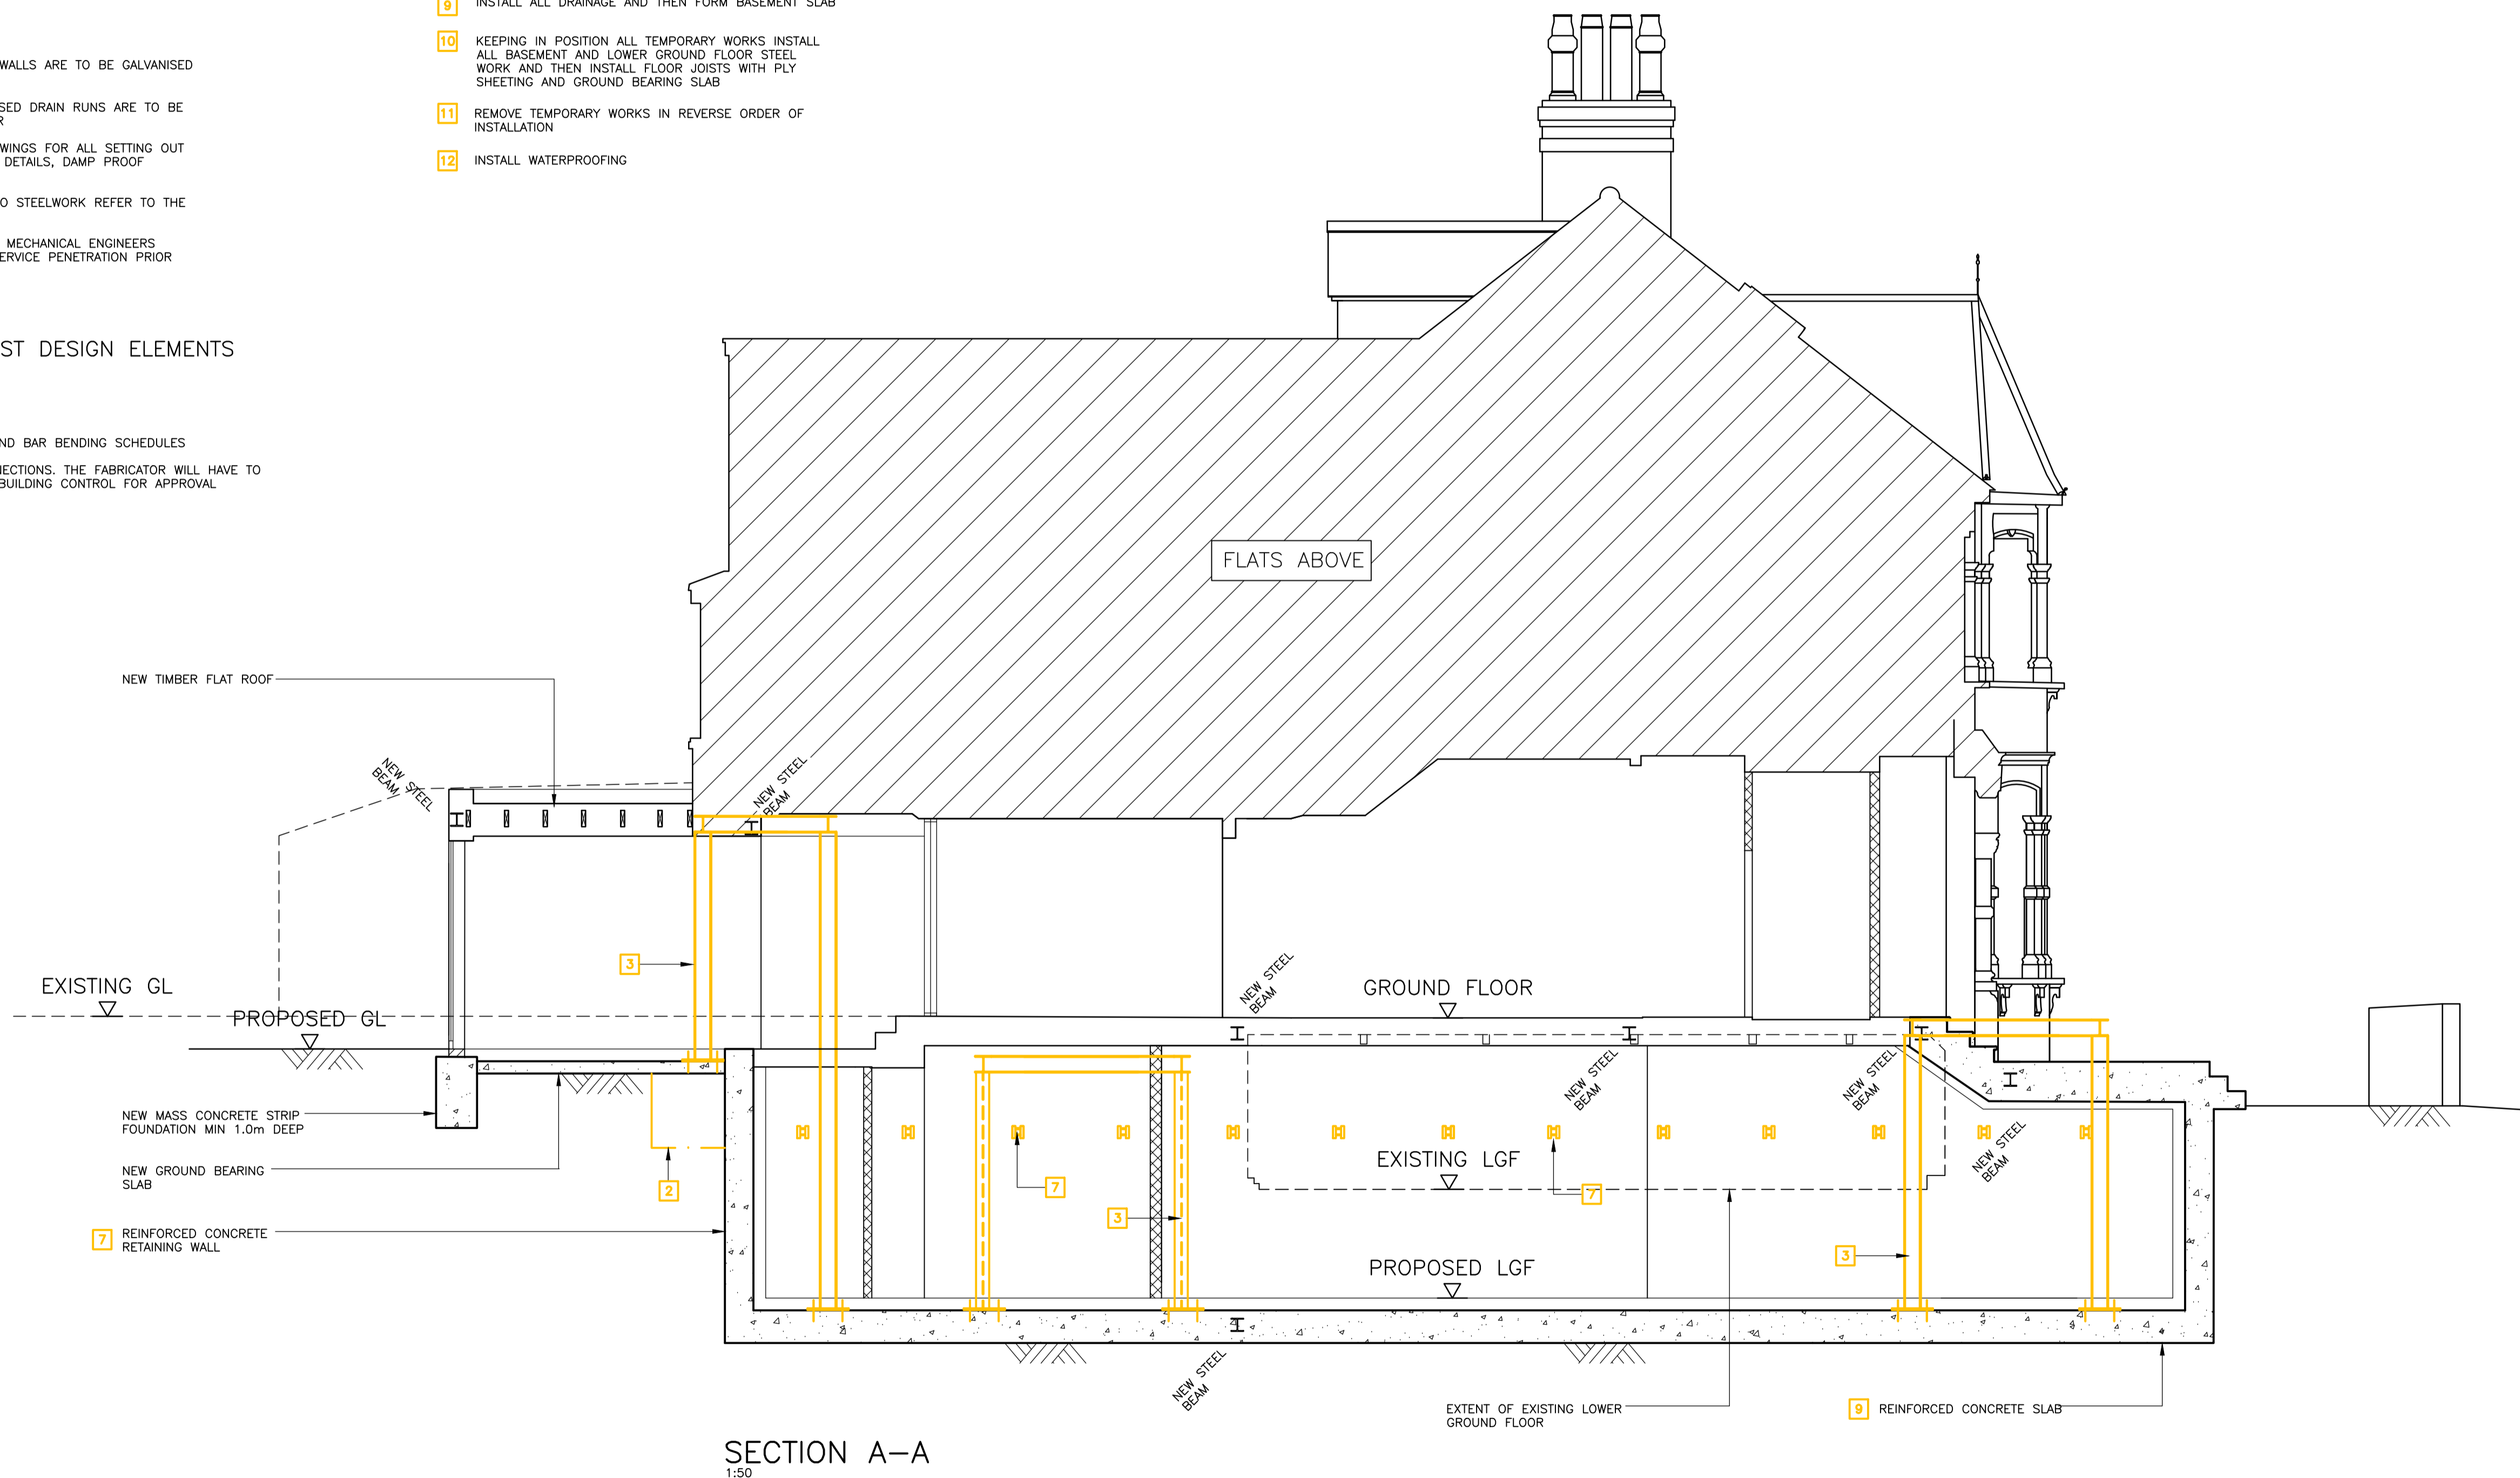
- 4 DEMOLISH ALL NON-LOAD BEARING WALLS AT LOWER GROUND FLOOR
- 5 REMOVE LOWER GROUND FLOOR SLAB
- 6 INSTALL TRANSITION UNDERPINS
- 7 INSTALL ALL TEMPORARY PROPS AND FORM THE NEW CONCRETE UNDERPINS AND PERIMETER FOUNDATIONS IN AN UNDERPINNED SEQUENCE. SEE DRAWING SK05 FOR PROPOSED PROPPING TO UNDERPINS

- 8 EXCAVATE BASEMENT
- 9 INSTALL ALL DRAINAGE AND THEN FORM BASEMENT SLAB
- 10 KEEPING IN POSITION ALL TEMPORARY WORKS INSTALL ALL BASEMENT AND LOWER GROUND FLOOR STEEL WORK AND THEN INSTALL FLOOR JOISTS WITH PLY SHEETING AND GROUND BEARING SLAB

- 11 REMOVE TEMPORARY WORKS IN REVERSE ORDER OF INSTALLATION
- 12 INSTALL WATERPROOFING

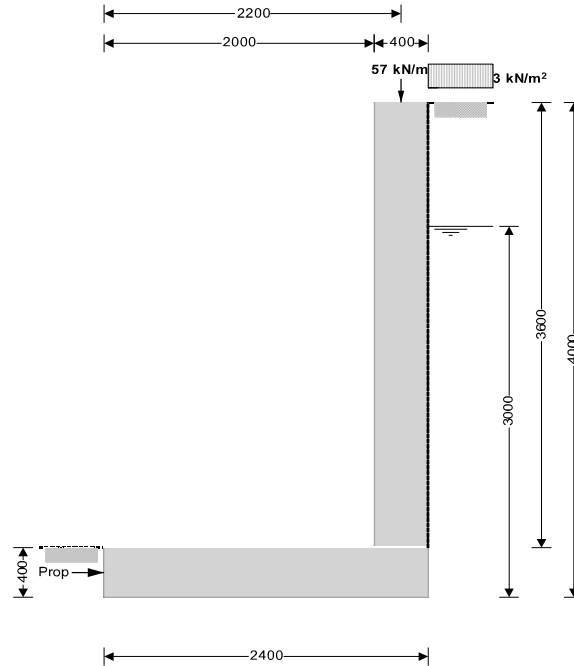
RETAINING WALL ANALYSIS (BS 8002:1994)

Wall details

Retaining wall type
Height of retaining wall stem
Thickness of wall stem
Length of toe
Length of heel
Overall length of base
Thickness of base
Depth of downstand
Position of downstand
Thickness of downstand
Height of retaining wall
Depth of cover in front of wall
Depth of unplanned excavation
Height of ground water behind wall
Height of saturated fill above base
Density of wall construction
Density of base construction
Angle of rear face of wall
Angle of soil surface behind wall
Effective height at virtual back of wall

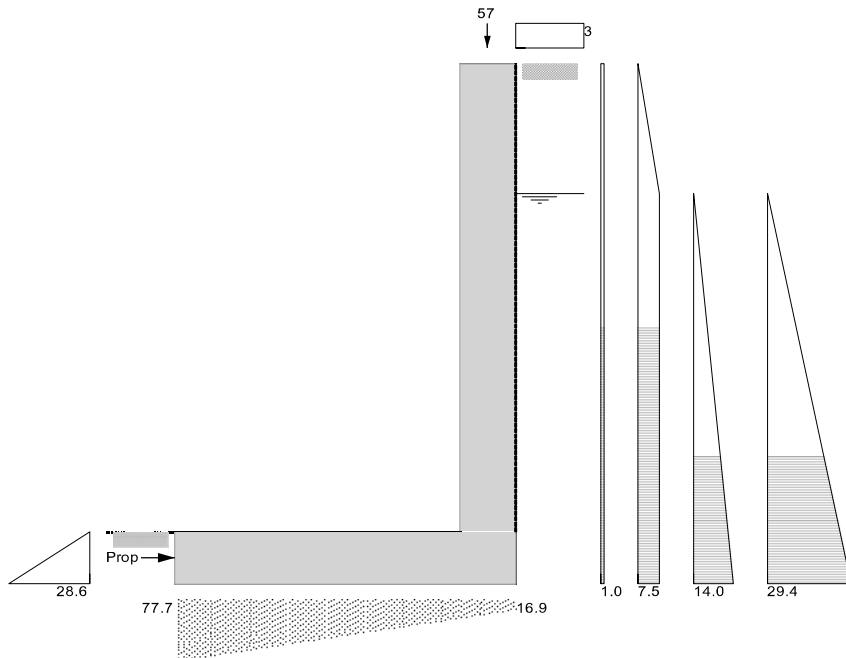
Surcharge load on plan Surcharge = 2.5 kN/m²
 Applied vertical dead load on wall $W_{\text{dead}} = 47.2 \text{ kN/m}$
 Applied vertical live load on wall $W_{\text{live}} = 9.7 \text{ kN/m}$
 Position of applied vertical load on wall $l_{\text{load}} = 2200 \text{ mm}$
 Applied horizontal dead load on wall $F_{\text{dead}} = 0.0 \text{ kN/m}$
 Applied horizontal live load on wall $F_{\text{live}} = 0.0 \text{ kN/m}$
 Height of applied horizontal load on wall $h_{\text{load}} = 0 \text{ mm}$

Loads shown in kN/m, pressures shown in kN/m²

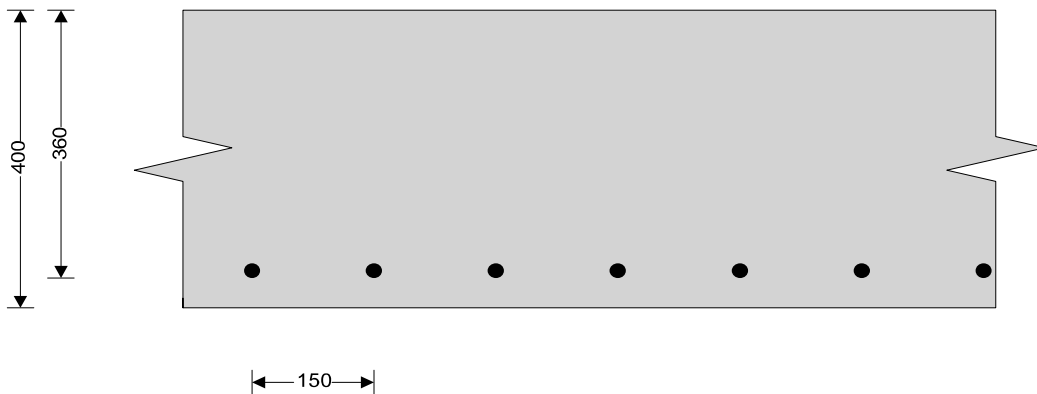
Calculate moment for toe design

Moment from bearing pressure $M_{toe_bear} = (2 \times p_{toe_f} + p_{stem_mid_f}) \times (l_{toe} + t_{wall} / 2)^2 / 6 = 257.2 \text{ kNm/m}$
 Moment from weight of base $M_{toe_wt_base} = (\gamma_{f_d} \times \gamma_{base} \times t_{base} \times (l_{toe} + t_{wall} / 2)^2 / 2) = 32 \text{ kNm/m}$
 Total moment for toe design $M_{toe} = M_{toe_bear} - M_{toe_wt_base} = 225.2 \text{ kNm/m}$

Check toe in bending

Width of toe $b = 1000 \text{ mm/m}$
 Depth of reinforcement $d_{toe} = t_{base} - c_{toe} - (\phi_{toe} / 2) = 360.0 \text{ mm}$
 Constant $K_{toe} = M_{toe} / (b \times d_{toe}^2 \times f_{cu}) = 0.043$

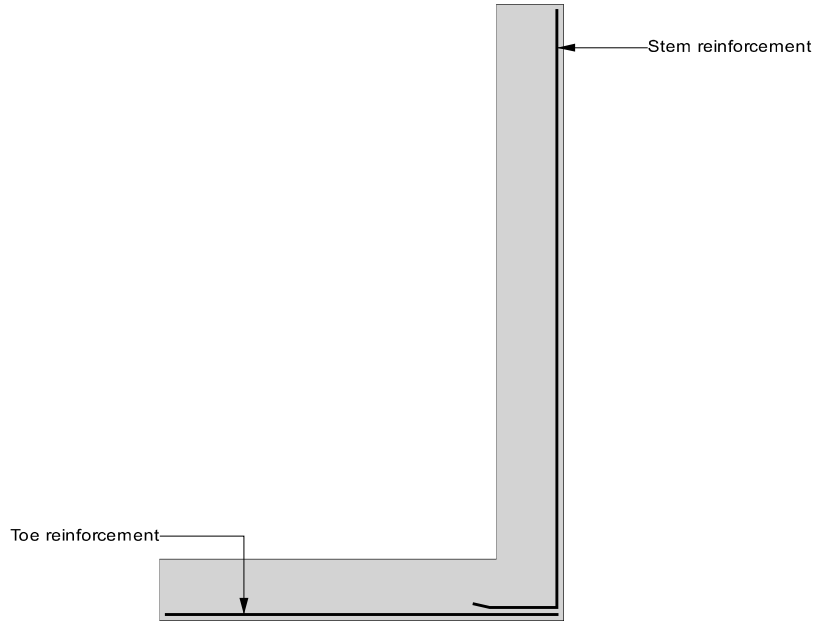
Indicative retaining wall reinforcement diagram

Toe bars - 20 mm dia. @ 150 mm centres - (2094 mm²/m)
Stem bars - 20 mm dia. @ 150 mm centres - (2094 mm²/m)

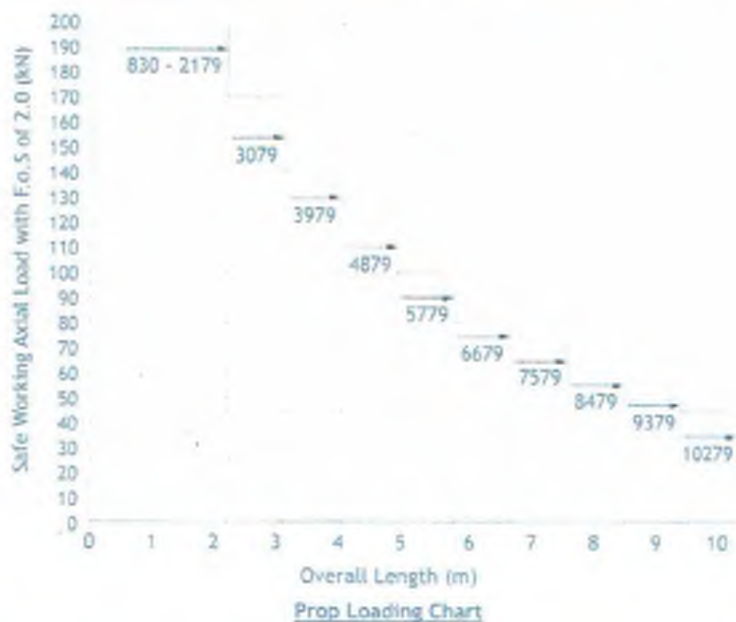
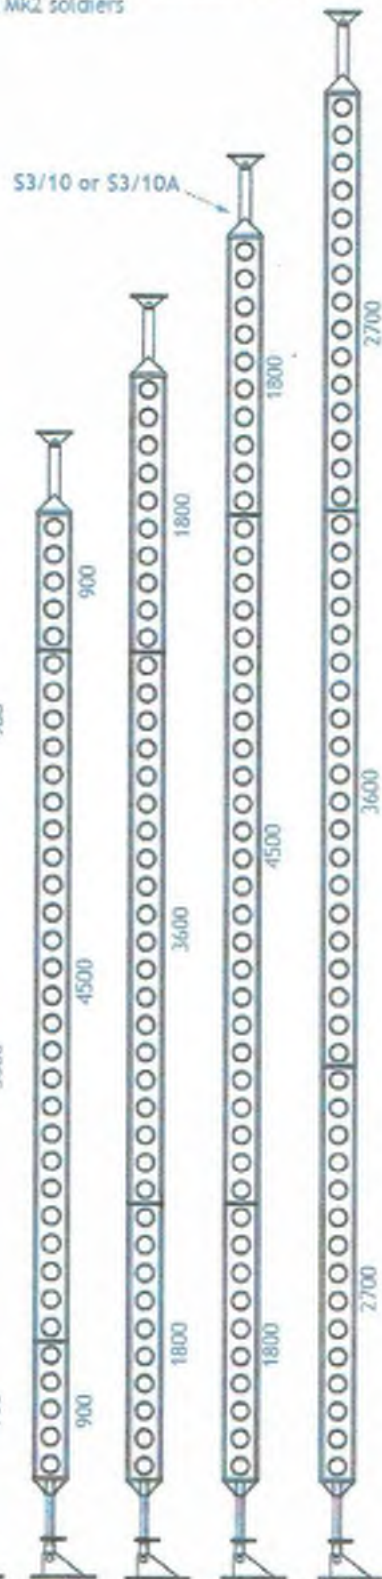
push pull props - lengths and capacities

Head of prop will comprise S3/10 or S310A used viz:
 S3/10 Use A - To prop Mk3 soldiers
 S3/10A Use B - To prop vertical members other than soldiers
 S3/10A Use C - To prop Mk2 soldiers

The safe working loads shown in the table are for props used in compression either vertically or horizontally. In horizontal applications, the props should always be used with the soldier webs/lightening holes in the vertical plane.

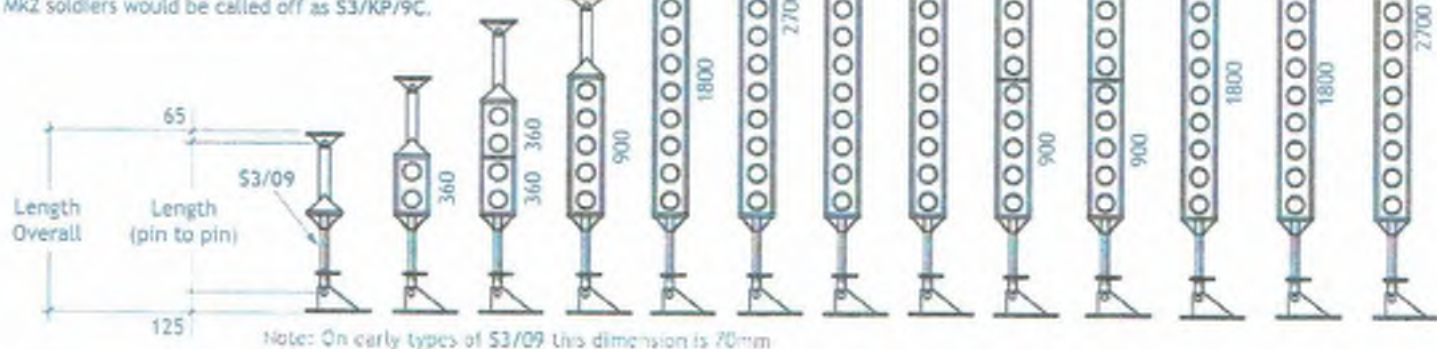
A kit assembly reference is given to assist in ordering the props. The kit includes all parts and bolts necessary depending upon the manner in which the prop is used. The kit assembly reference number must be followed by the A, B or C suffix i.e. a Type 9 Prop to support Mk2 soldiers would be called off as S3/KP/9C.

| PROP | 1 | 2 | 3 | 4 | 5 | 6 | 7 | 8 | 9 | 10 | 11 | 12 | 13 |
| KIT ASSEMBLY REF | S3/KP/1 | S3/KP/2 | S3/KP/3 | S3/KP/4 | S3/KP/5 | S3/KP/6 | S3/KP/7 | S3/KP/8 | S3/KP/9 | S3/KP/10 | S3/KP/11 | S3/KP/12 | S3/KP/13 |
