Proposed replacement patio and boundary fence at 107 Highgate West Hill, London, N6 6AP
Arboricultural report

APPENDIX 2

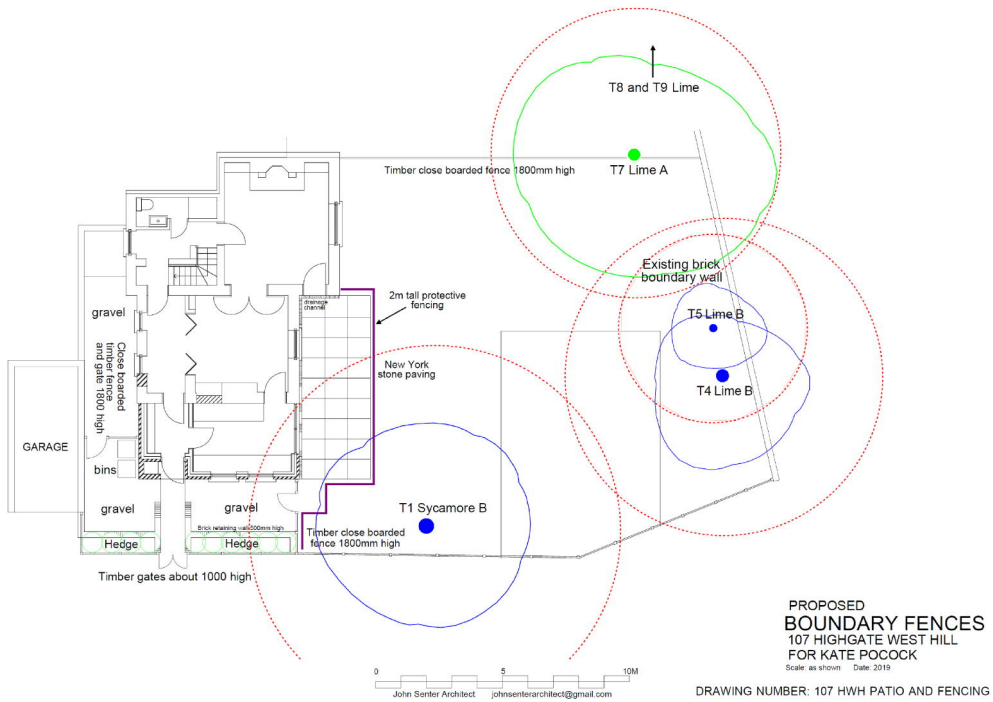
Tree protection plan showing retained trees, root protection areas (dashed circles) and 2 m high protective fencing (purple line).

3. An updated tree protection plan (TPP) to deal with the removal and replacement of the existing patio and erection of boundary fencing is presented at Appendix 2 and will be implemented once the main works to the house have been completed. At that time the 2 m high protective fencing that was specified in the approved arboricultural report will be moved from its original position to the new position marked on the TPP. The fencing is intended to enclose the patio area so that works do not stray into the garden and into tree RPAs.
