Kebony House, Oak Hill Park, NW3 7LP

Ecological Enhancement Plan

Report for Black & Milk

Job Number	6801.1		
Author	Daniel Connaghan BSc (Hons) MSc		
Version	Checked by	Approved by	Date
2.0	Tim Lees BA (Hons) MSc MCIEEM	Wendy McFarlane MSc MA MCIEEM	18/04/2019

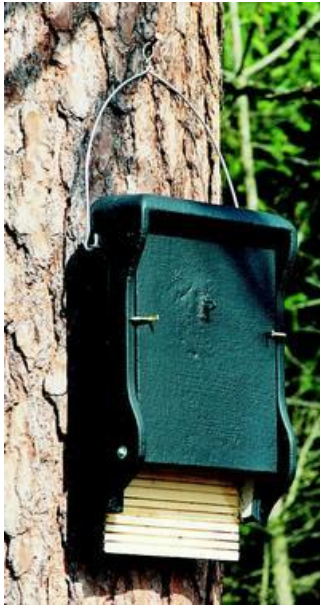
Photograph 1: 1FF Bat box closed

- 3.13 New opportunities for roosting bats will be provided in the form of a bat box located on retained mature trees along the northern edge of the site (Appendix 1, Figure 1). This will consist of the Bat Box 1 FF model from Schwegler. This model is made from woodcrete, and as such, is long lasting compared to wooden boxes and insulates occupants from extremes of temperature and condensation.
- 3.14 The bat box will be positioned at least 3m above the ground facing a south westerly, southerly or south easterly direction on a retained mature tree. The bat box will not be directly lit by artificial lighting and their entrances will not be obscured by vegetation.

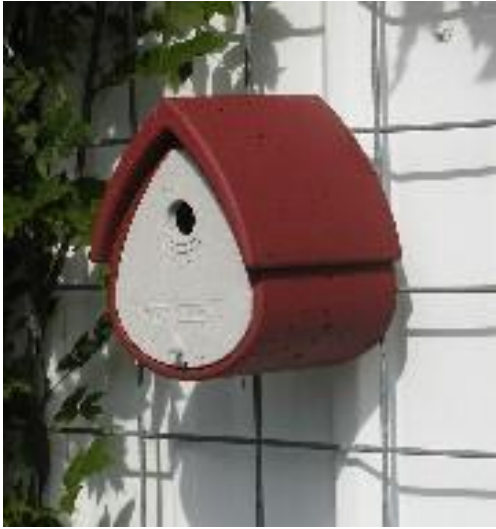
Photograph 3: 1MR Bird box with 32mm hole © Schwegler.

- 3.15 New opportunities for nesting birds will be provided in the form of a bird box to be installed on one of the larger trees to be retained at the north of the site (Appendix 1, Figure 1). The type of bird box which will be utilised is the Schwegler Nest Box 1MR. This model is made from woodcrete, and as such, is longer lasting compared to wooden boxes and insulates occupants from extremes of temperature and condensation. This model provides a range of suitable conditions for a variety of garden bird species, such as blue tits, great tits and house sparrows.
- 3.16 The bird box will be secured using galvanised nails/screws, at a height of 2-4m above ground level and be accessible for maintenance.

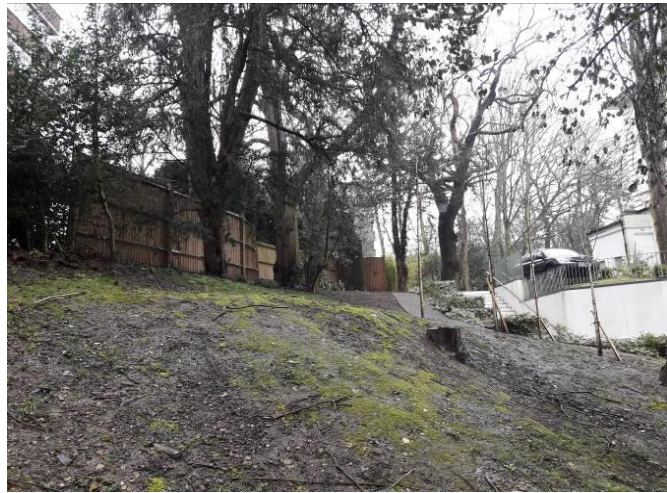
Photograph 1

Area of bare ground beside the footpath designated for wildflower planting. View looking south-east.

- 3.6 The area of bare ground on the right side to the path leading to the garden will be planted with a flowering lawn mixture (Appendix 1, Figure 1 / Appendix 3, Photograph 1).
- 3.7 The plant mix used will include native species or species of known wildlife value, as listed by the RHS website. It is recommended that the 'EW1 Woodland Mixture' from
