**EXISTING MATERIALS KEY**

IMPERIAL HOTEL

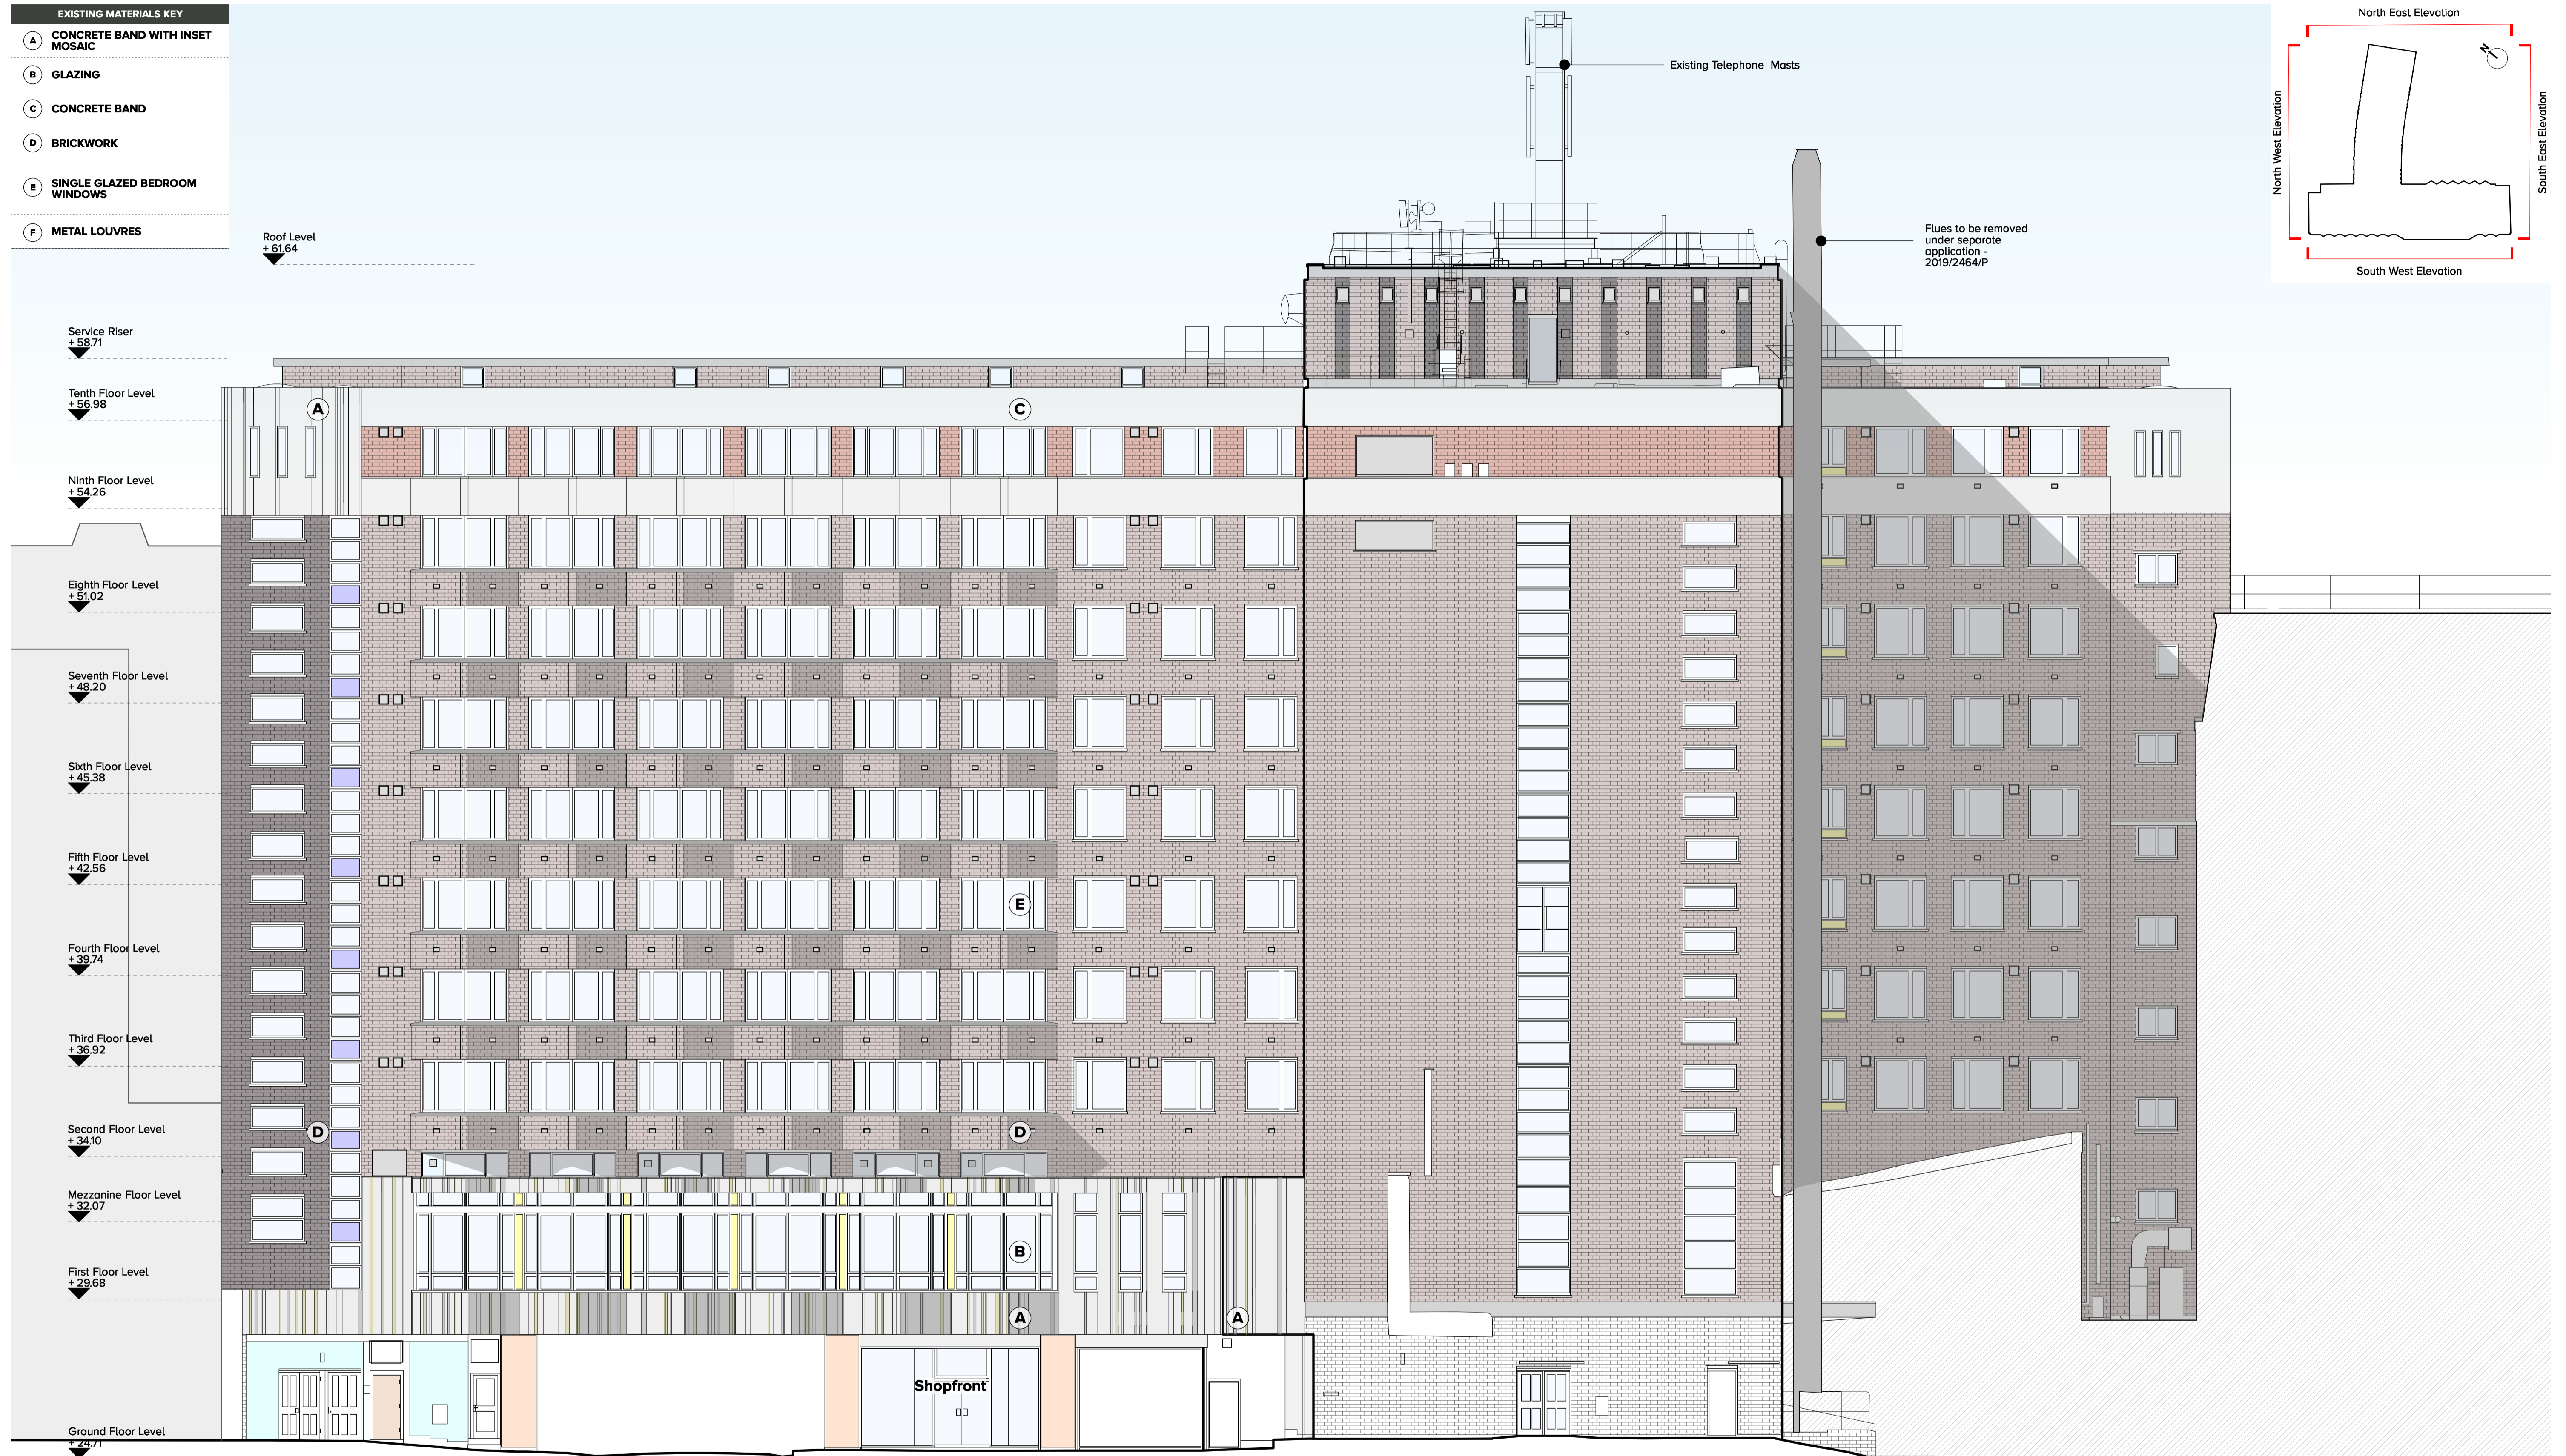
A	CONCRETE BAND WITH INSET MOSAIC
B	GLAZING
C	CONCRETE BAND
D	BRICKWORK
E	SINGLE GLAZED BEDROOM WINDOWS
F	METAL LOUVRES

Existing Telephone Masts

Flues to be removed  
under separate  
application -  
2019/2464/P
