PLANNING

KSR ARCHITECTS & INTERIOR DESIGNERS
INTERIOR DESIGN

22 FROGNAL WAY

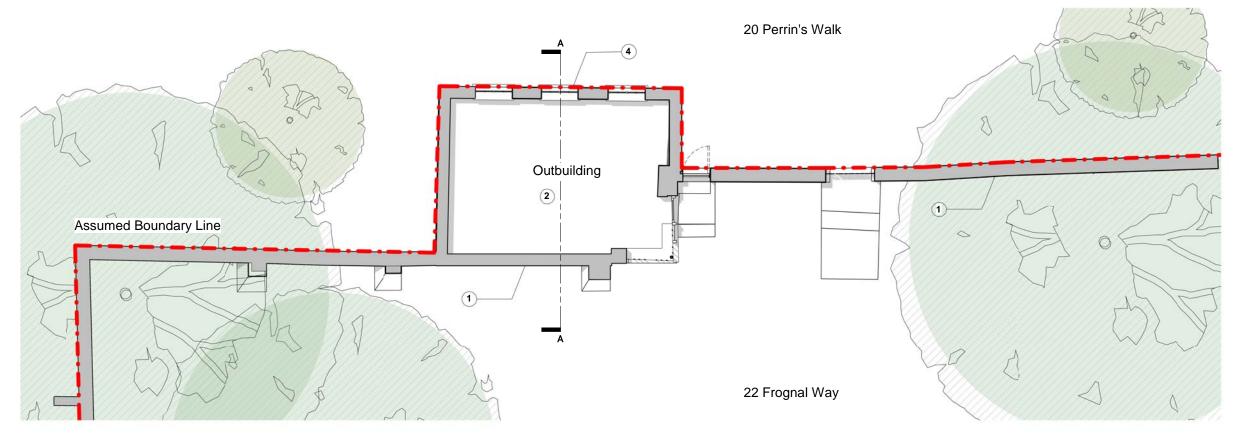
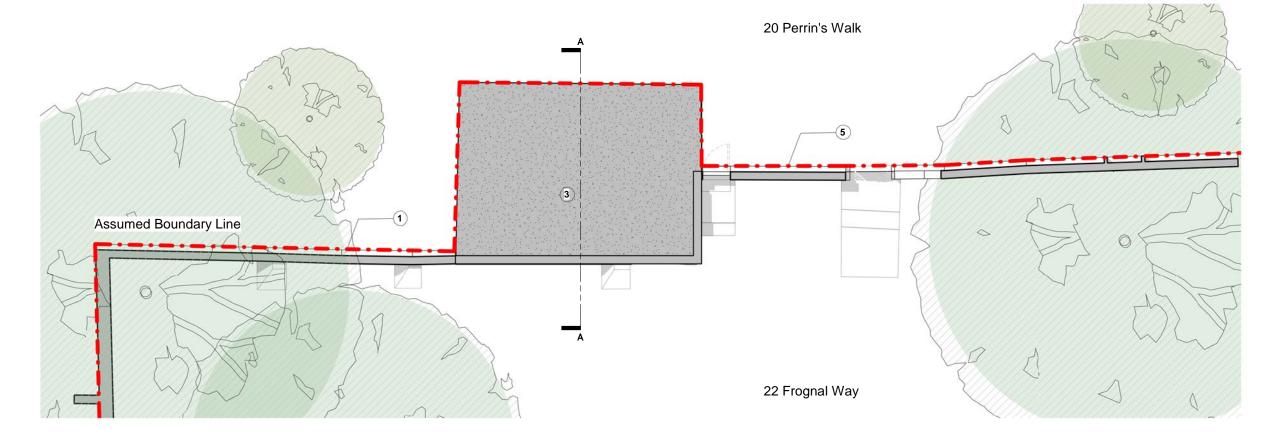
Existing Plans

1. Sections of structurally unstable wall, in need of repair

2. Existing outbuilding left unused, in need of renovation

3. Old felt roof and associated gutter, downpipes in need to be replaced

4 Existing windows corroded in need

be replaced

5. Missing brick coursing at high level

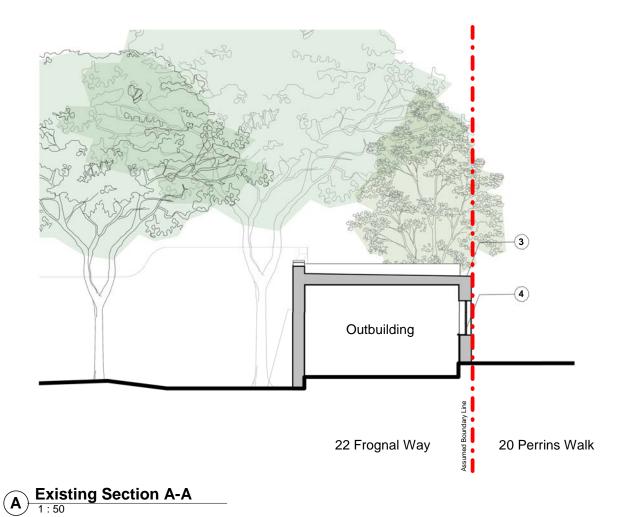
Existing Section A-A

1. Sections of structurally unstable wall, in need of repair

2. Existing outbuilding left unused, in need of renovation

3. Old felt roof and associated gutter, downpipes in need to be replaced

4. Existing windows corroded, in need to be replaced

5. Missing brick coursing at high level

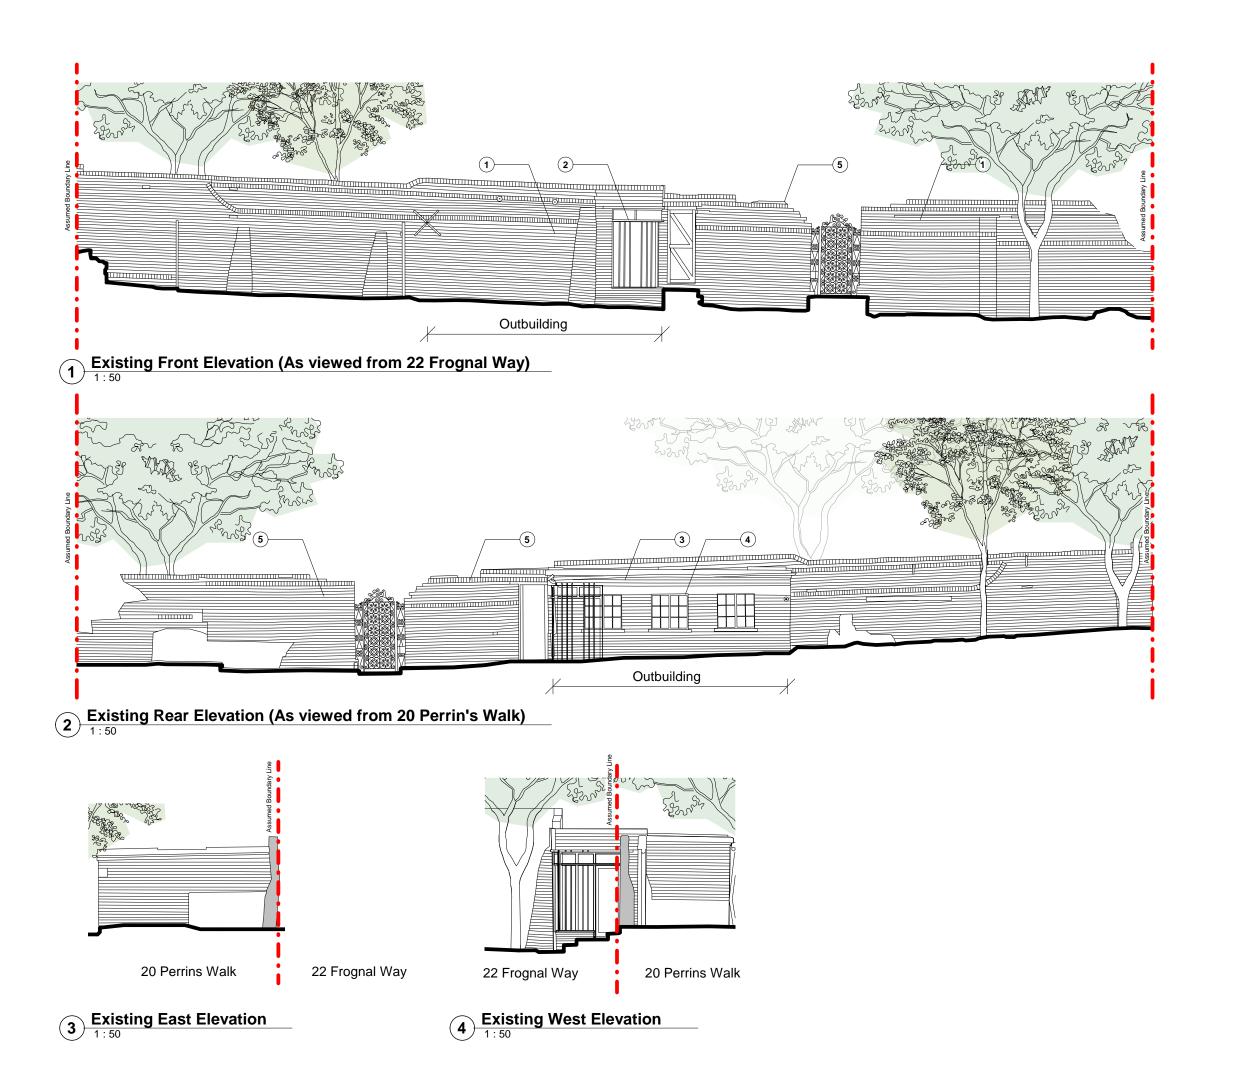
Existing Elevations

- Sections of structurally unstable wall, in need of repair
- 2. Existing outbuilding left unused, in need of renovation
- Old felt roof and associated gutter, downpipes in need to be replaced
- 4. Existing windows corroded, in need
- 5. Missing brick coursing at high level

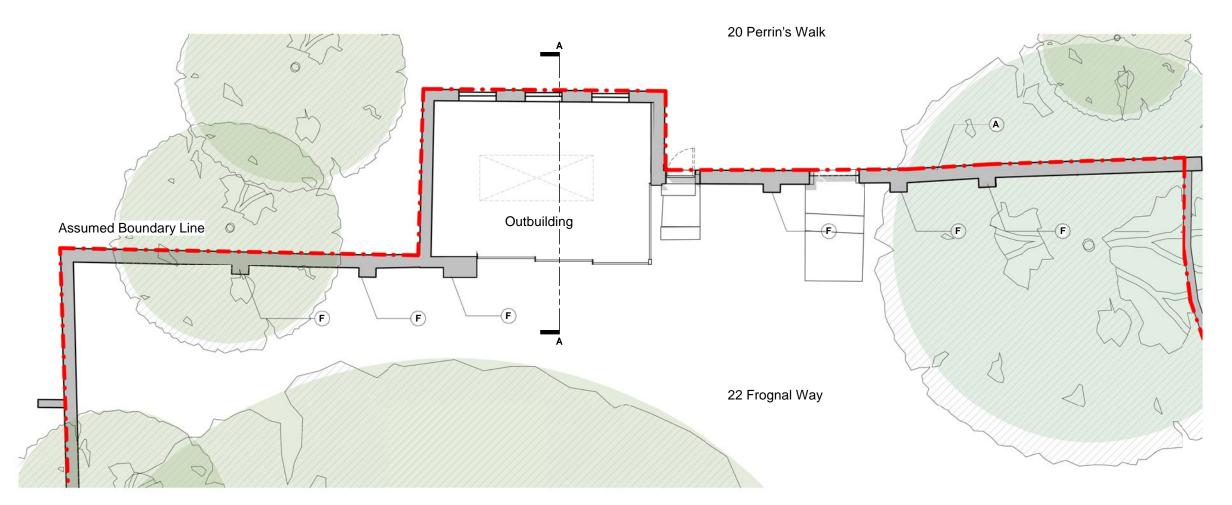
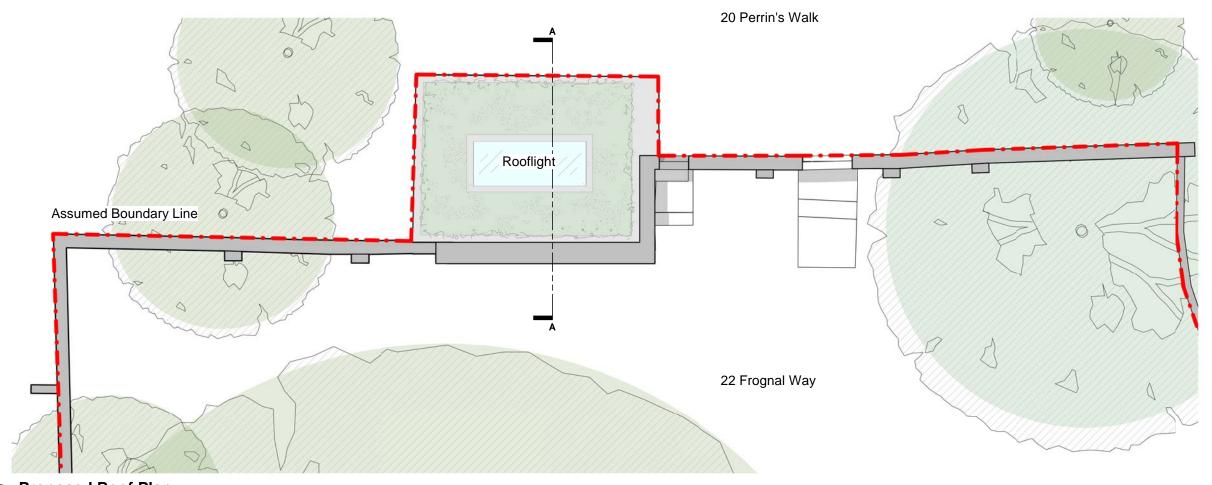
Proposed Plans

A. Existing brick wall to be repaired, repointed and made structurally sound. Missing brickwork coursing to be repaired using the salvaged/reclaimed bricks from the wall with lime mortar.

B. Existing corroded windows to be replaced with the new ones to match.

C. Green roof

D. Render

E. Slim profile glazing

F. Existing failing piers to be carefully rebuilt and new ones introduced where required using reclaimed/salvaged bricks with lime mortar to ensure the structural stability of the wall is restored. Shown indicatively, subject to structural engineers developed design

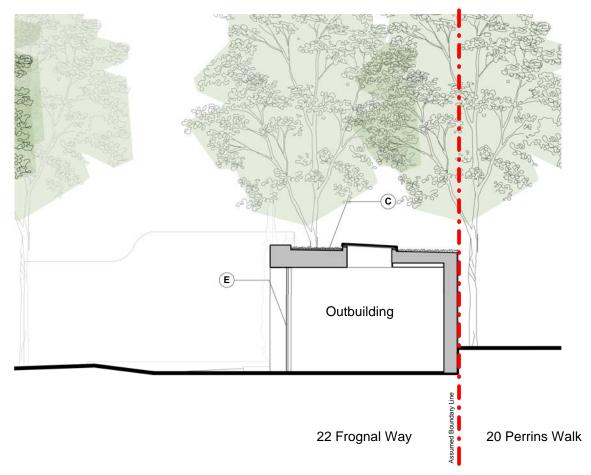
Proposed Section A-A

A. Existing brick wall to be repaired, repointed and made structurally sound. Missing brickwork coursing to be repaired using the salvaged/reclaimed bricks from the wall with lime mortar.

B. Existing corroded windows to be replaced with the new ones to match.

. Green roof

D. Render

E. Slim profile glazing

F. Existing failing piers to be carefully rebuilt and new ones introduced where required using reclaimed/salvaged bricks with lime mortar to ensure the structural stability of the wall is restored. Shown indicatively, subject to structural engineers developed design

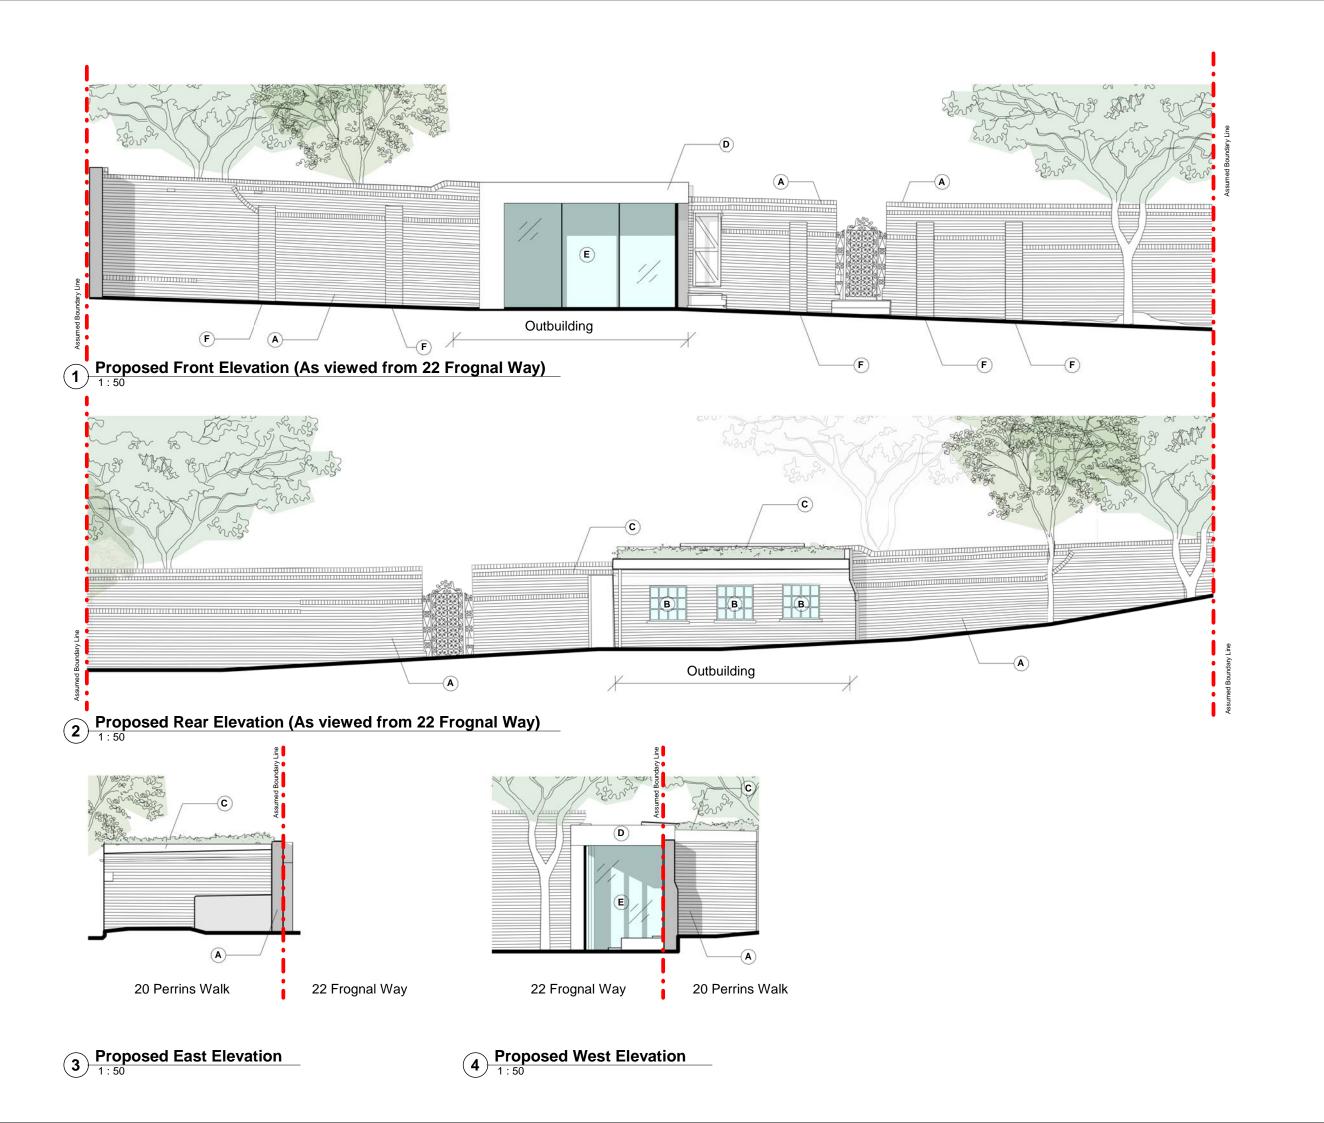
Proposed Elevations

A. Existing brick wall to be repaired, repointed and made structurally sound. Missing brickwork coursing to be repaired using the salvaged/reclaimed bricks from the wall with lime mortar.

B. Existing corroded windows to be replaced with the new ones to match.

Green roof

D. Render

E. Slim profile glazing

F. Existing failing piers to be carefully rebuilt and new ones introduced where required using reclaimed/salvaged bricks with lime mortar to ensure the structural stability of the wall is restored. Shown indicatively, subject to structural engineers developed design
