project
2 WILLOW RD

drawing
OPTION 1:
COMPREHENSIVE REPAIR

drawing number
07068/SK/00/A

avanti architects

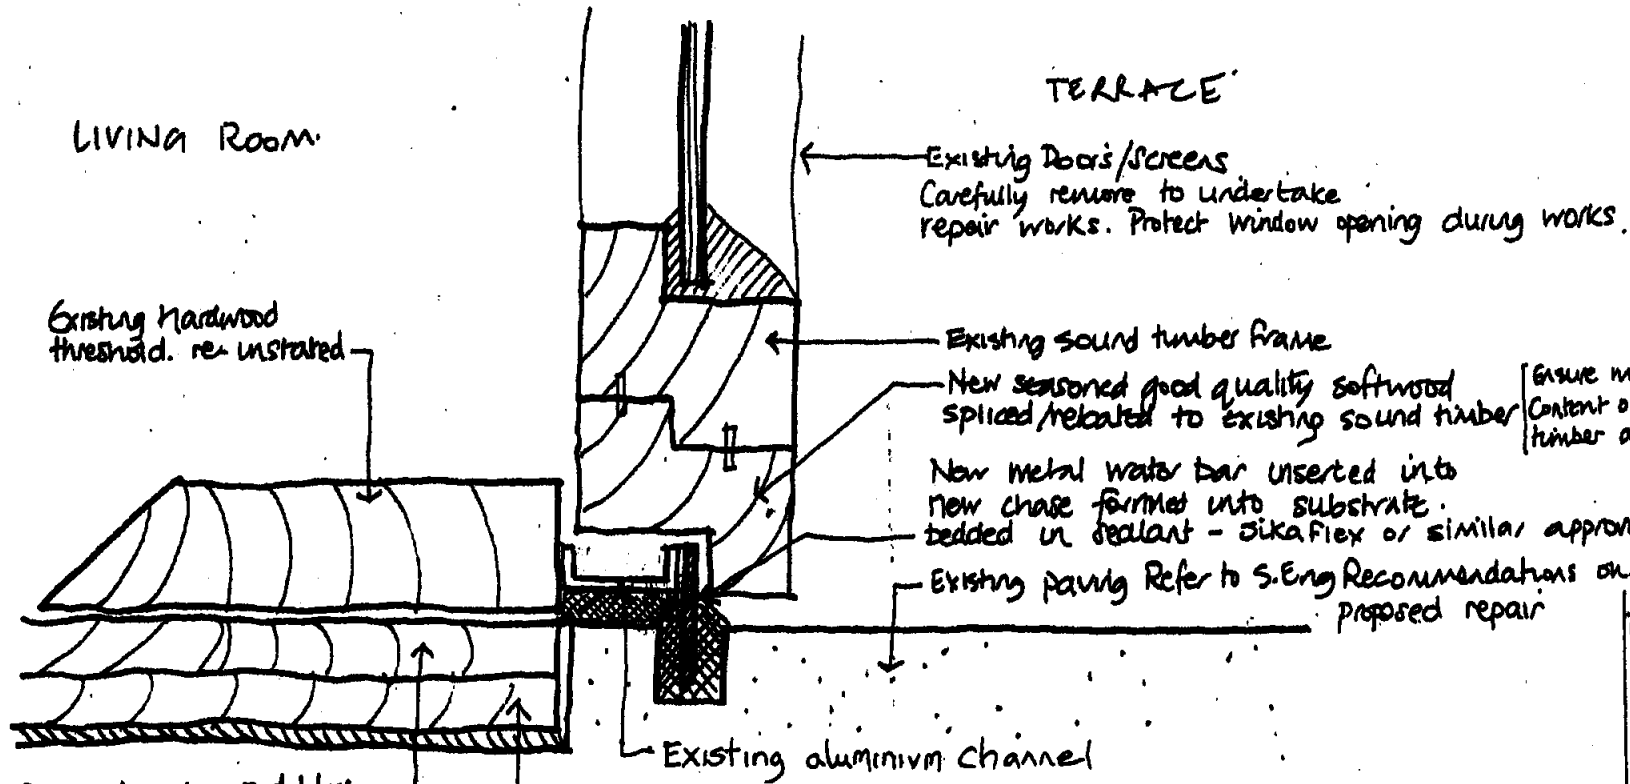
Existing hardwood threshold. re-instated

Ensure moisture content of both timber are equivalent

Original oak wood block laminated to new oak underlay

OPTION 1: COMPREHENSIVE REPAIR
