11MS/2/001 - AS BUILT CONDITION

<b>BDP.</b>	
16 Brewhouse Yard Clerkenwell London EC1V 4LJ United Kingdom T +44 (0)20 7812 8000 F +44 (0)20 7812 8399 www.bdp.com	
PROJECT TITLE British Museum Perimeter Properties Refurbishment	
PROJECT NUMBER P2002323	SCALE Varies@A3
PROJECT TITLE Additional works Type A, A1, B Removal of horizontal /vertical trunking	DATE 14/06/2019
PROJECT NO. (70)AD001	REVISION -

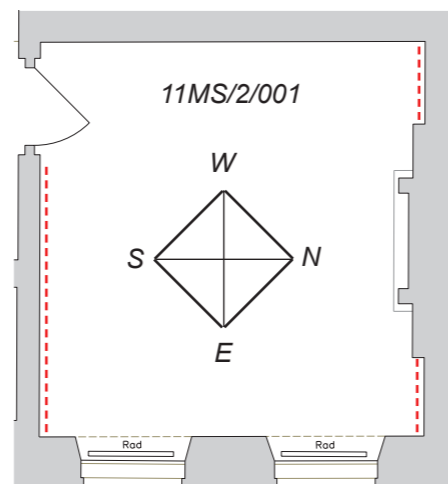
Trunking Location plan

--- Trunking Removed

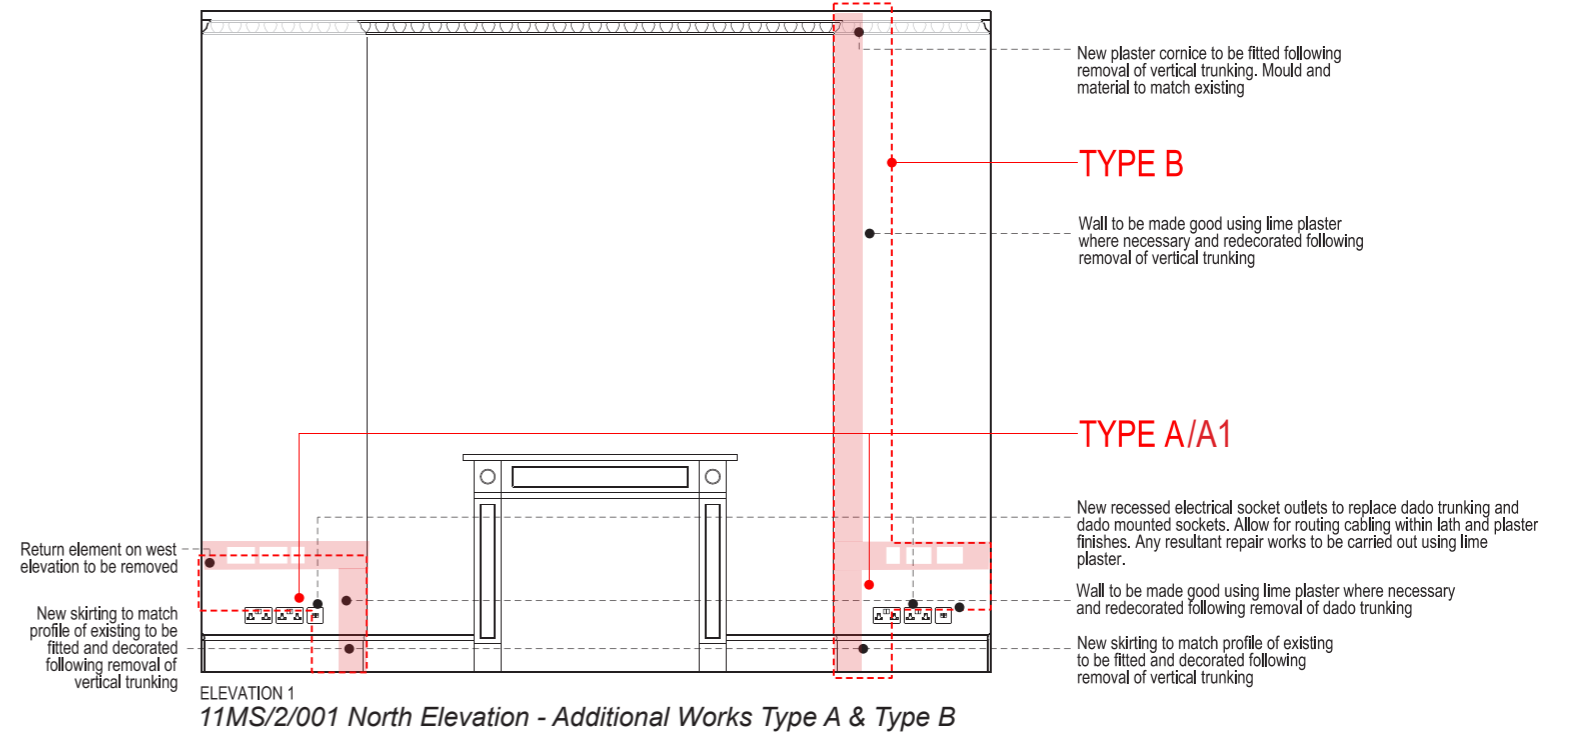
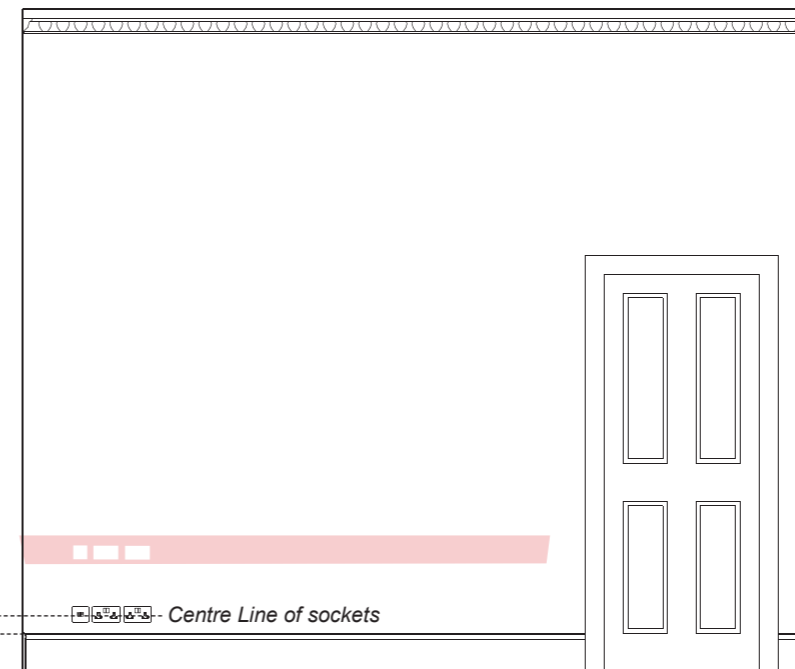
**TYPE A1**

Dado trunking carefully removed and timber skirting reinstated and decorated. Wiring chased into walls, walls made good in materials to match existing - see method statements.
