PROJECT  
AEL-18129  
16 Lyndhurst Gardens  
London NW3 5NR

TITLE  
Tree Impact Plan

Drawing Number  
AEL-18129-TIP

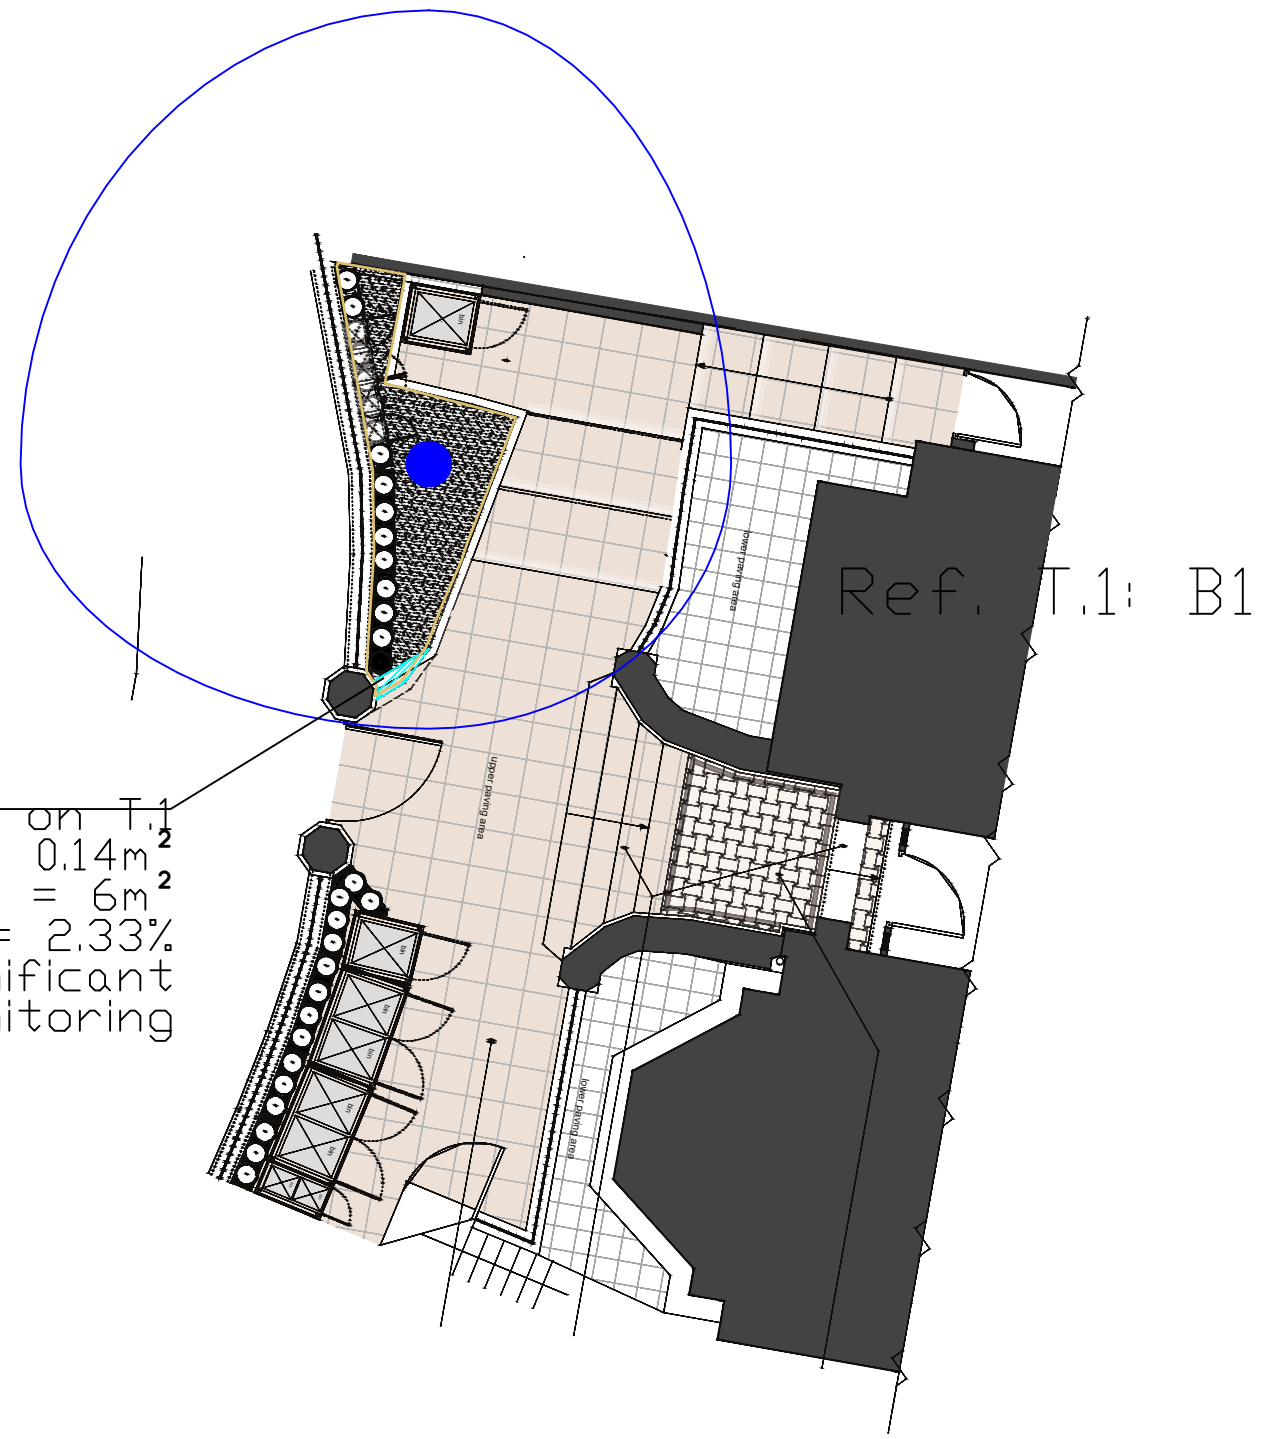
Incursion of wall on T.1  
 Incursion = 0.14m<sup>2</sup>  
 Area available = 6m<sup>2</sup>  
 TOTAL = 2.33%  
 Comments= Insignificant  
 but will require monitoring
