ISSUE	DATE	DRAWN	CHECKED	DESCRIPTION
<b>DRAWING TITLE</b>	GA PROPOSED DEMOLITIONS AND STRIP OUT FIRST FLOOR LEVEL PLAN			
<b>DRAWING NO.</b>	CTH-PUR-MP-01-DR-A-91002			
<b>REVISION</b>	SS P01			
<b>SIZE &amp; SCALE</b>	A1L 1:200			
<b>DRAWING STATUS</b>	SS SUITABLE FOR PLANNING

**I 91002 1:200 @ A1**  
**FIRST FLOOR LEVEL PLAN PROPOSED DEMOLITIONS AND STRIP OUT**

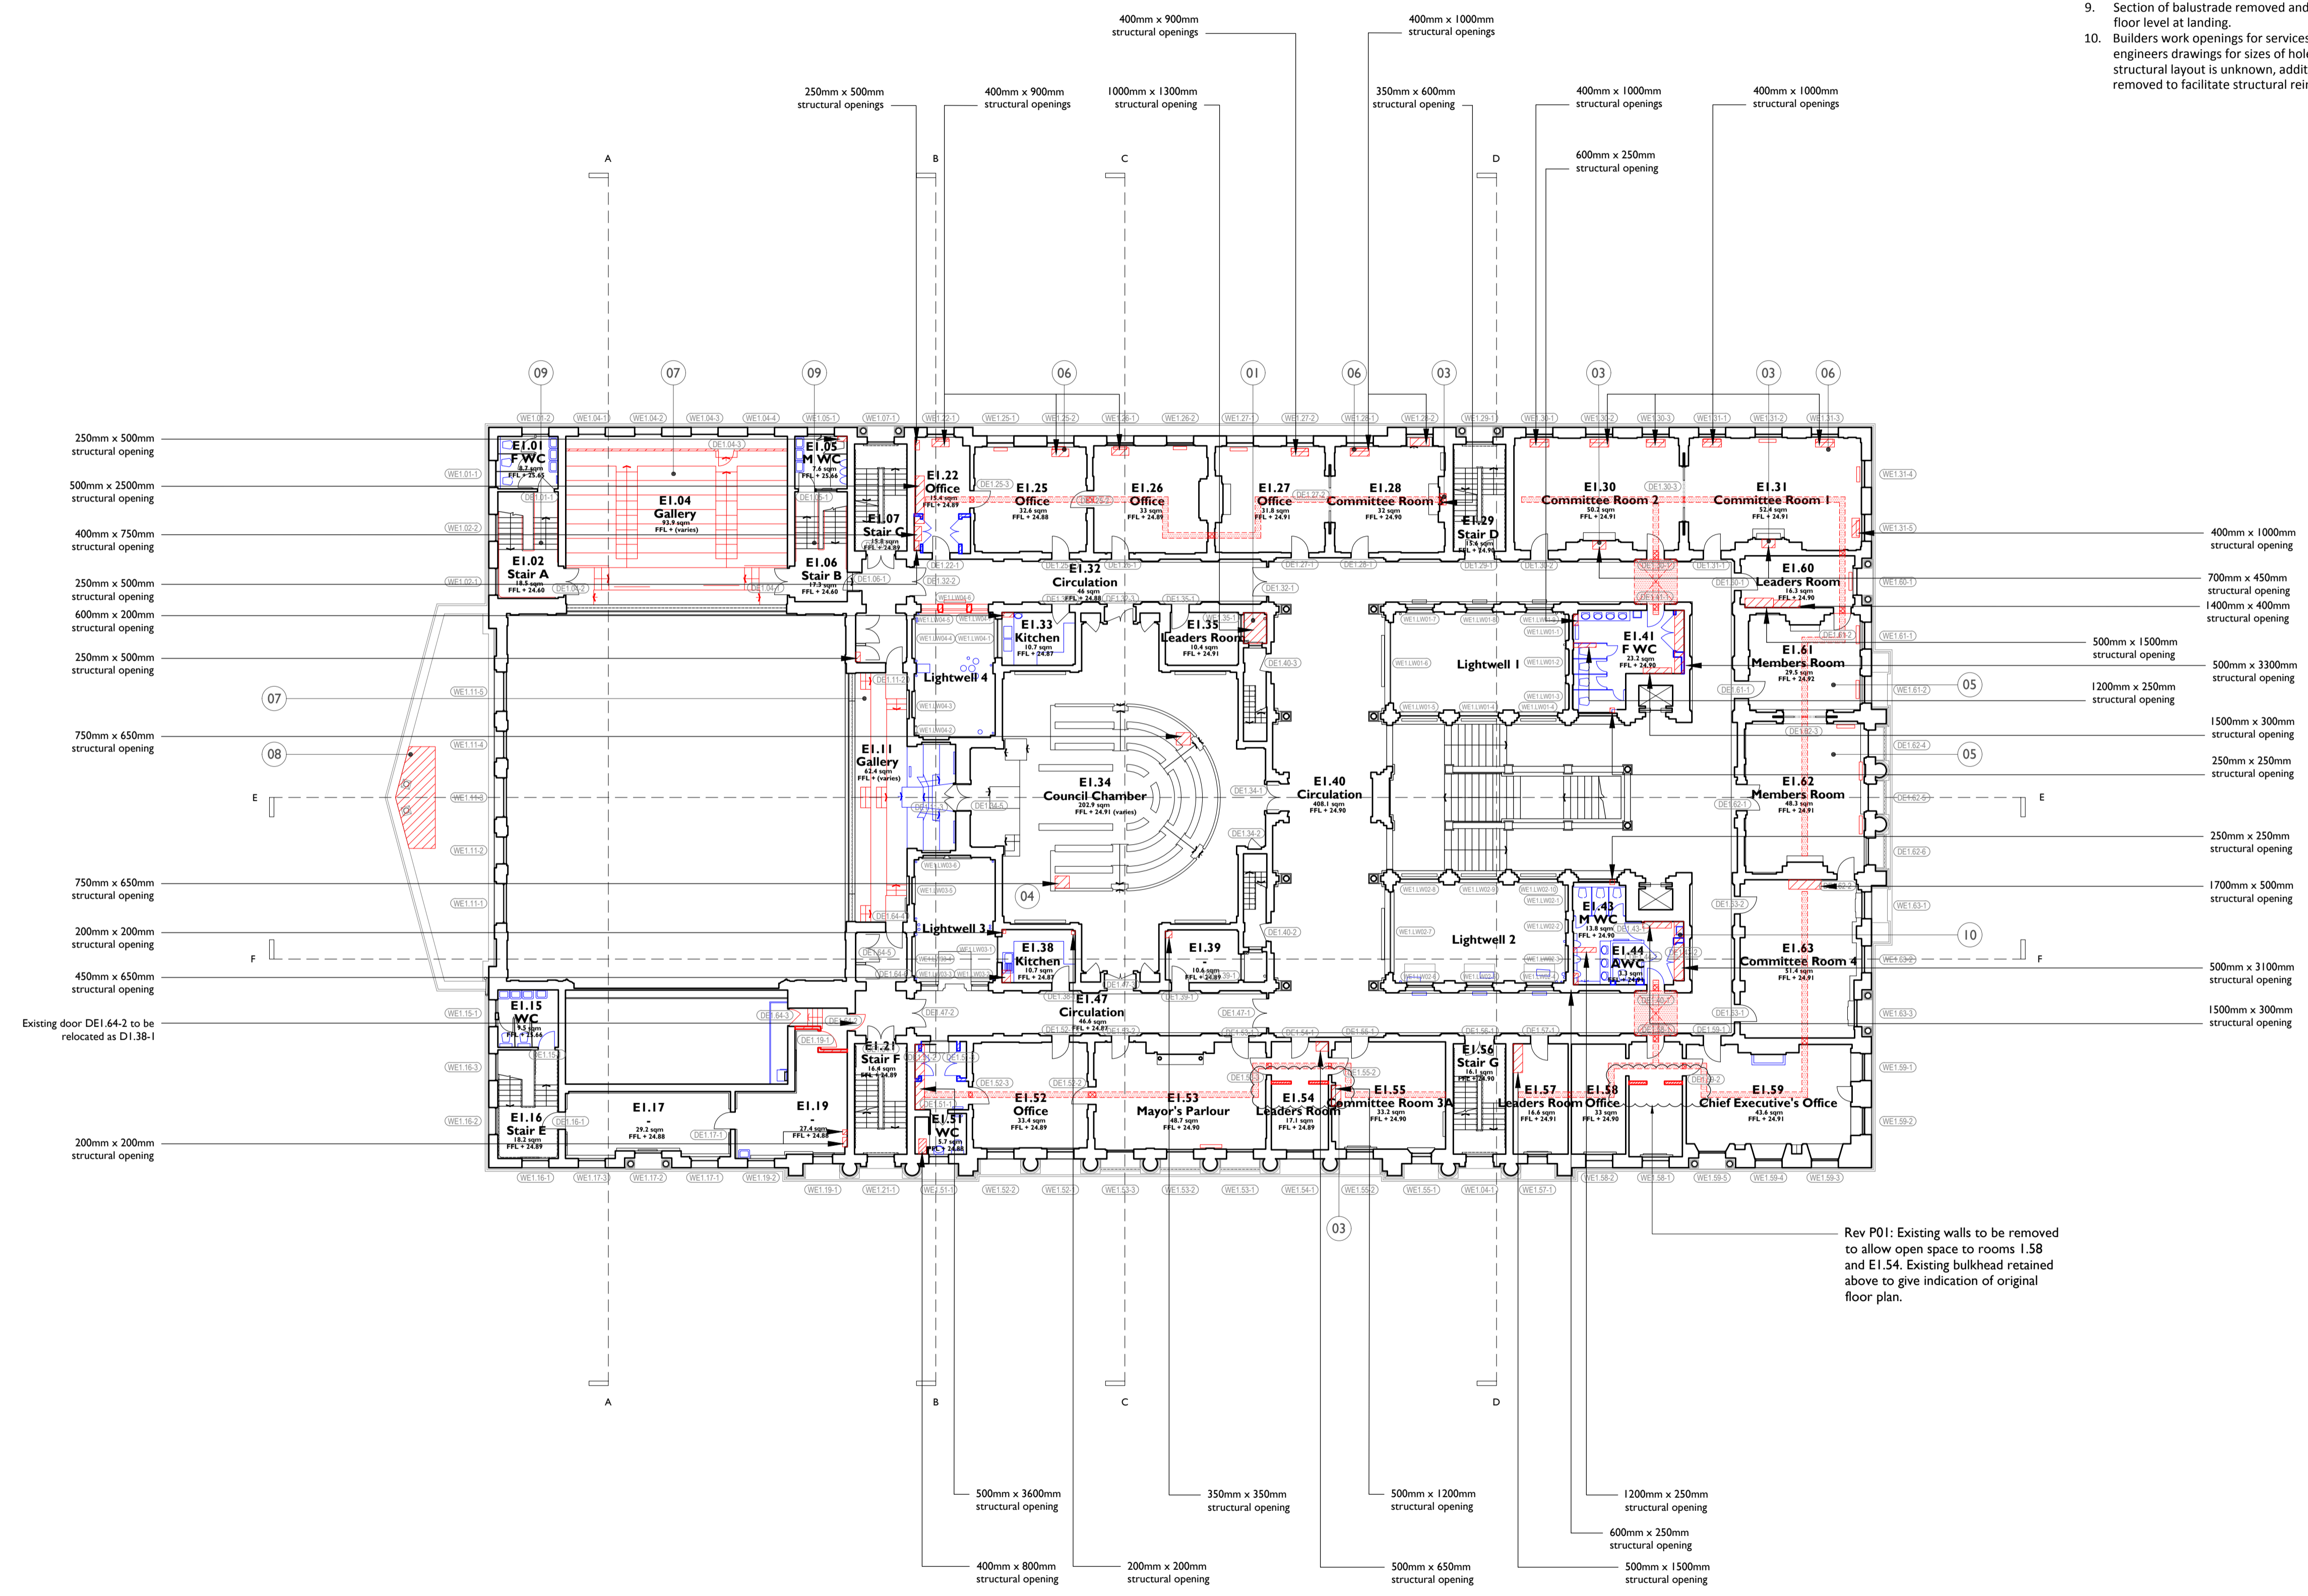
- Existing lightwell slab to be demolished for mechanical services penetration. Refer to proposed architectural drawings for new slab scope of work;
- New toilets to use existing drainage routes. Allowance to be made for opening up works to new drainage outlets;

- Structural openings for existing fireplaces. Make allowance for opening up works and/or fireplace repairs. Refer to services engineers' + architectural drawings for services strategy within significant heritage rooms;

- Structural openings for air supply within underside of seat structure. Refer to propose architectural drawings for repair/upgrade and reinstatement scope of works.

- Make allowance for H/L openings for walls for ventilation grilles. Refer to services engineers' + architectural drawings for services strategy within significant heritage rooms;

- Local builders work openings for ducts to low level FCUs.
- Existing gallery raked seating removed. Existing structure retained.
- Opening in roof slab to allow for exhaust ventilation from below

- Section of balustrade removed and adjusted to suit new raised floor level at landing.
- Builders work openings for services risers - refer to services engineers drawings for sizes of holes. Note: as existing structural layout is unknown, additional fabric may need to be removed to facilitate structural reinforcement.
