## **GROUND MOVEMENT ASSESSMENT**

**23 LYNCROFT GARDENS  
WEST HAMPSTEAD  
LONDON  
NW6 1LB**

**Report Title:** Ground Movement Assessment for Mr and Mrs Raja

**Job No:** P1899J1585

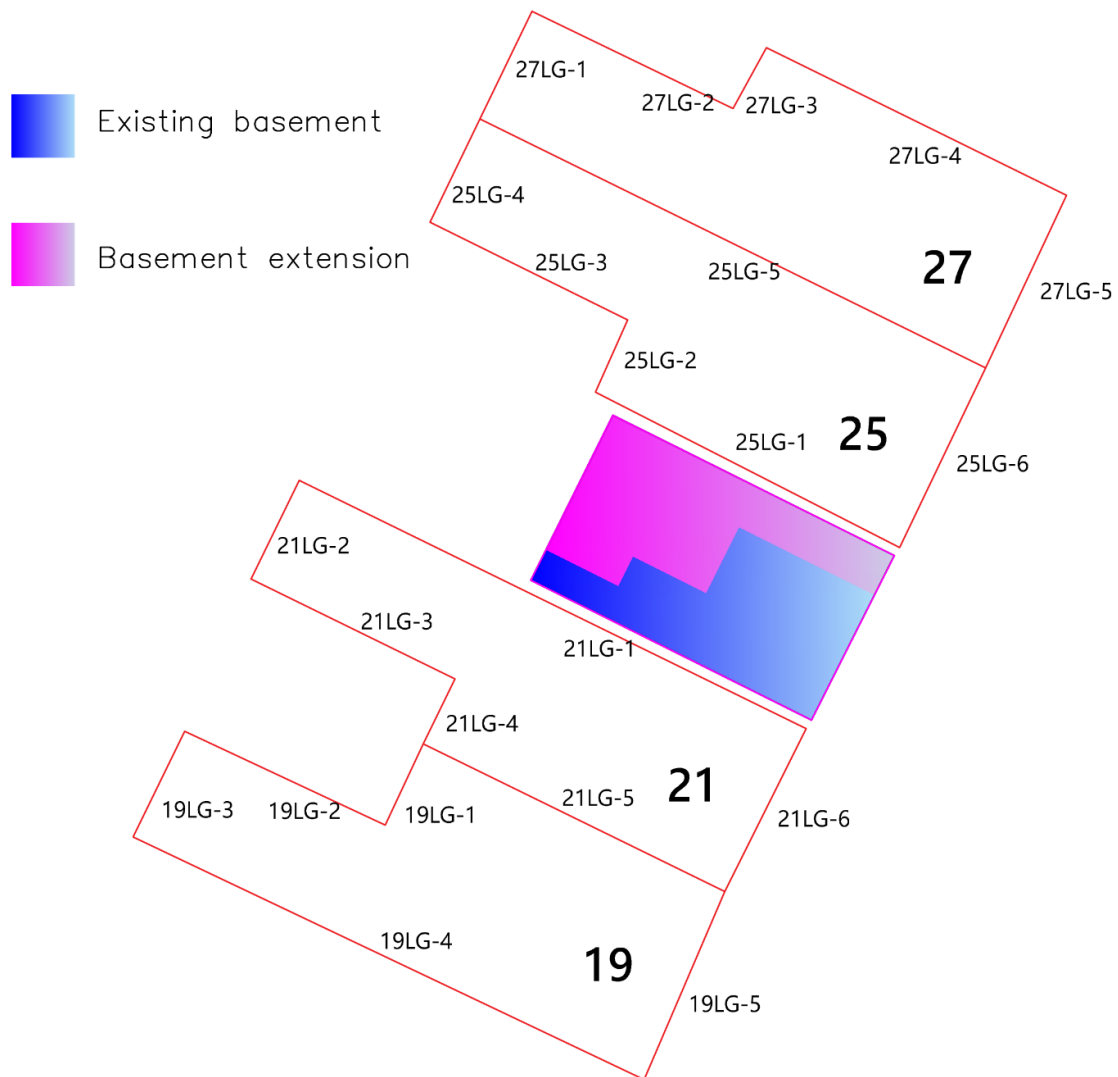
Figure 3.1: Idealised proposed scheme, neighbouring buildings within zone of influence (indicated with red lines) and adopted façade nomenclature. Numbers indicate the properties' addresses.

3.2.8 A series of three-dimensional models of the proposed scheme have been developed in both software packages outlined previously and have been combined by means of superposition to represent the various ground displacement fields summarised above. An indicative plot of the analytical model is presented below in Figure 3.1.

3.2.11 The structural walls of concern are shown in Figure 3.1 including the wall nomenclature/reference system adopted.

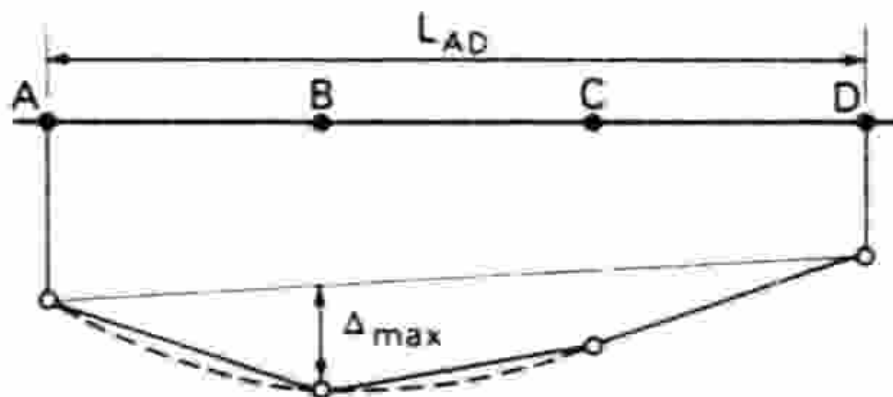
Figure 3.2: Definition of relative deflection  $\Delta$  and deflection ratio  $\Delta/L$ .

3.2.13 Tensile strains induced within the building masonry walls have been evaluated based on a combination of direct tension and the deflection ratios  $\Delta/L$  estimated from the analyses (Figure 3.2). The assessment considers the well-established Burland (1997) damage classification method, as presented and summarised in Figure 3.3. This method involves a simple but robust means of assessment, which is widely adopted and is considered to comprise an industry standard/best practice basis for impact assessments of this type.

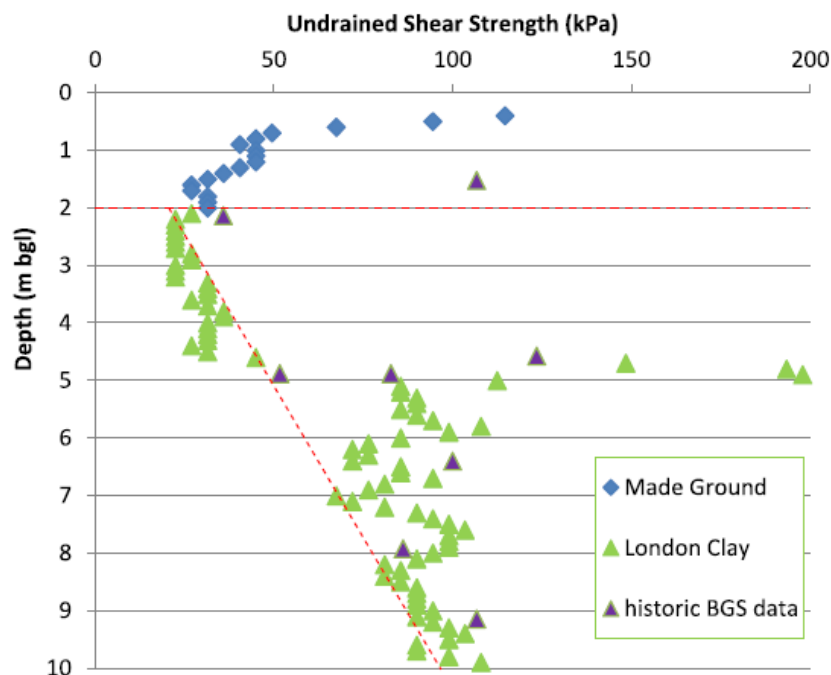
**Figure 3.2: Adopted London Clay undrained shear strength profile from SPT and triaxial testing with interpreted trend (red dashed line) obtained from the 6 Kidderpore Ave. site investigation.**

- 3.3.5 The undrained shear strength profile of London Clay is shown in Figure 3.2.
- 3.3.6 Table 3.1 presents the ground model adopted for this analysis.

- 3.3.7 The correlations  $E_u = 500c_u$  and  $E' = 0.8E_u$  have been used to determine the drained Young's Modulus of the London Clay.
- 3.3.8 Based on the site-specific ground investigation data the Made Ground layer has been recorded to vary between 0.2m and 0.65m. The existing basement is indicated to be

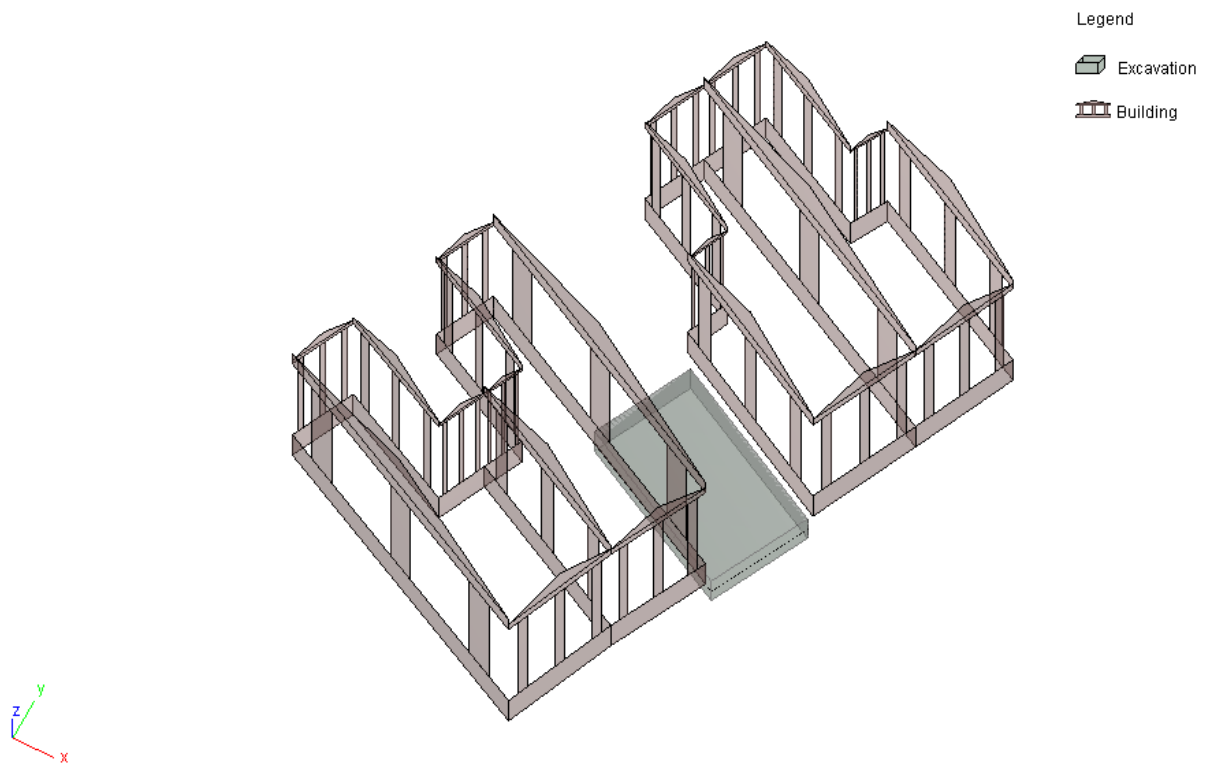
Figure 3.3: Perspective view of Xdisp 3d model indicating the excavation zones and neighbouring properties.

3.4.4 A perspective view of the Xdisp 3d model is depicted in Figure 3.3.

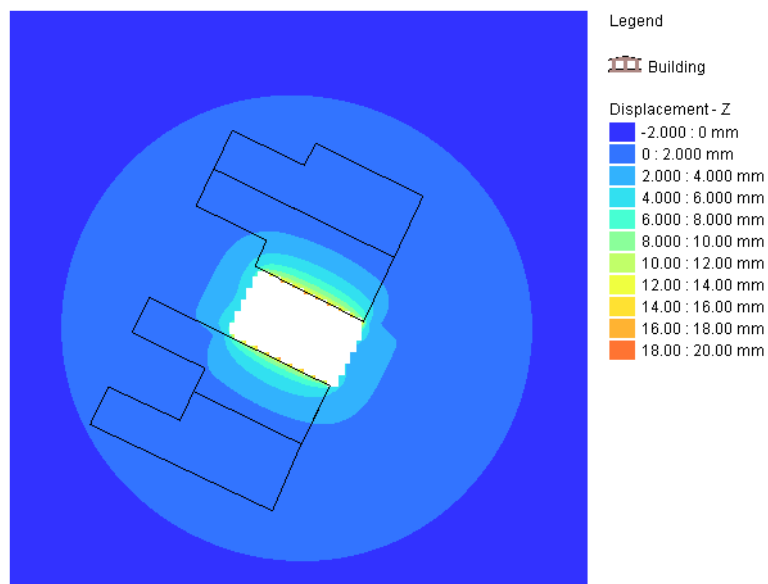
Figure 3.4: Vertical ground movement contour plot induced by the underpins installation, basement excavation and reloading of soil at a greater depth.

3.4.1 The assessment results indicate minimal impact on adjacent properties as a result of the proposed works. Maximum vertical and horizontal displacements of **20mm and 4mm**, respectively have been calculated for the worst-case scenario representing the long-term effects of the proposed scheme (CIRIA C760 wall installation of planar diaphragm wall in stiff clay, CIRIA C760 excavation in front of a stiff wall in stiff clay, long-term reloading).

3.4.5 Contour plots of vertical and horizontal ground movements are presented below in Figures 3.4 and 3.5.

- 5.1.4 The results from the analysis are presented in Figures 3.3 and 3.4.
- 5.1.5 The assessment results have been found to be nominal. Maximum global vertical and horizontal displacements of 6mm and 4mm, respectively, have been observed for the worst-case scenario representing the long-term effects of the proposed scheme.

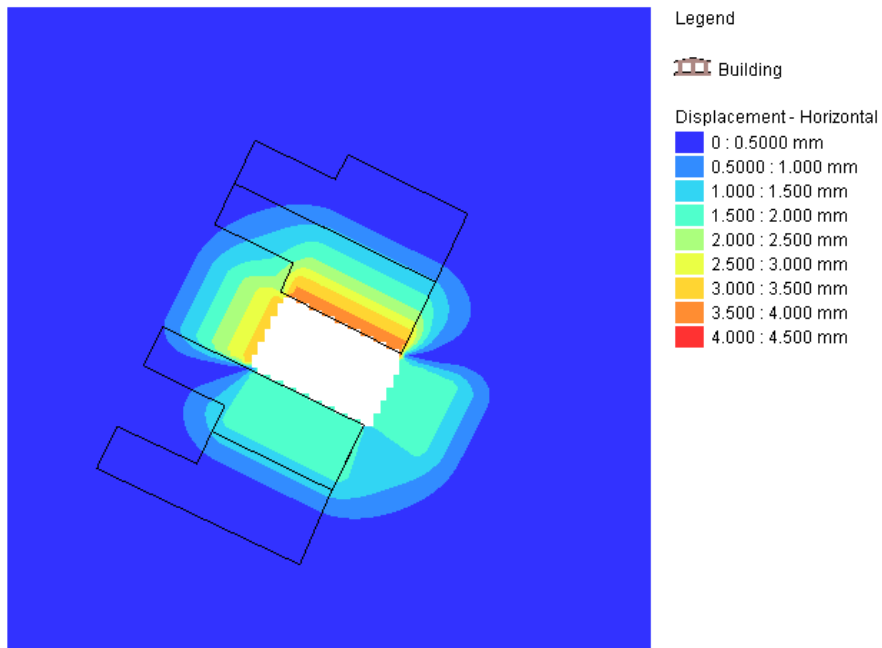
**Figure 3.5: Resultant horizontal ground movement contour plot induced by the underpins installation, basement excavation and reloading of soil at a greater depth.**
