8-11 Montague Street - To be read in conjunction with BDP drawings (20)AP007 Rev B, (20)AP009 Rev A & (20)AE001

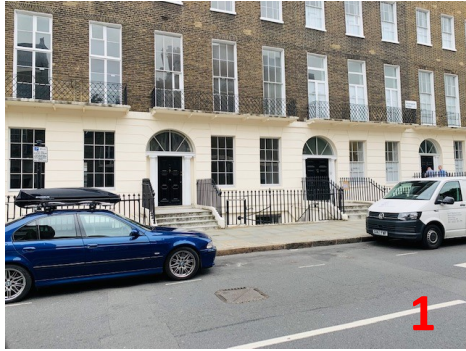
Front elevation 8-11 MS - all external lights confirmed removed

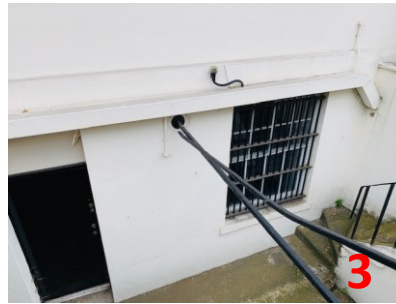
Front lightwell 9 MS - previously installed service light removed

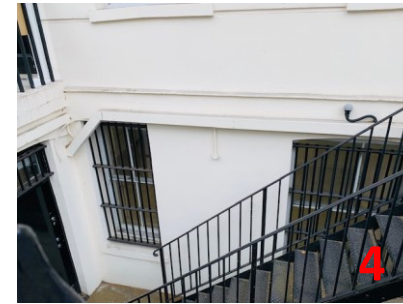
Front lightwell 10 MS - previously installed service light removed

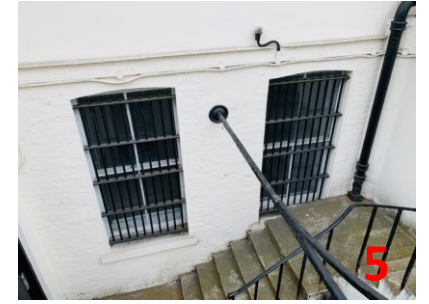
Front lightwell 11 MS - previously installed service light removed

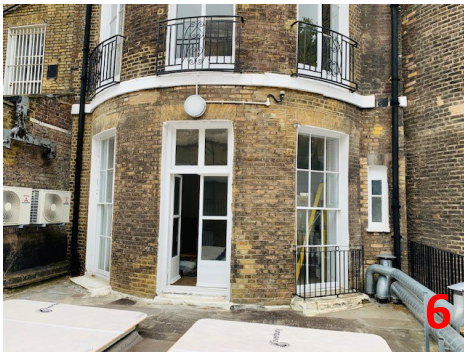
Rear of 11 Montague St - external light fitting installed to provide illumination to the ground floor terrace area, where safe access for maintenance is required to mechanical services and existing rooflights.

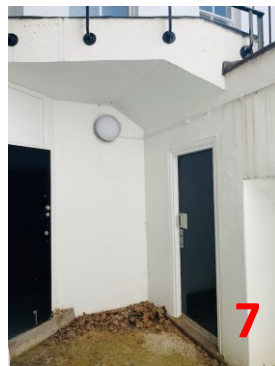
Rear lightwell 8 MS - service light installed at 2500mm h

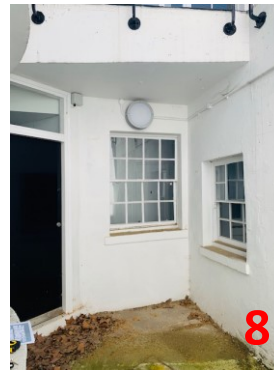
Rear lightwell 9 MS - service light installed at 2500mm h

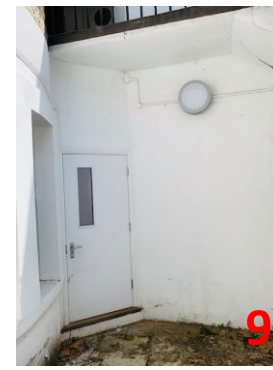
Rear lightwell 10 MS - service light installed at 2500mm h

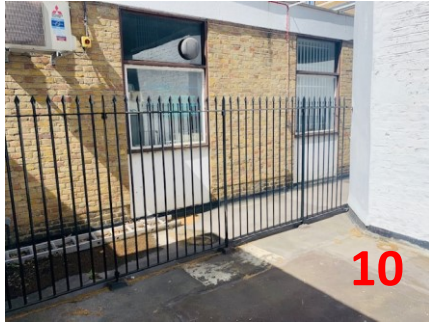
**Railings** to rear of 8 MS – 1850mm high

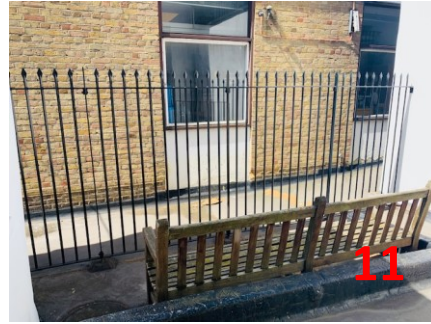
**Railings** to rear of 9 MS – 1850mm high

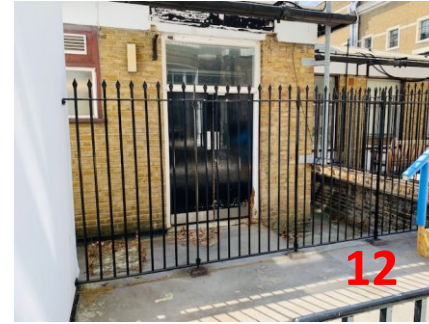
**Railings** to rear of 10 MS – 1850mm high

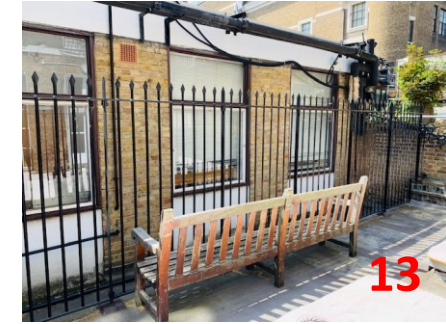
**Railings** to rear of 11 MS – 1850mm high

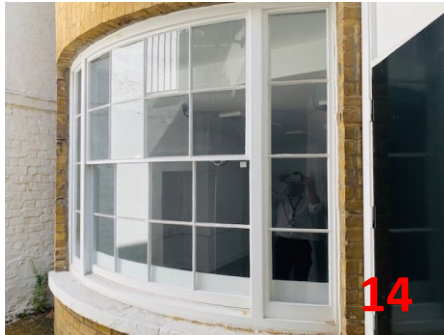
**News sash window B.01.W03**  
Basement level of 8 MS – new sliding timber sash window to match existing rotten and damaged window

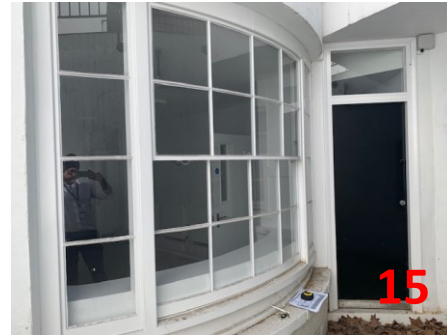
**News sash window B.01.W09**  
Basement level of 9 MS – new sliding timber sash window to match existing rotten and damaged window

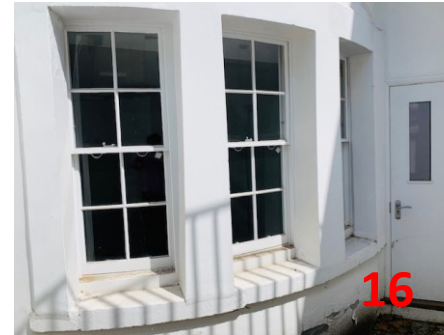
**News sash window B.01.W13**  
Basement level of 10 MS – new sliding timber sash window to match existing rotten and damaged window

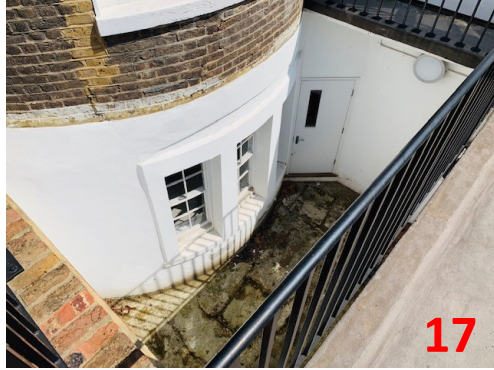
**Lightwell** to rear of 10 MS reinstated
