bmj architects

London School Of Hygiene & Tropical Medicine TP2

Drawing issue for Section 96a Planning Submission

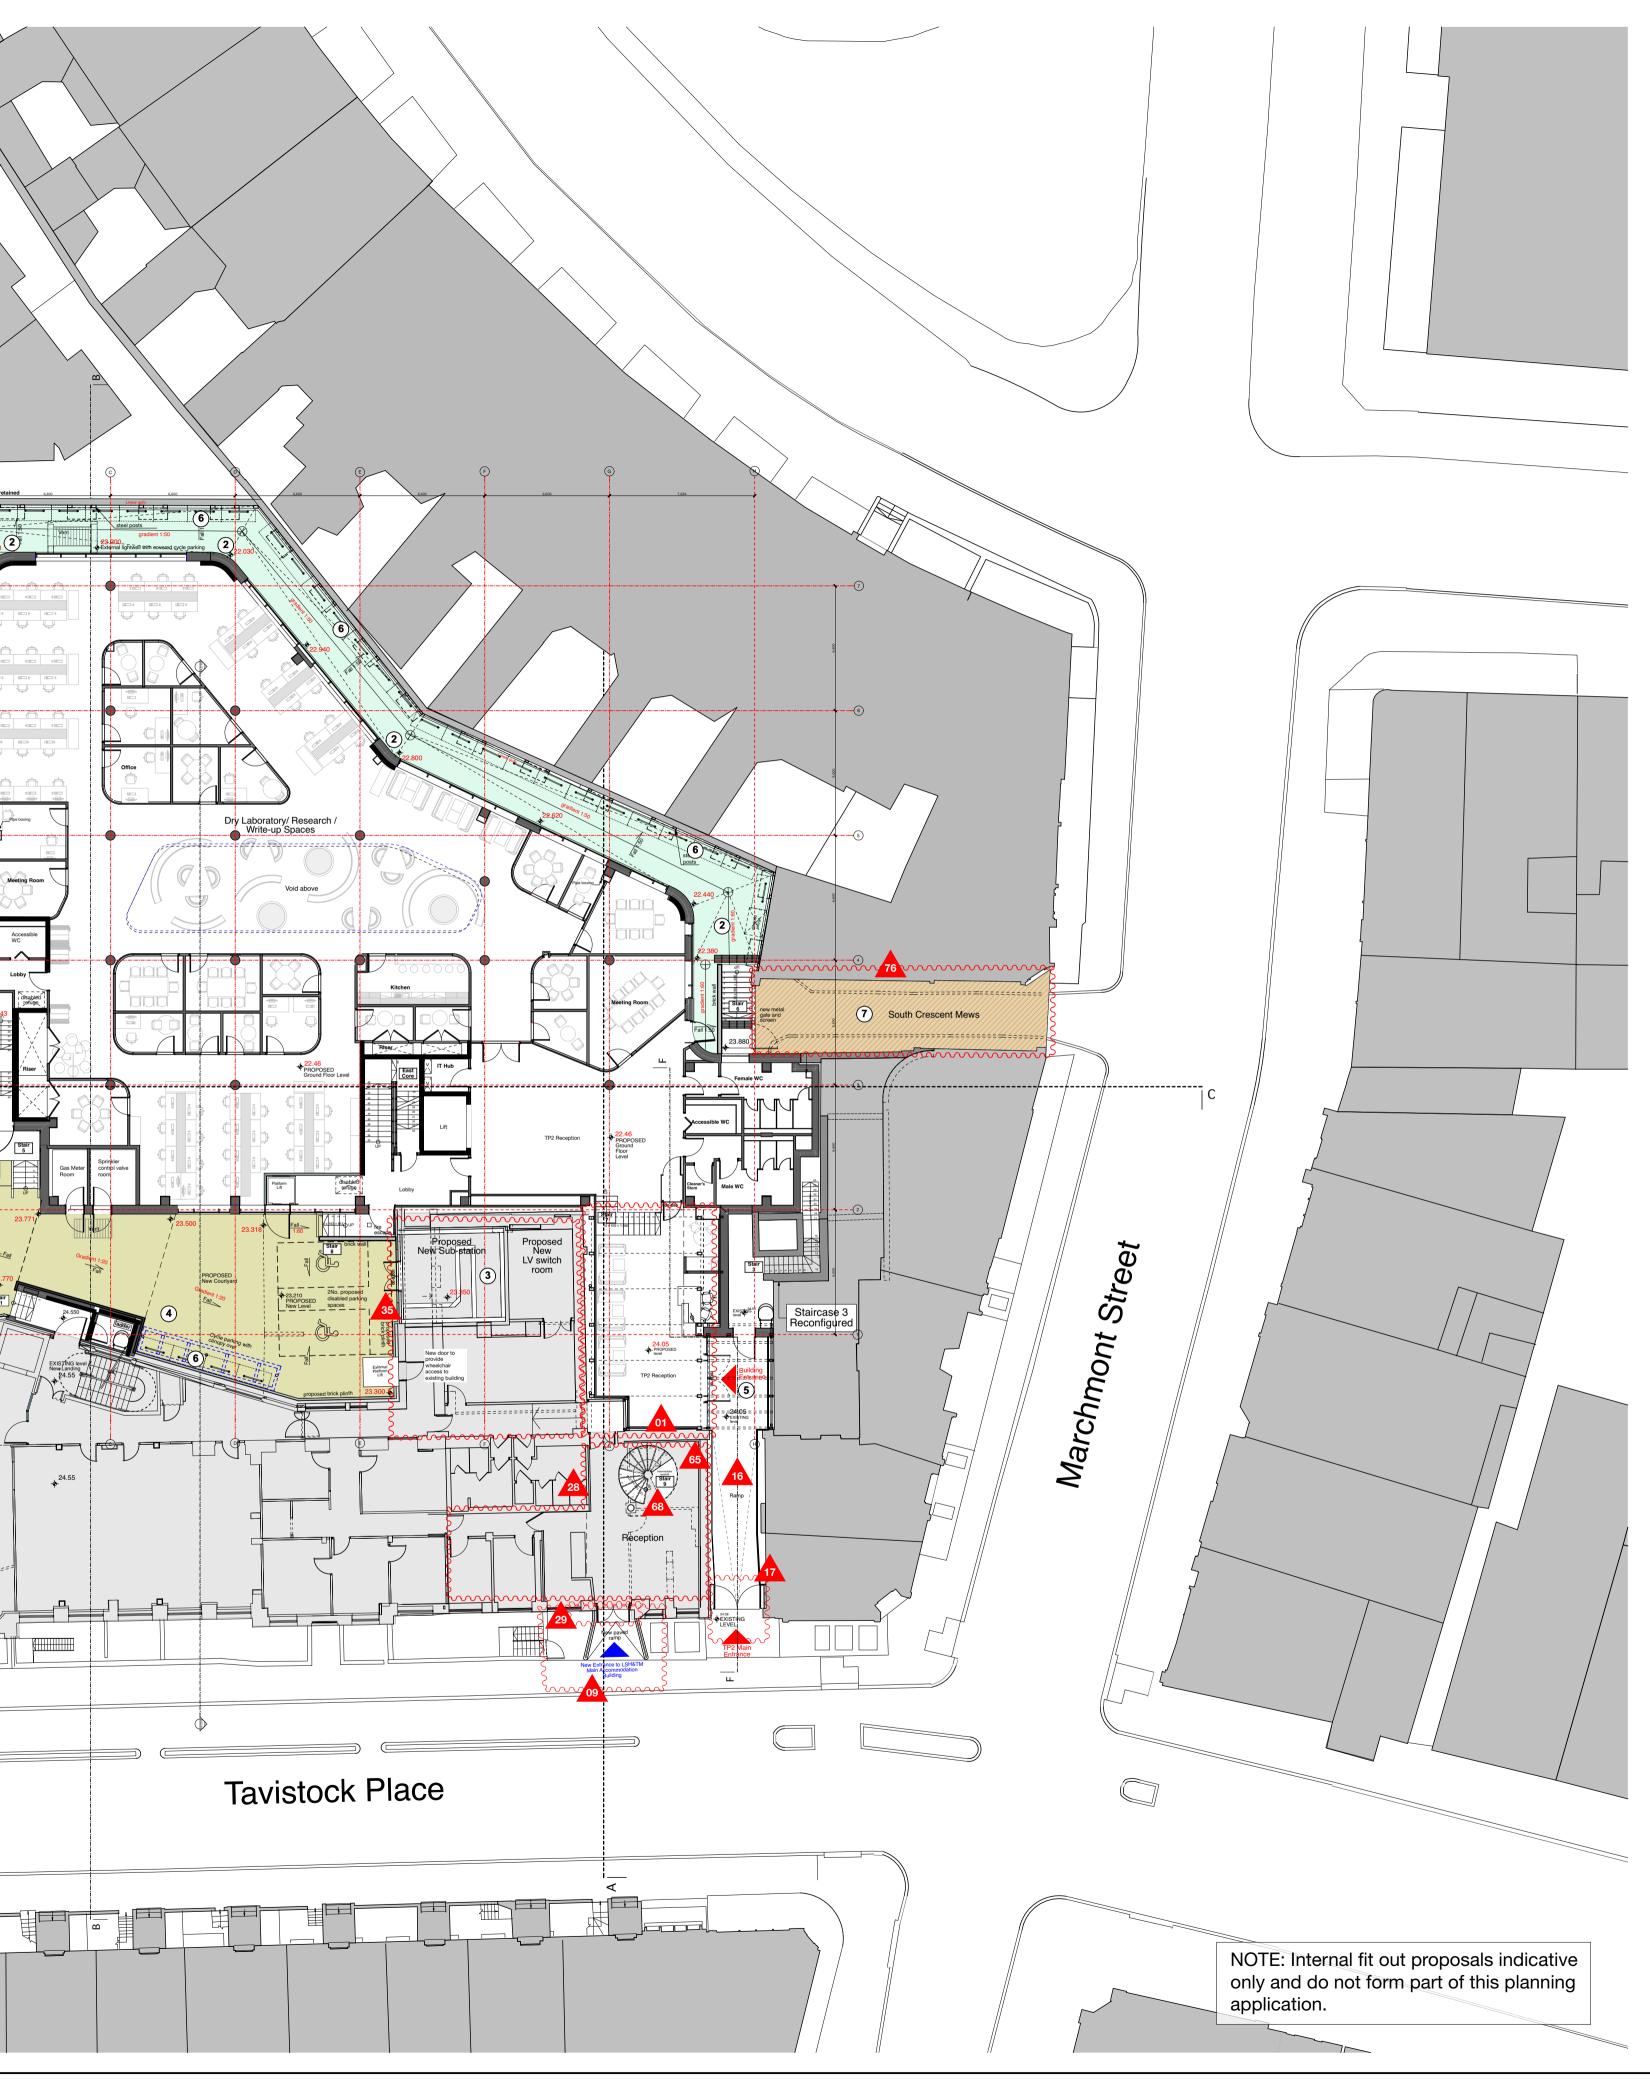
- 1 New Means of Escape to existing building
- Precast Concrete Paving to Pathways and Pedestrian Circulation
- ③ New substation & New LV Switch Room Small Unit Precast Concrete Block Paving to Courtyard
- 5 Slate Paving Slabs
- New 'Sheffield Hoop' cycle stands (40 single sided + 2 double sided: total 44 cycle spaces)
- (7) Existing kerbs removed and levels adjusted, with new stone cobbles and flag paving surface to Mews.
