Third Floor Plan: Landlord LBC Rectification Works

UCL Institute of Innovation & Public Purpose 11 Montague Street

813/GA/024

Burwell Architects Third Floor Plan: Landlord LBC Rectification Works

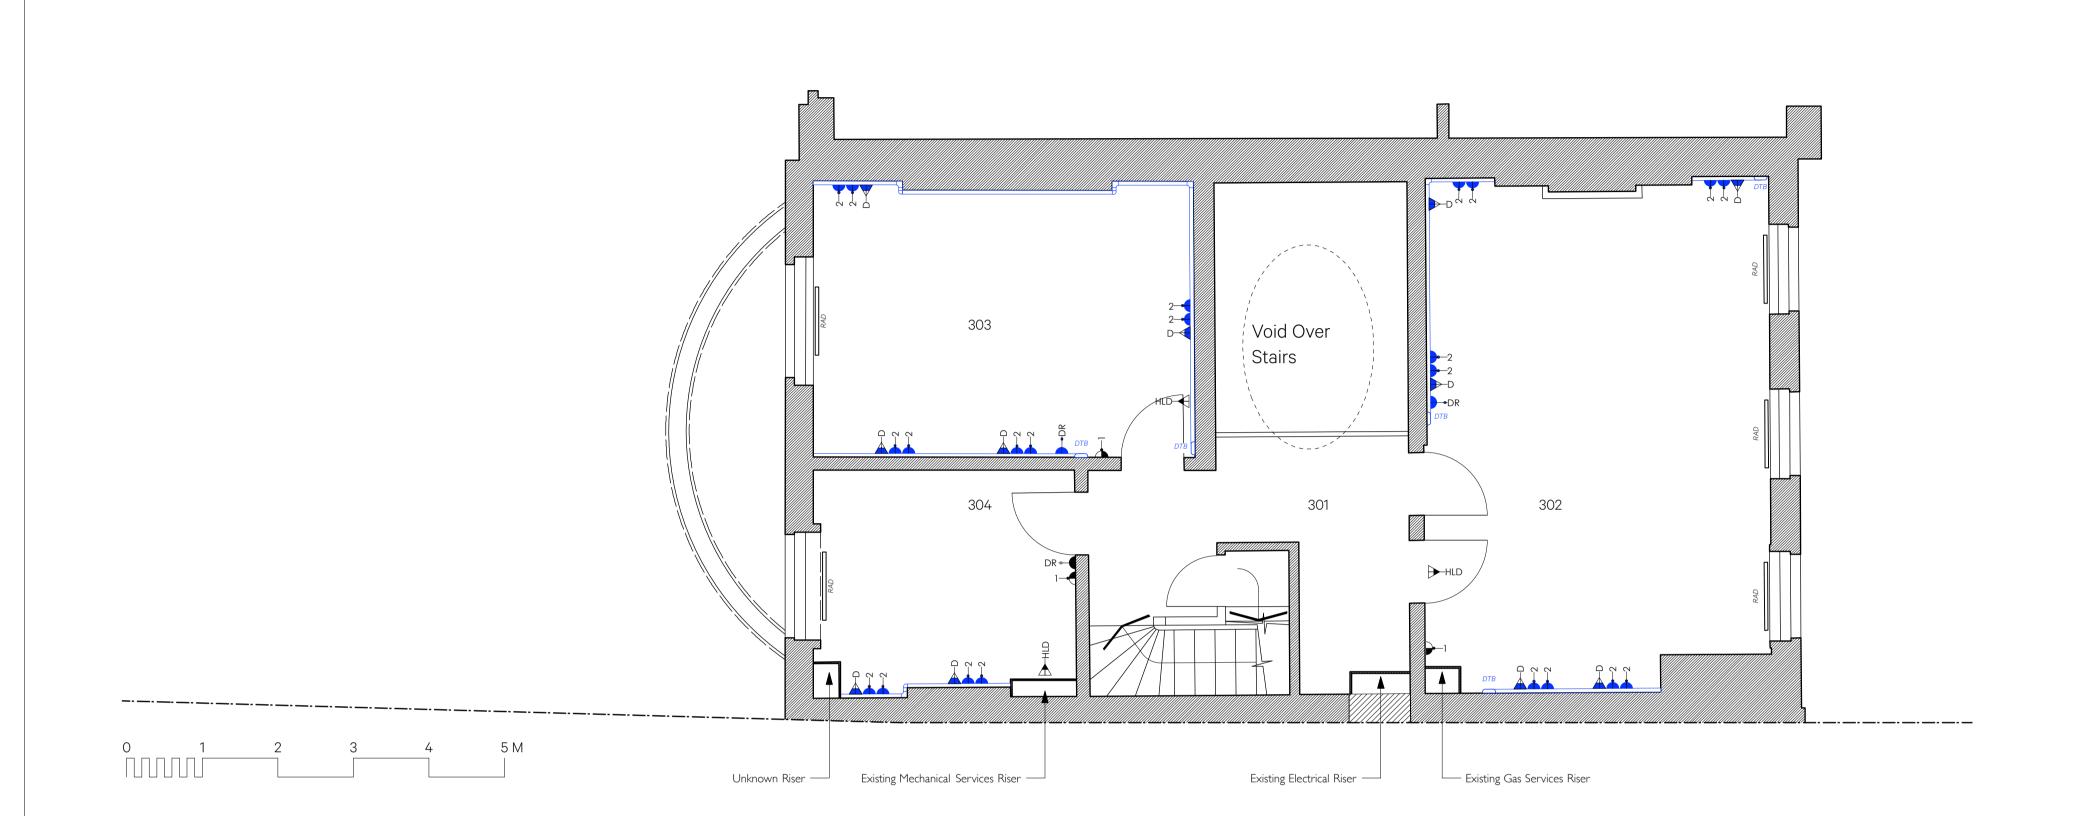
SCOPE OF WORKS

EXISTING DADO TRUNKING AND SOCKETS RETAINED

EXISTING DADO TRUNKING & SOCKETS REMOVED & REPLACED WITH NEW RECESSED SOCKETS NEW RECESSED SOCKETS TO BE SET OUT 350MM AFFL EXCEPT WHERE SKIRTINGS ARE HIGH, IN THESE LOCATIONS, UNDERSIDE OF SOCKETS TO BE SET OUT 100MM ABOVE TOP OF SKIRTING

1. Existing horizontal and vertical dado trunking to be removed.

2. Existing power and data cables to be retained and reused for new recessed outlets.

Refer to 837_G_030 series proposed drawings for locations. 3. New plaster cornice to be fitted following removal of vertical trunking.

Mould and material to match existing.

4. New skirting to match profile of existing to be fitted following removal of trunking.

Whole skirting to be redecorated to match existing paint finish where new skirting has been pieced in. 5. Walls to be made good using lime plaster where dado trunking has been removed.

Whole wall to be redecorated to match existing paint finish following removal of trunking.

Where trunking has been fixed to low level boxing out beneath radiators: 6. Low level boxing out and trunking to be removed.

7. New skirting to match profile of existing to be fitted and decorated to match existing if required.

8. Walls to be made good using lime plaster where boxing out and radiators have been removed and redecorated to match existing.

EXISTING DADO TRUNKING AND SOCKETS LOWERED AND REPOSITIONED AT 350MM AFFL, EXCEPT WHERE SKIRTINGS ARE HIGH, IN THESE LOCATIONS, UNDERSIDE OF DADO TRUNKING TO BE SET OUT JUST ABOVE TOP OF SKIRTING

1. Existing horizontal and vertical dado trunking to be reused and lowered to just above skirting level. 2. Walls to be made good using lime plaster where dado trunking has been removed. Whole wall to be redecorated to match existing paint finish following removal of trunking.

EXISTING RADIATORS RETAINED

EXISTING WALL MOUNTED RADIATORS REMOVED FROM HISTORIC FABRIC AND REINSTALLED ON NEW STELRAD FLOOR STANDING BRACKETS

1. Existing low level boxing in with trunking to be carefully removed (where installed).

painted white. Allow for installing new pipework and fittings from the riser.

2. Existing radiator wall brackets to be removed from wall.

3. Any resultant repair work to be carried out using lime plaster and decoration to match existing.

4. Existing radiator to be reused and floor mounted using stelrad floor standing brackets. 5. Where radiators have been fixed on boxing with electrical trunking and outlets installed under them at skirting level, the boxing and trunking is to be removed. In these circumstances, remove the radiators and connecting pipework after removal of boxing and trunking, reposition the radiators at normal height in line with other radiators. Where due to height of skirting board, radiators cannot be fixed back to the wall fabric, mount the radiators on proprietary feet from Stelrad subject to approval from Architect. It is permissible to install pipework exposed under radiators from the riser, fixed back to the skirting and

EXISTING SERVICE RISER REDUCED IN SIZE

1. Existing service riser to be reduced in size as is practicable to minimize abutment to historical fabric

including ceiling cornices, fan lights, etc.
