Historic Items Schedule and Salvage Strategy

This document covers the retention of historic building fabric, as identified in the Heritage Assessment and developed in coordination with the client, contractor and design team. For most items of special architectural or historic interest, the strategy will be to retain in place and repair or refurbish in situ if necessary. Where items of special interest require removal, storage, reuse or disposal, it should be carried out using the methodology below.

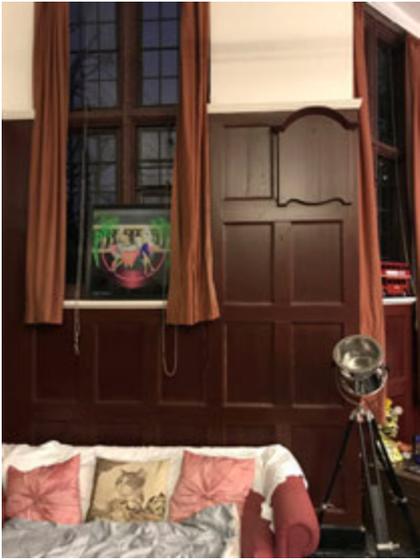
A501 A

A - Items to be Retained and Protected			
Reference	Photo Reference	Room No.	Description
A501	A501A, A501B	D3	Wood panelling throughout room to be retained and protected. Non-original paint to be stripped off and panelling refurbished and protected against future damage using a suitable finish.
A502	A502	D3	Fireplace and hearth to be retained and refurbished.
A503	A503	D3	All original wood skirting to be retained and protected. Non-original paint to be stripped off and repainted using black gloss paint.
A504	A504A	D3	Door DG19 to be retained as secondary entrance into unit. Door to be stripped of non-original paint and re-painted to match original red door paint elsewhere. For panelling on inside of door see note A501
A505	A505A, A505B	D3	Wall tiles in cupboard behind DG22 to be retained.
A506	A503	D3	Door DG20 retained and protected. See also note A501
A507	A507	D2	Glazed wall bricks to be retained and protected. All redundant services to be removed from walls and soffit, any penetrations through glazed bricks to be made good. Any white paint to be removed (note black lettering to be retained).

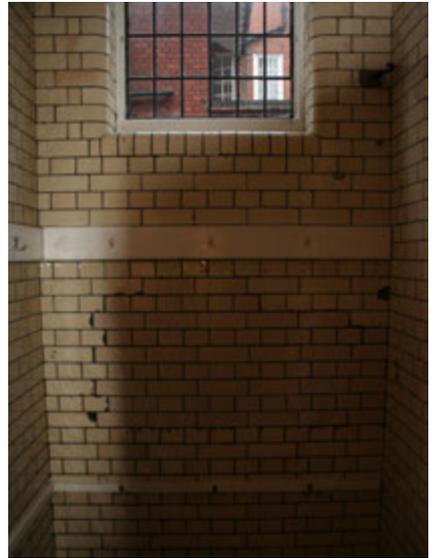
C504	C506	D1	Portion of wall underneath window WG30 is to be removed to form a new door DG26
C504	B505	D4/D6	Wall bricks underneath window WDG01 are to be removed
C506	n/a	D2	Portion of wall behind door DG26 to be removed to create new opening into bathroom D8. Glazed wall bricks to be carefully removed.

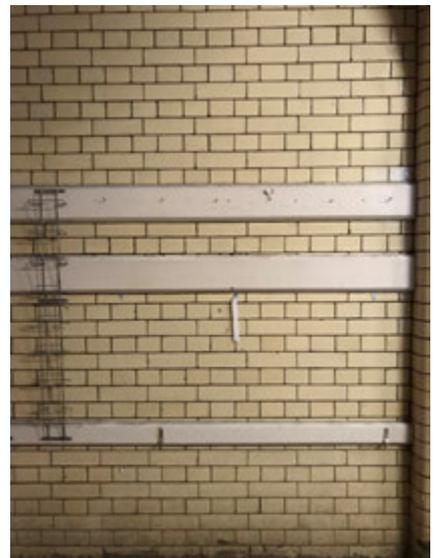
A606 A

A612	A606A	F1	Painted white wooden peg rails to be retained and protected, all non-original ironmongery to be removed and rails to be re-decorated.
A613	A613	F2	Firepole from first floor to be retained and protected. Opening in slab above to be filled with concrete, a collar or similar method of protection around firepole to protect firepole.
A614	A606C	F6	Firepole from first floor to be retained and protected. Opening in slab above to be filled with concrete, a collar or similar method of protection around firepole to protect firepole.
A615	A615	F2	Steel column and steel beams to be retained and protected. Steels to all be exposed where possible. Where not possible in terms of fire or acoustics steel column and beams to be treated appropriately.
A616	A616	F2	Ceiling mounted coloured 'watch' light indicator to be retained and protected.
A617	A617	F3	Door DG02 to be retained and protected. Door to be stripped of non-original paint and painted to match original red door paint elsewhere.

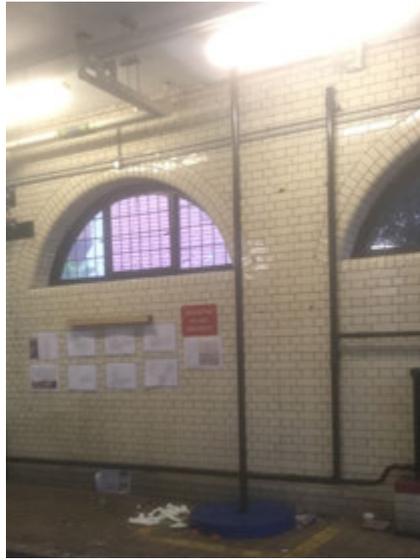
A606 C

A607	A606C	F2	New door DG35 to be installed underneath window WG35, glazed wall bricks to be removed and used elsewhere if possible.
A608	A608	F4	New door EXDG11 to be installed underneath window WG32, glazed wall bricks to be removed and used elsewhere if possible.
A609	A609	F4	Door DG28 to be retained and protected. Door to be stripped of non-original paint and painted to match original red door paint elsewhere. Door to be sealed shut to form Bedroom F4. Glass to be replaced to meet Building Control.
A610	A610	F5	Door DG29 to be retained and protected. Door to be stripped of non-original paint and painted to match original red door paint elsewhere. Door to be sealed shut to form Ensuite F5. Glass to be replaced to meet Building Control.
A611	TBC	F1	Door DG31 to be retained and protected. Door to be stripped of non-original paint and painted to match original red door paint elsewhere. Glass to be replaced to meet Building Control.

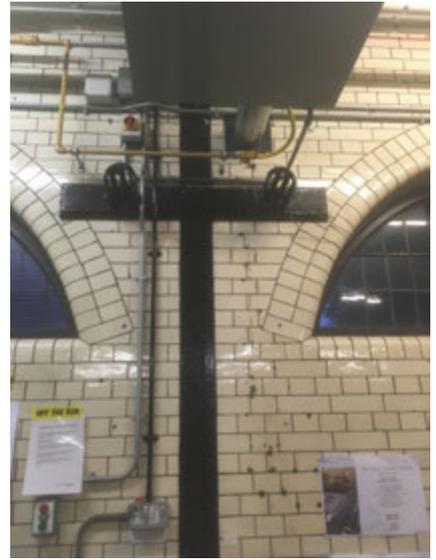
A606 D

B - Items to be Moved			
Reference	Photo Reference	Room No.	Description
B601	B601, A606D	F2/F6	Metal saddle pegs to be removed and relocated within Unit 6 if necessary. Items may remain in the same location.
B602	B602	F6	Radiator to be decommissioned, removed during works, cleaned and recommissioned in original location prior to completion. Original pipework may run in the false floor if necessary.
B603	B603	F2	Radiator to be decommissioned, removed during works, cleaned and recommissioned in original location prior to completion. Original pipework may run in the false floor if necessary.
B604	A606E	F2	Radiator to be decommissioned, removed during works, cleaned and recommissioned in original location prior to completion. Original pipework may run in the false floor if necessary.
B605	TBC	F2	Radiator to be decommissioned, removed during works, cleaned and recommissioned in original location prior to completion. Original pipework may run in the false floor if necessary.

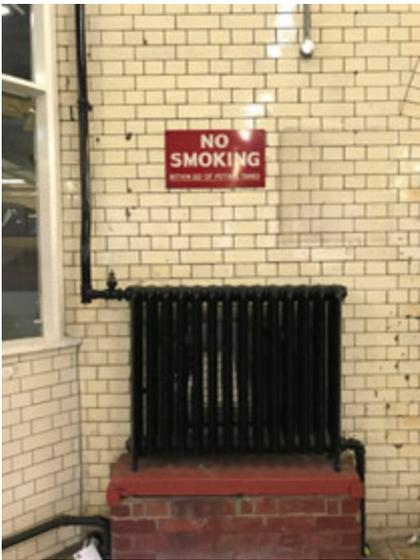
A606 E

B606	TBC	F2	Radiator to be decommissioned, removed during works, cleaned and recommissioned in original location prior to completion. Original pipework may run in the false floor if necessary.
B607	B607	F2	Belfast sink to be removed and reused if required.
B608	A606E	F2	2no. Wall mounted 'No Smoking' signs to be removed and reused within common areas.
C - Items to be Removed			
Reference	Photo Reference	Room No.	Description
C601	TBC	F4	Wall to be removed to create bedroom F4. Small nibs of the wall are to remain to invoke the memory of the walls location.
C602	TBC	F4	Portion of wall underneath window WG32 to be removed to form new doorway EXDG11.
C603	A606C	F2	Portion of wall underneath window WG35 to be removed to form new doorway DG35.

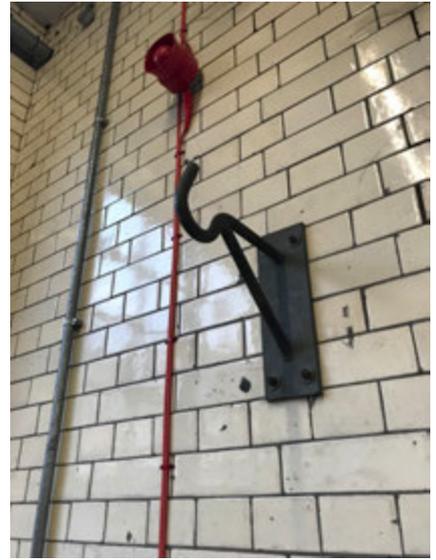
A618	B609	F2	Wall mounted metal hook to be retained and protected.
A619	N/A	F1	Battery charging' sign to be retained and protected.
A620	N/A	F1	Keys board to be retained and protected.

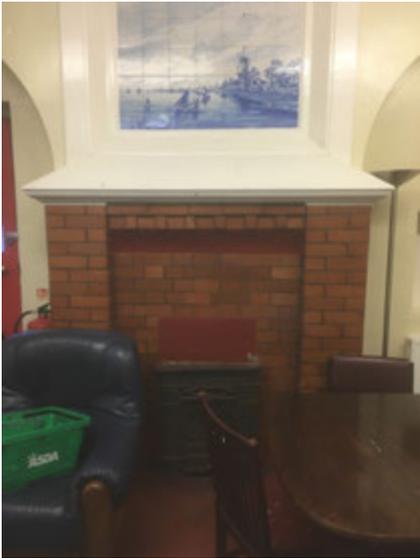
A701 A

A - Items to be Retained and Protected			
Reference	Photo Reference	Room No.	Description
A701	A701A, A701B, A701C	G2	Original fireplace, mantelpiece, tiled image and wooden frame above to be retained and protected. Minor existing damage to tiles to be left and not repaired.
A702	A702A, A702B	G2	Archways either side of main fireplace to be retained.
A703	n/a	n/a	Note now covered within Unit 8
A704	n/a	n/a	Note now covered within Unit 8
A705	A705	G3	Door D108 retained and protected on stairwell side and plasterboarded over on Unit 7 side (to form a blocked door detail). Door to be repainted in original red door paint.
A706	A706	G2	Archway to be retained
A707	A707	G2	Wooden skirting to be retained and refurbished.
A708	n/a	G3	Wooden skirting to be retained and refurbished.
B - Items to be Moved			
Reference	Photo Reference	Room No.	Description
C - Items to be Removed			
Reference	Photo Reference	Room No.	Description

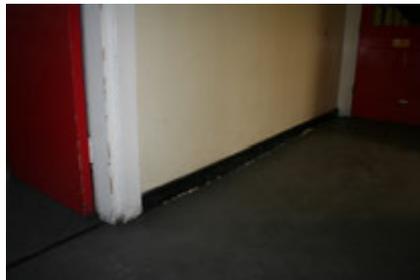
C701	C701	G2	Hatch in wall filled in. See note C801.

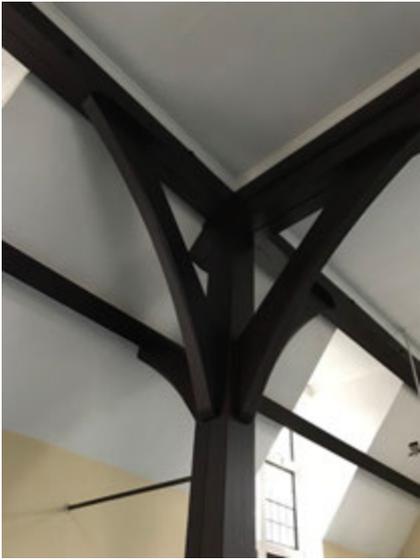
A801 A

A - Items to be Retained and Protected			
Reference	Photo Reference	Room No.	Description
A801	A801A, A801B	H1	Existing wooden columns and brackets to be retained and protected. A new mezzanine level will be supported partially on the columns and partially on the eastern wall providing a new bedroom space. The new balustrade and newels for the mezzanine will be set inside the <u>existing brackets to remain clear of the existing structure.</u>
A802	A802	H1	Archway and timber architrave leading to unit 7 to be retained. See note A704.
A803	A803	H1	Firepole, enclosure and door D101 to be retained. Panelling to be refurbished where necessary and redecorated. Door to be repainted in original red door colour, 'Dangerous' sign on door to be retained. Opening in slab above to be filled with concrete, a collar or similar method of protection around firepole to be installed to protect firepole. White paint on pole <u>at high level to be removed.</u>

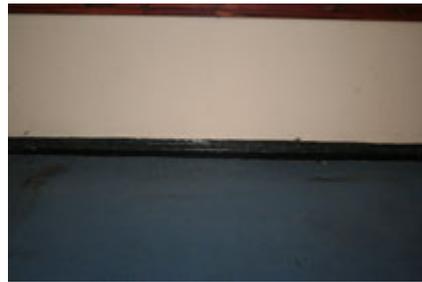
A804	A804	H1	Wooden skirting to be retained and stripped down and repainted where necessary.
A805	A805	H1	Wooden panelling below windows W101, W102 to be retained and protected. Panelling to be refurbished and re-painted.
A806	A806	H5	Firepole, enclosure and door D106 to be retained. Panelling to be refurbished where necessary and redecorated. Door to be repainted where necessary in original red door colour, 'Dangerous' sign on door to be retained. Opening in slab above to be filled with concrete, a collar or similar method of protection around firepole to protect firepole.
A807	A807	H5	Archway and timber architrave leading to H1 to be retained and door reinstated.
B - Items to be Moved			
Reference	Photo Reference	Room No.	Description
B801	B801	H3	Radiator to be decommissioned, removed during works, cleaned and recommissioned in original location prior to completion.
B802	B802	H4	Radiator to be decommissioned, removed during works, cleaned and recommissioned in original location prior to completion.

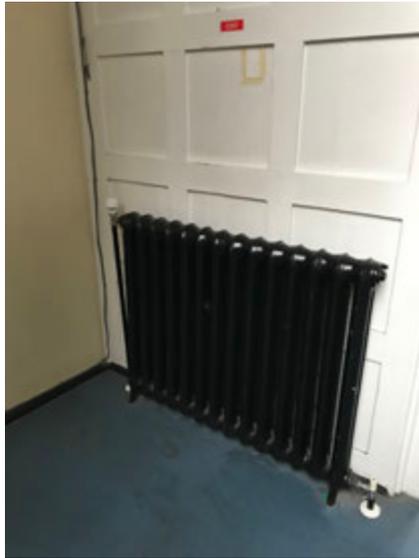
B803	B803	H2	Radiator to be decommissioned, removed during works, cleaned and recommissioned in original location prior to completion.
B804	B804	H1	Radiator to be decommissioned, removed during works, cleaned and recommissioned in original location prior to completion.
B805	B805	H5-H6	Square tiles to be carefully removed and reused (where possible).
C - Items to be Removed			
Reference	Photo Reference	Room No.	Description
C801	C801	H3	Hatch in wall between unit 8 and 7 to be removed and filled in.
C802	C802	H1	Door EXD109 to be removed as non-original door and replaced with door to match original in red colour to match doors elsewhere. Contractor to take steps to find alternative owner if condition allows.

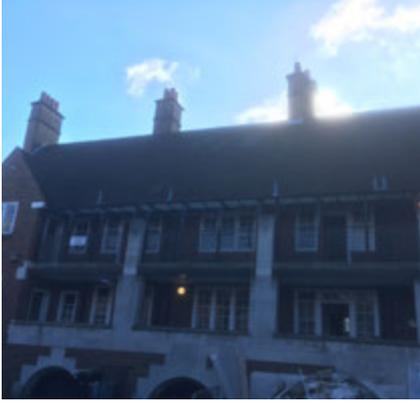
Unit Number/Name			Unit 9
Floor(s)			Second
Proposed Area			126m ²
General Description			
A disused loft space converted into a new 2 bed unit with 6 new dormer windows.			
A - Items to be Retained and Protected			
Reference	Photo Reference	Room No.	Description
B - Items to be Moved			
Reference	Photo Reference	Room No.	Description
B901	B901	J1	Portion of roof tiles and roof structure to be removed to allow for construction of new dormer window W203. Where possible roof tiles to be re-used in new dormer window construction.
B902	B901	J1	Portion of roof tiles and roof structure to be removed to allow for construction of new dormer window W204. Where possible roof tiles to be re-used in new dormer window construction.
B903	B901	J2	Portion of roof tiles and roof structure to be removed to allow for construction of new dormer window W205. Where possible roof tiles to be re-used in new dormer window construction.

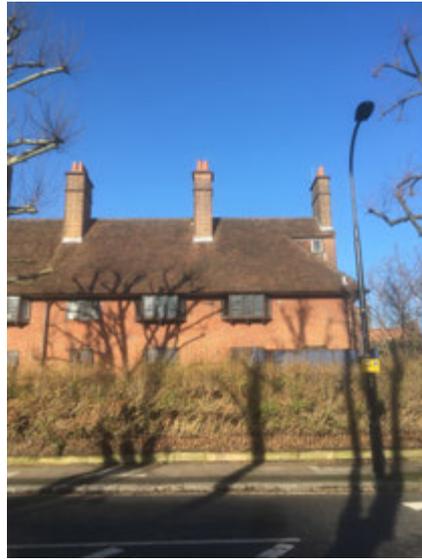
B904	B904	J2	Portion of roof tiles and roof structure to be removed to allow for construction of new dormer window W208. Where possible roof tiles to be re-used in new dormer window construction.
B905	B905	J6	Portion of roof tiles and roof structure to be removed to allow for construction of new dormer window W209. Where possible roof tiles to be re-used in new dormer window construction.
B906	B905	J4	Portion of roof tiles and roof structure to be removed to allow for construction of new dormer window W210. Where possible roof tiles to be re-used in new dormer window construction.
C - Items to be Removed			
Reference	Photo Reference	Room No.	Description
C901	C901	J1	Portion of existing wall and chimney stack to be removed to form new opening for door D2017.

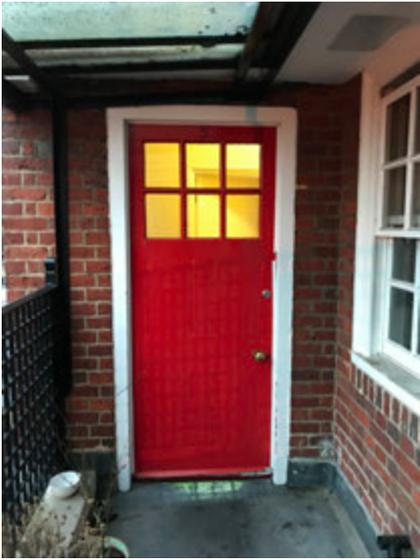
A - Items to be Retained and Protected			
Reference	Photo Reference	Room No.	Description
A1501	A1501	Q1	Door EXD104 to be removed, refurbished and repainted prior to reinstatement (subject to confirmation that fire requirements met). All non original ironmongery, including entry systems to be removed. New ironmongery to be installed. Red stone door threshold to be retained.
A1502	n/a	Q4/Q6	Fire opening to be retained behind plaster finish. Fireplace already removed from prior occupation.
A1503	A1503	Q2	Fireplace to be retained and refurbished to original condition. Damaged or missing tilework, mantels or hearths to be removed and replaced with reproductions.
B - Items to be Moved			
Reference	Photo Reference	Room No.	Description
C - Items to be Removed			
Reference	Photo Reference	Room No.	Description
C1501	n/a	Q1-Q6	Internal finishes (wall, ceiling, floors) to be removed and replaced.

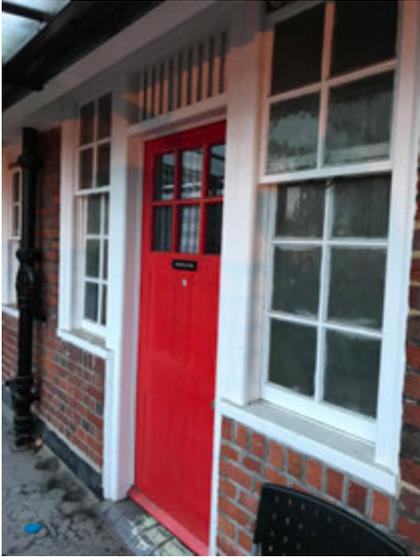
A - Items to be Retained and Protected			
Reference	Photo Reference	Room No.	Description
A1601	A1601	R1	Door EXD103 to be removed, refurbished and repainted prior to reinstatement (subject to confirmation that fire requirements met). All non original ironmongery, including entry systems to be removed. New ironmongery to be installed.
A1602	n/a	R2	Fire opening to be retained behind plaster finish. Fireplace already removed from prior occupation.
A1603	n/a	R4	Fire opening to be retained behind plaster finish. Fireplace already removed from prior occupation.
B - Items to be Moved			
Reference	Photo Reference	Room No.	Description
C - Items to be Removed			
Reference	Photo Reference	Room No.	Description
C1601	n/a	R1-R6	Internal finishes (wall, ceiling, floors) to be removed and replaced.

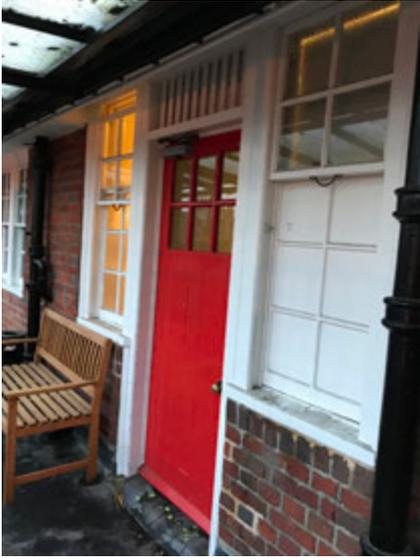
A - Items to be Retained and Protected			
Reference	Photo Reference	Room No.	Description
A1701	A1701	S1	Door EXD102 to be removed, refurbished and repainted prior to reinstatement (subject to confirmation that fire requirements met). All non original ironmongery, including entry systems to be removed. New ironmongery to be installed.
A1702	n/a	S2	Fire opening to be retained behind plaster finish. Fireplace already removed from prior occupation.
A1703	n/a	S4	Fire opening to be retained behind plaster finish. Fireplace already removed from prior occupation.
B - Items to be Moved			
Reference	Photo Reference	Room No.	Description
C - Items to be Removed			
Reference	Photo Reference	Room No.	Description
C1701	n/a	S1-S6	Internal finishes (wall, ceiling, floors) to be removed and replaced.

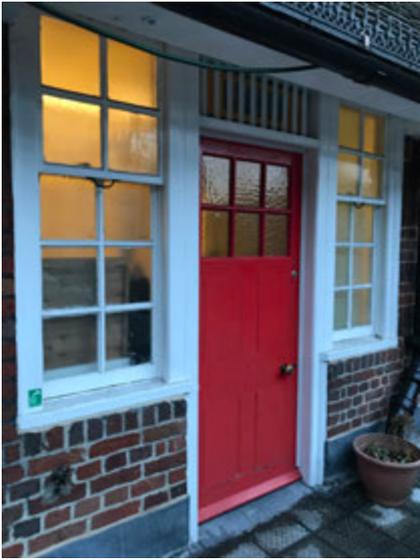
A - Items to be Retained and Protected			
Reference	Photo Reference	Room No.	Description
A1801	A1801	T1	Door EXD105 to be removed, refurbished and repainted prior to reinstatement (subject to confirmation that fire requirements met). All non original ironmongery, including entry systems to be removed. New ironmongery to be installed.
A1802	n/a	T2	Door D125 to be retained and protected. Door to be painted using original red door paint.
A1803	A1803	T6/T7	Fireplace and tiled mantelpiece to be retained and refurbished to original condition. Damaged or missing tilework, mantels or hearths to be removed and replaced with reproductions.
B - Items to be Moved			
Reference	Photo Reference	Room No.	Description
C - Items to be Removed			
Reference	Photo Reference	Room No.	Description
C1801	TBC	T4	Non-original fireplace and hearth above to be removed.
C1802	n/a	T1-T8	Internal finishes (wall, ceiling, floors) to be removed and replaced.

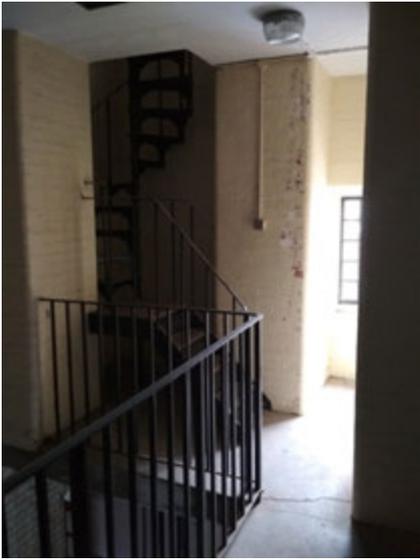
AV01 A

A - Items to be Retained and Protected			
Reference	Photo Reference	Room No.	Description
AV01	AV01A, AV01B	V1/V2/V3	Spiral staircase to be retained including all steps, structure, handrail, balustrade, balusters and associated fixtures to be retained and protected. Where necessary any damage to be repaired and any redecoration required to match original black gloss finish.
B - Items to be Moved			
Reference	Photo Reference	Room No.	Description
C - Items to be Removed			
Reference	Photo Reference	Room No.	Description

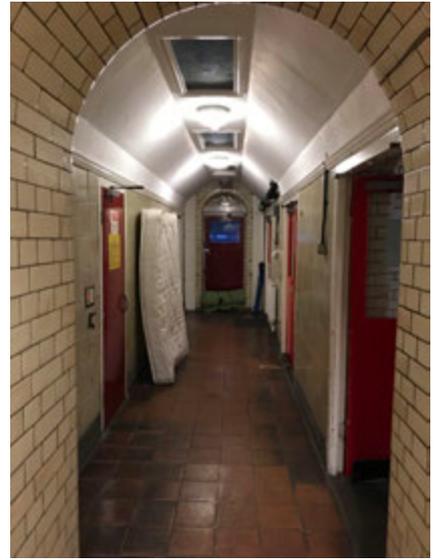
AE102 B

AE106	AE102B	E1	Wooden dado rail to be retained and protected, all redundant services to be removed. Gaps and damage to the dado rail to be filled in/repaired with the same profile.
AE107	AE107	E1	Ironmongery immediately adjacent to door EXDG05 to be retained and protected.
AE108	AE108	E1	Firepole to be retained and protected.
AE110	AE110A, AE110B, AE110C	E1	Handrail, balustrade, balusters and associated fixtures to be retained and protected. Where necessary any damage to be repaired and any redecoration required to match original black gloss finish.
AE111	AE111	E1	Non-original Lino and metal stair coverings, including risers, goings and nosing's to be removed and any damage to original stairs to be repaired prior to new stair coverings being installed.
AE112	A617	E1	Door DG02, see note A617.
AE113	A504B	E1	Door DG19, see note A504.
AE114	A609	E1	Door DG28, see note A609.
AE115	A610	E1	Door DG29, see note A610.

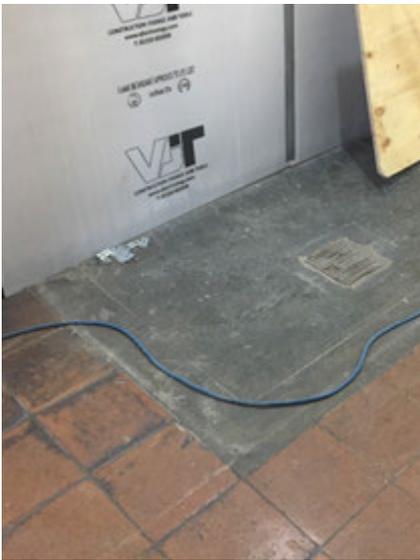
AE102 B

AE116	TBC	E1	Door DG31, see note A611.
AE117	n/a	E1	Door DG30 to be retained and protected if possible. Subject to a potential fire isolation review due to new plant room.
AE118	AE102B	E1	Sloped ceiling soffit to be retained and protected, existing lights and all redundant services to be removed. New lighting to be sympathetically incorporated.
AE119	AE102B	E1	3no. Skylights, including wooden frames, to be retained and protected. Skylight glass to be replaced with stippled wired glass.
AE120	AE120A, AE120B	E1	Steel beams at high level to be retained and protected.
AE121	AE109	E1	Hose drain gulley and grille to be retained, subject to confirmation of lift requirements. Drain grille to be wire brushed and painted black. Any further changes covered under condition submission for 2016/1128/L Condition 14c.
B - Items to be Moved			
Reference	Photo Reference	Room No.	Description
C - Items to be Removed

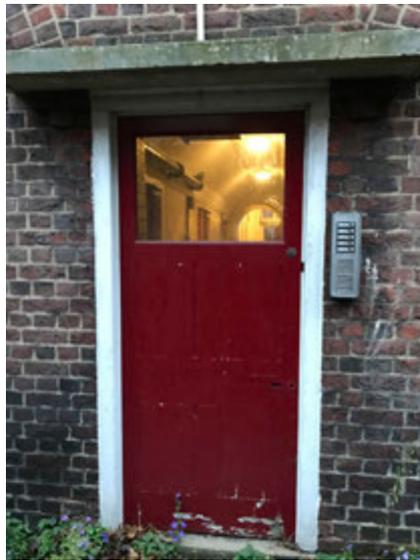
AE109

Reference	Photo Reference	Room No.	Description
CE101	CE101	E1	Rear door to be removed and replaced with new glazed door EXDG10, to be fixed shut. Door frame colour to match original red door colour.

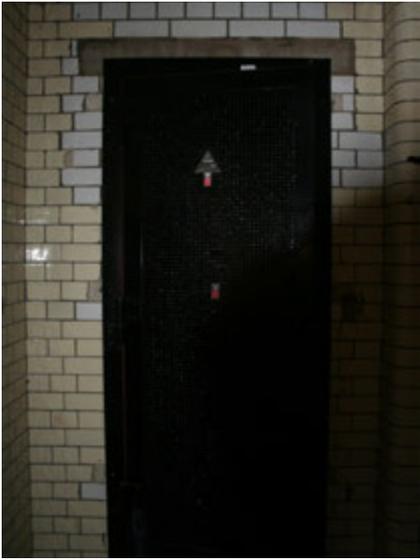
A514 A

A - Items to be Retained and Protected			
Reference	Photo Reference	Room No.	Description
AE301	n/a	E3	Door DG30, see note AE117.
AE302	A514A	E3	Redundant door into firepit, see note, A514.
AE303	A509	E3	High level vents, see note A509.
AE304	n/a	E3	Glazed wall bricks to be retained and protected, all redundant services to be removed and bricks made good.
AE305	N/A	E3	Red access steps and handrail to be retained and protected.
B - Items to be Moved			
Reference	Photo Reference	Room No.	Description
BE301	N/A	E3	Boiler dials to be removed, retained and rehoused in common areas.
BE302	N/A	E3	Painted metal pulleys to be removed, retained and rehoused in adjacent wall.
C - Items to be Removed			
Reference	Photo Reference	Room No.	Description
CE301	n/a	E1	Wall separating firepit to be removed to enable plant room to be enlarged
CE302	AE304A	E1	Wall separating room with existing water tank to be removed to enable plant room to be enlarged

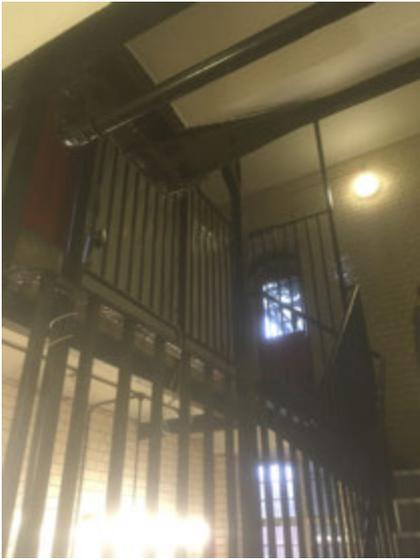
AU101 A

A - Items to be Retained and Protected			
Reference	Photo Reference	Room No.	Description
AU101	AU101A, AU101B	U1	Glazed wall bricks, including all archways and reveals, to be retained and protected. Any redundant services to be removed and bricks to be made good. Bricks to all remain exposed in communal areas.
AU102	AU101, AU101B, AU102	U1	Handrail, balustrade, balusters and associated fixtures to be retained and protected. Where necessary any damage to be repaired and any redecoration required to match original black gloss finish.
AU103	AU101A	U1	Non-original stair coverings, including risers, goings and nosing's to be removed and any damage to original stairs to be repaired prior to new stair coverings being installed.
AU104	AU104	U1	Firepole to be retained and protected.
AU105	AU105	U1	Doors D110 leading to firepole to be retained and protected, doors to be repainted with original red door paint and sealed shut to prevent access to firepole.

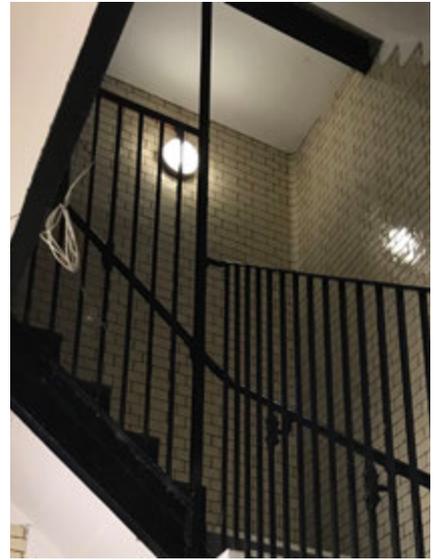
AU106 A

AU106	AU106A,	U1	Steel beams at high level to be retained and protected.
AU107	n/a	U1	Door D125 see note A1802.
B - Items to be Moved			
Reference	Photo Reference	Room No.	Description
BU101	n/a	U1	Section of metal balustrade to be removed to allow a landing to be installed for the new lift serving the first and second floors.
Bu102	n/a	U1	Door D111 leading up to the second floor via the staircase to be removed and used elsewhere in the building in order to create a safer access stair to the second floor.
C - Items to be Removed			
Reference	Photo Reference	Room No.	Description
CU101	CU101	U1	Door EXD106 to be removed and repaired/replaced as necessary externally due to extensive existing damage to the glazing, the frame, panelling and threshold. Replacement to be finished in original red door paint as elsewhere.

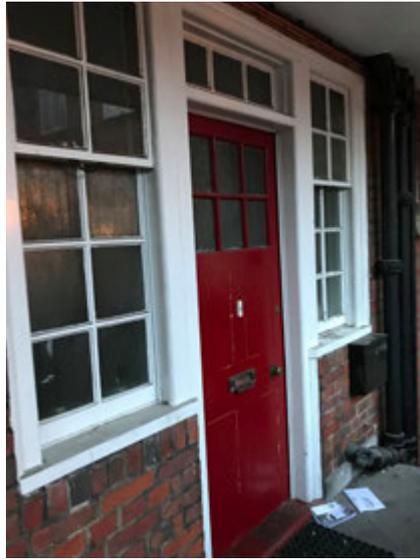
A - Items to be Retained and Protected			
Reference	Photo Reference	Room No.	Description
AU201	AU201	U2	Red facing brickwork to be retained and protected, including archways and door and window reveals, any redundant services to be removed and brickwork made good.
AU202	AU202	U2	Door EXD101 to be retained and protected.
AU203	A1501	U2	Door EXD104 see note A1501
AU204	A1601	U2	Door EXD103 see note A1601
AU205	A1701	U2	Door EXD102 see note A1701
AU206	N/A	U2	Cast iron SVP's (including visible pipework) to be retained and protected.
B - Items to be Moved			
Reference	Photo Reference	Room No.	Description
C - Items to be Removed			
Reference	Photo Reference	Room No.	Description
CU201	AU203	U2	Non-original metal glazed canopy to be removed and replaced with a new minimal canopy. Contractor to take steps to find alternative owner.

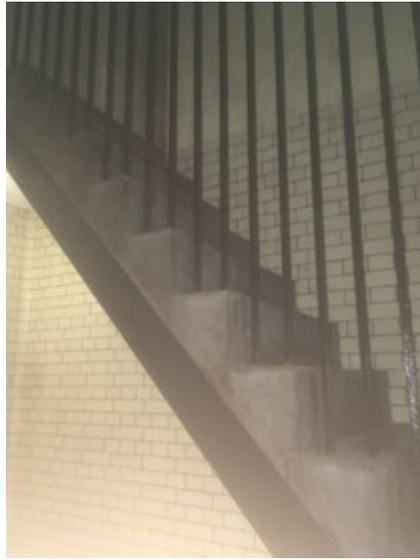
AU101 B

A - Items to be Retained and Protected			
Reference	Photo Reference	Room No.	Description
AL101	AU101B	L1	Wall bricks, including all archways and reveals, to be retained and protected. Any redundant services to be removed and bricks to be made good. Bricks to all remain exposed in communal areas.
AL102	A1102	L1	Handrail, balustrade, balusters and associated fixtures to be retained and protected. Where necessary any damage to be repaired and any redecoration required to match original black gloss finish.
AL103	AV01A	L1	Small metal spiral staircase leading to tower to be retained and protected. Where necessary any damage to be repaired and any redecoration required to match original black gloss finish.
B - Items to be Moved			
Reference	Photo Reference	Room No.	Description
BL101	BL101	L1	Section of metal balustrade to be removed to allow a landing to be installed for the new lift serving the first and second floors.

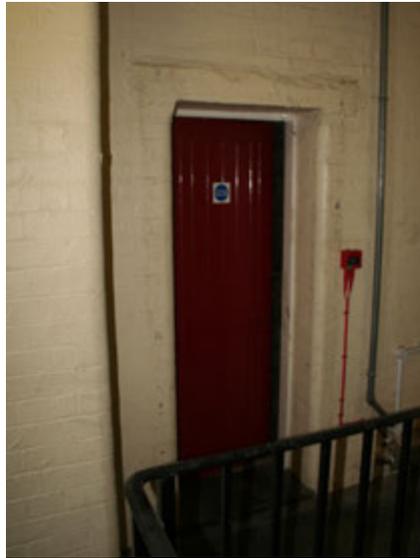
BL101

BL102	BL102	L1	Door D204 leading into unit 11 to be removed and relocated to the right of the existing location to create a new entrance way into proposed unit 11. Door to be painted in original red door paint.
BL103	B104	L1	Portion of wall removed to relocate door D204, brickwork to be reused if possible to fill in opening of previous location of door D204.
C - Items to be Removed			
Reference	Photo Reference	Room No.	Description
CL101	B104	L1	Section of brickwork at top of main staircase removed to create entranceway into units 9 and 10. Brickwork to be made good with brickwork to match existing.

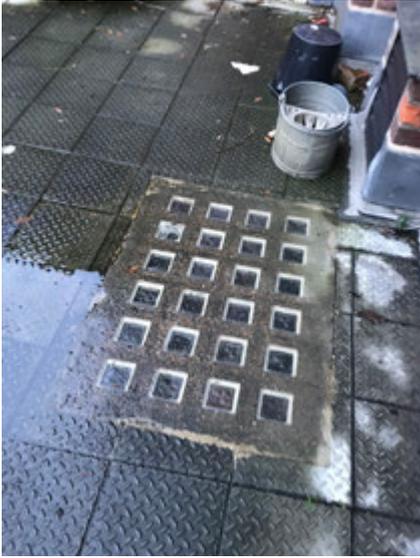
A - Items to be Retained and Protected			
Reference	Photo Reference	Room No.	Description
AU301	AU301	U3	Pavement lights W138, W139, W140 & W141 are not thought to be original however they are still to be retained.
AU302	AU302A, AU302B, AU302C, AU302D	U3	All red facing brickwork, including archways, door and windows reveals, cills and other decorations to be retained and protected. All redundant services to be removed from the walls and brickwork made good with bricks to match original brickwork.
AU303	AU302B, AU302C	U3	All original guttering, guttering decoration, downpipes and hoppers to be retained and where necessary refurbished and repaired to their original condition.
AU304	A806	U3	Door EXD109 see note A806.
AU305	A705	U3	Door EXD108 see note A705.
AU306	A1801	U3	Door EXD105 see note A1801.
AU307	AU307	U3	Vent stack and grills from plant room below to be retained and protected.
AU308	AU307	U3	Air vent brick to be retained and protected.

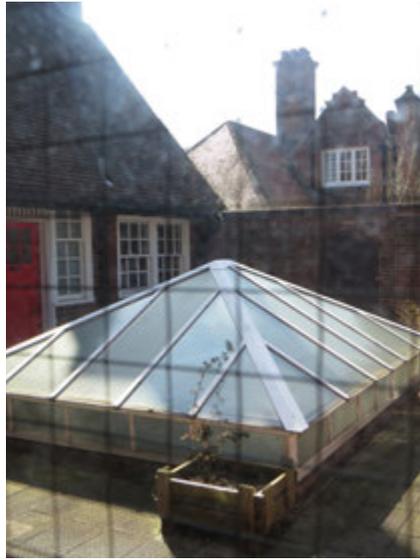
AU309	AU309	U3	Door EXD107 to be retained and sealed shut.
Reference	Photo Reference	Room No.	Description
C - Items to be Removed			
Reference	Photo Reference	Room No.	Description
CU301	CU101	U3	Door EXD106 see note CU101.
CU302	CU302	U3	Existing skylight removed and replaced with infill slab.
CU303	CU302	U3	Existing floor tiles, screed and waterproofing is not fit for purpose and will be removed and replaced, as well as extended over skylight infill area.

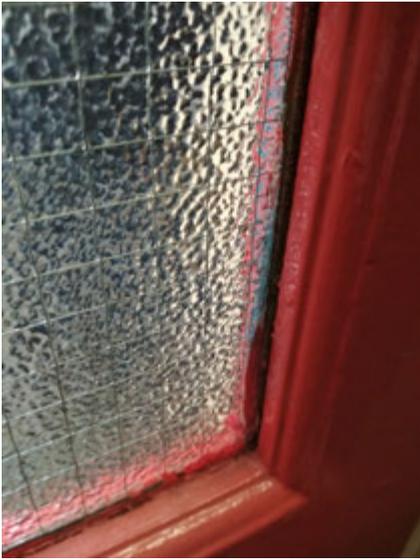
A - Items to be Retained and Protected			
Reference	Photo Reference	Room No.	Description
AEX01	AEX01	N/A	All external doors and windows (including window pulls and restrictors) are to be retained and refurbished. All stippled and/or wired glass to be retained and refurbished if possible or replaced like-for-like if necessary to meet fire protection requirements.
AEX02	See all external photos	N/A	All external brickwork is to be retained and protected, all redundant services are to be removed and brickwork made good using bricks to match the existing facing brickwork.
AEX03	AEX03A, AEX03B	N/A	All original guttering, gutter decoration, downpipes, hopper heads including castellated hopper heads, and gully covers are to be retained and protected and refurbished where necessary.
AEX04	AEX04	N/A	LCC crest mounted on external wall of unit 6 to be retained.
AEX05	AEX05	N/A	LCC crest mounted on external wall of unit 7 to be retained.

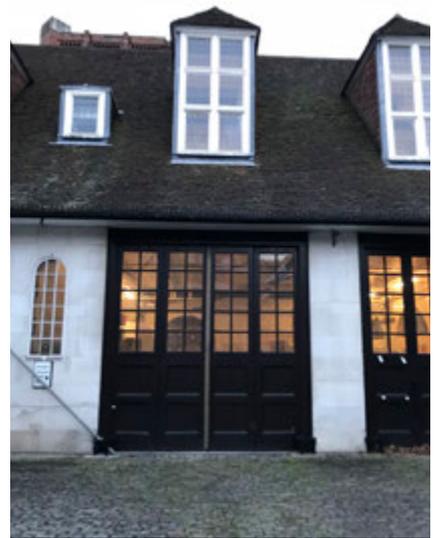
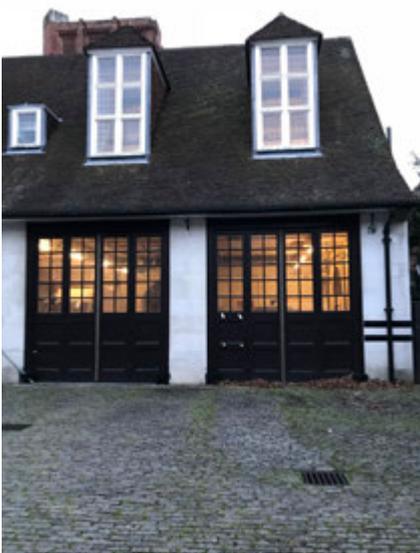
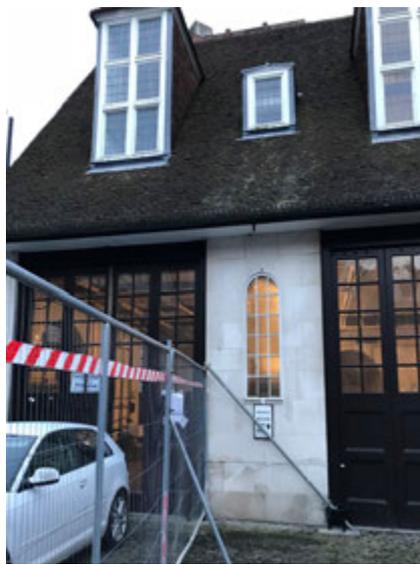
AEX06	A601C, A601D, A601E	N/A	3no. Hanging basket hooks wall mounted above doors EXDG01, EXDG02 and EXDG03 to be retained.
AEX07	A601C, A601D, A601E	N/A	Metal corner protection to external building corners and on either side of doors EXDG01, EXDG02 and EXDG03 to be retained.
AEX08	AEX08	N/A	Metal corner protection on either side of vehicle entrance gate retained.
AEX09	AEX09	N/A	Wooden ladder rest panel wall mounted on the side of unit 7, between windows W106 and W107 to be retained and refurbished if necessary.
AEX10	AEX10	N/A	All small tile ventilators to be retained and protected.
AEX20	AEX20	N/A	Original concrete tiled external finish to main enclosed yard to be retained and protected. Tiles to be cleaned and replaced with tiles to match existing where required.
AEX21	A601E	N/A	Enquiry bell and associated brass window-mounted sign on window WG01 to be retained.
AEX22	AEX22	N/A	Original granite setts north of Gridline 1 to be retained and refurbished where possible. Setts to be removed and reinstated for drainage works.

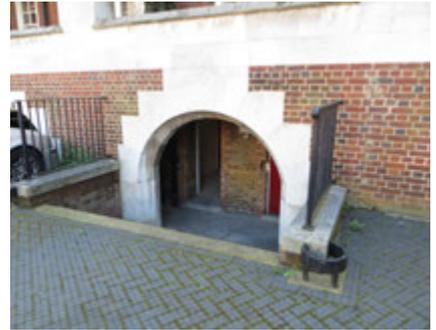
AEX23	AEX23	N/A	Existing balustrade to basement corridor stair to be retained and refurbished.
AEX24	A601B	N/A	Existing tannoy to be retained and protected.
AEX25	AEX25	N/A	Painted stripes and signage near entrance door to be retained and protected.
AEX26	N/A	N/A	Motorcycle hook to be retained and protected.
AEX27	N/A	N/A	Stone dedication panel to be retained and protected.
AEX28	A601F	N/A	Emergency phone recessed panel to be retained and refurbished.
B - Items to be Moved			
Reference	Photo Reference	Room No.	Description
BEX01	n/a	N/A	Fire Brigade Personnel Only' sign currently fixed on main vehicle gate to be removed, cleaned and installed elsewhere within the building.
C - Items to be Removed			
Reference	Photo Reference	Room No.	Description
CEX01	n/a	N/A	Timber signage under window WG01 removed.
CEX24	n/a	N/A	Existing lighting removed and replaced like-for-like.
