Proposed Tree Planting Location Assessment

Kiln Place, London

This report following a site visit on the 17/02/2019 evaluates the approved tree planting locations at Kiln Place before detailing and justifying proposed amendments.

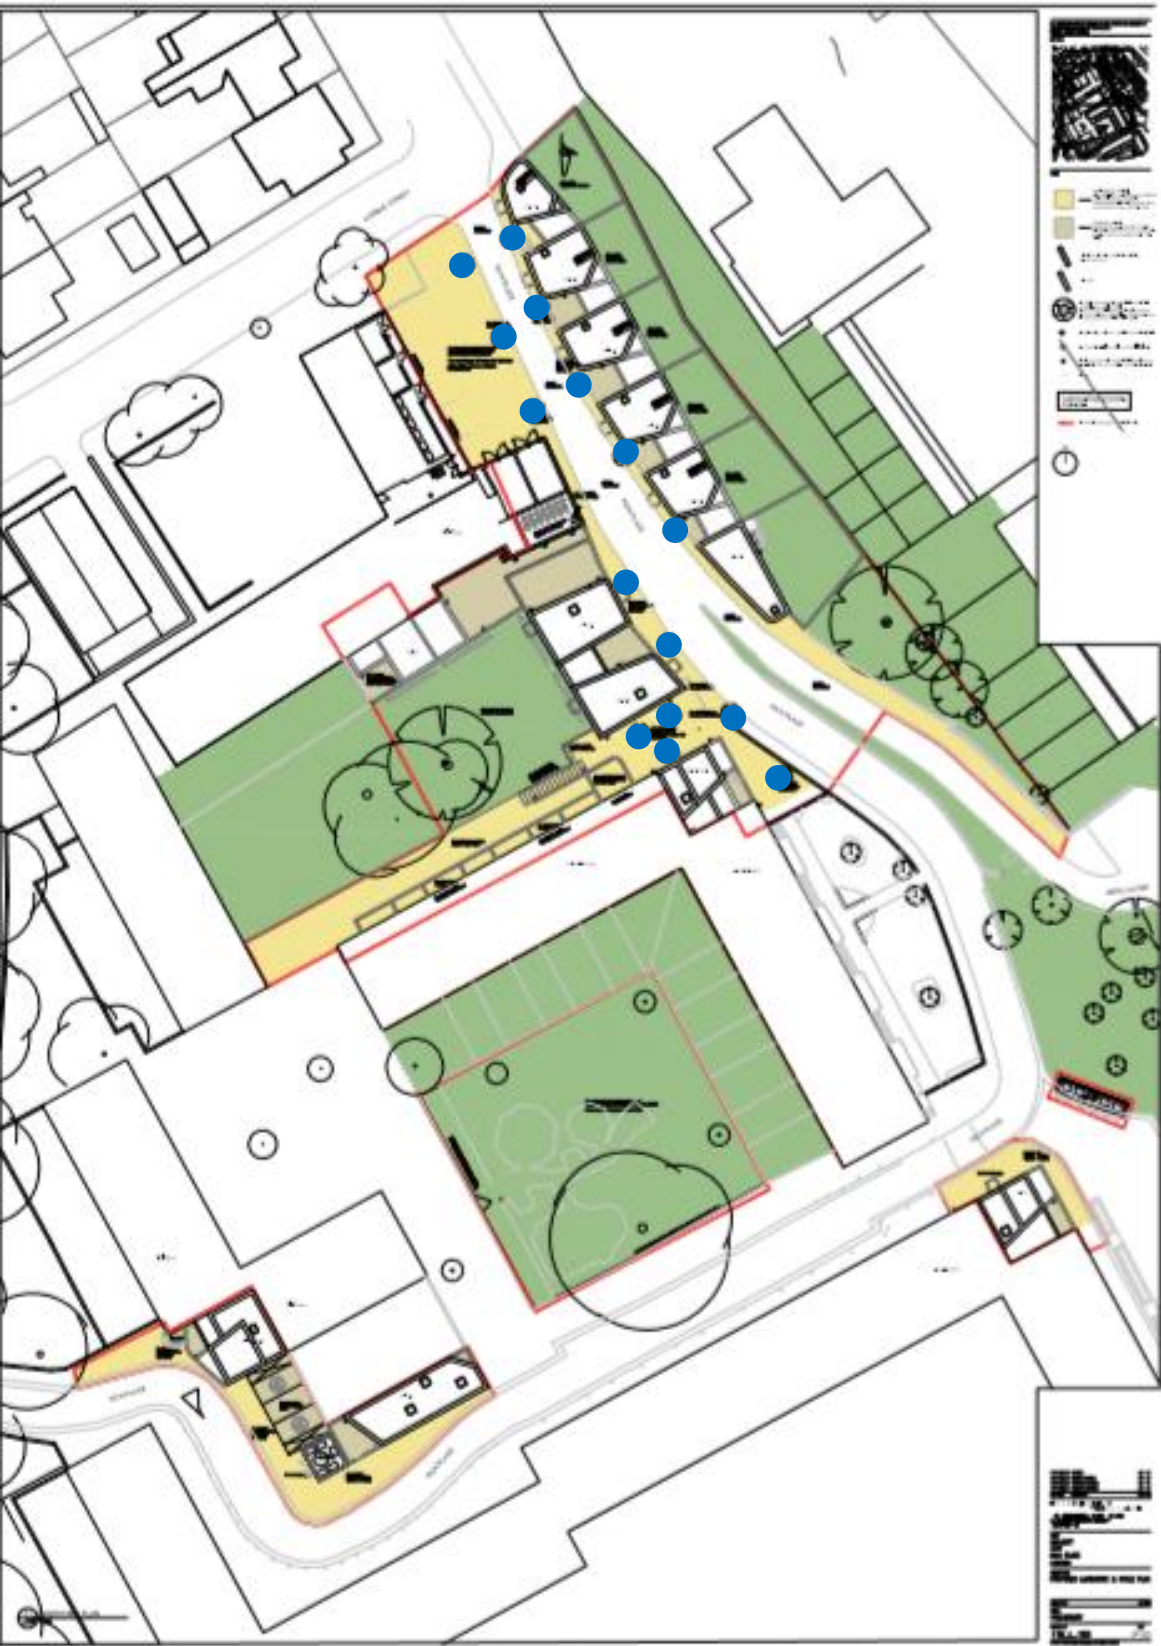
Figure 1 Approved Tree Planting Locations
Approved tree planting locations ●

- 2.4 A plan is included in this report showing the approved tree planting locations in relation to the new properties (please see figure 1).
- 2.5 The findings of this report are based on a visual assessment of the site and proposed tree locations only, no trial pits or excavations have been dug nor has any soil analysis been done. If required these further investigations will be recommended.

- 4.1 The extant planning permission (as amended) provides that 14 new trees are planted as part of the new construction scheme at Kiln Place, London.
- 4.2 The proposed locations for the trees are all adjacent to the new areas of construction and are currently to be located within non permeable hard standing.

- 4.9 As the newly planted trees will be within the street scene they will be at risk of impacts from vehicles and vandalism.
- 4.10 The approved current tree planting locations can be described as being unsuitable for trees to be planted and if undertaken will likely result in the loss and or the none establishment of any newly planted trees, unless suitable planting conditions are created.
