Project:
 9 Carlingford Road,
 Hampstead,
 London,
 NW3 1RY

Drawing:
 Arboricultural Impact Assessment

Drawing No:
 Arbtech AIA 01

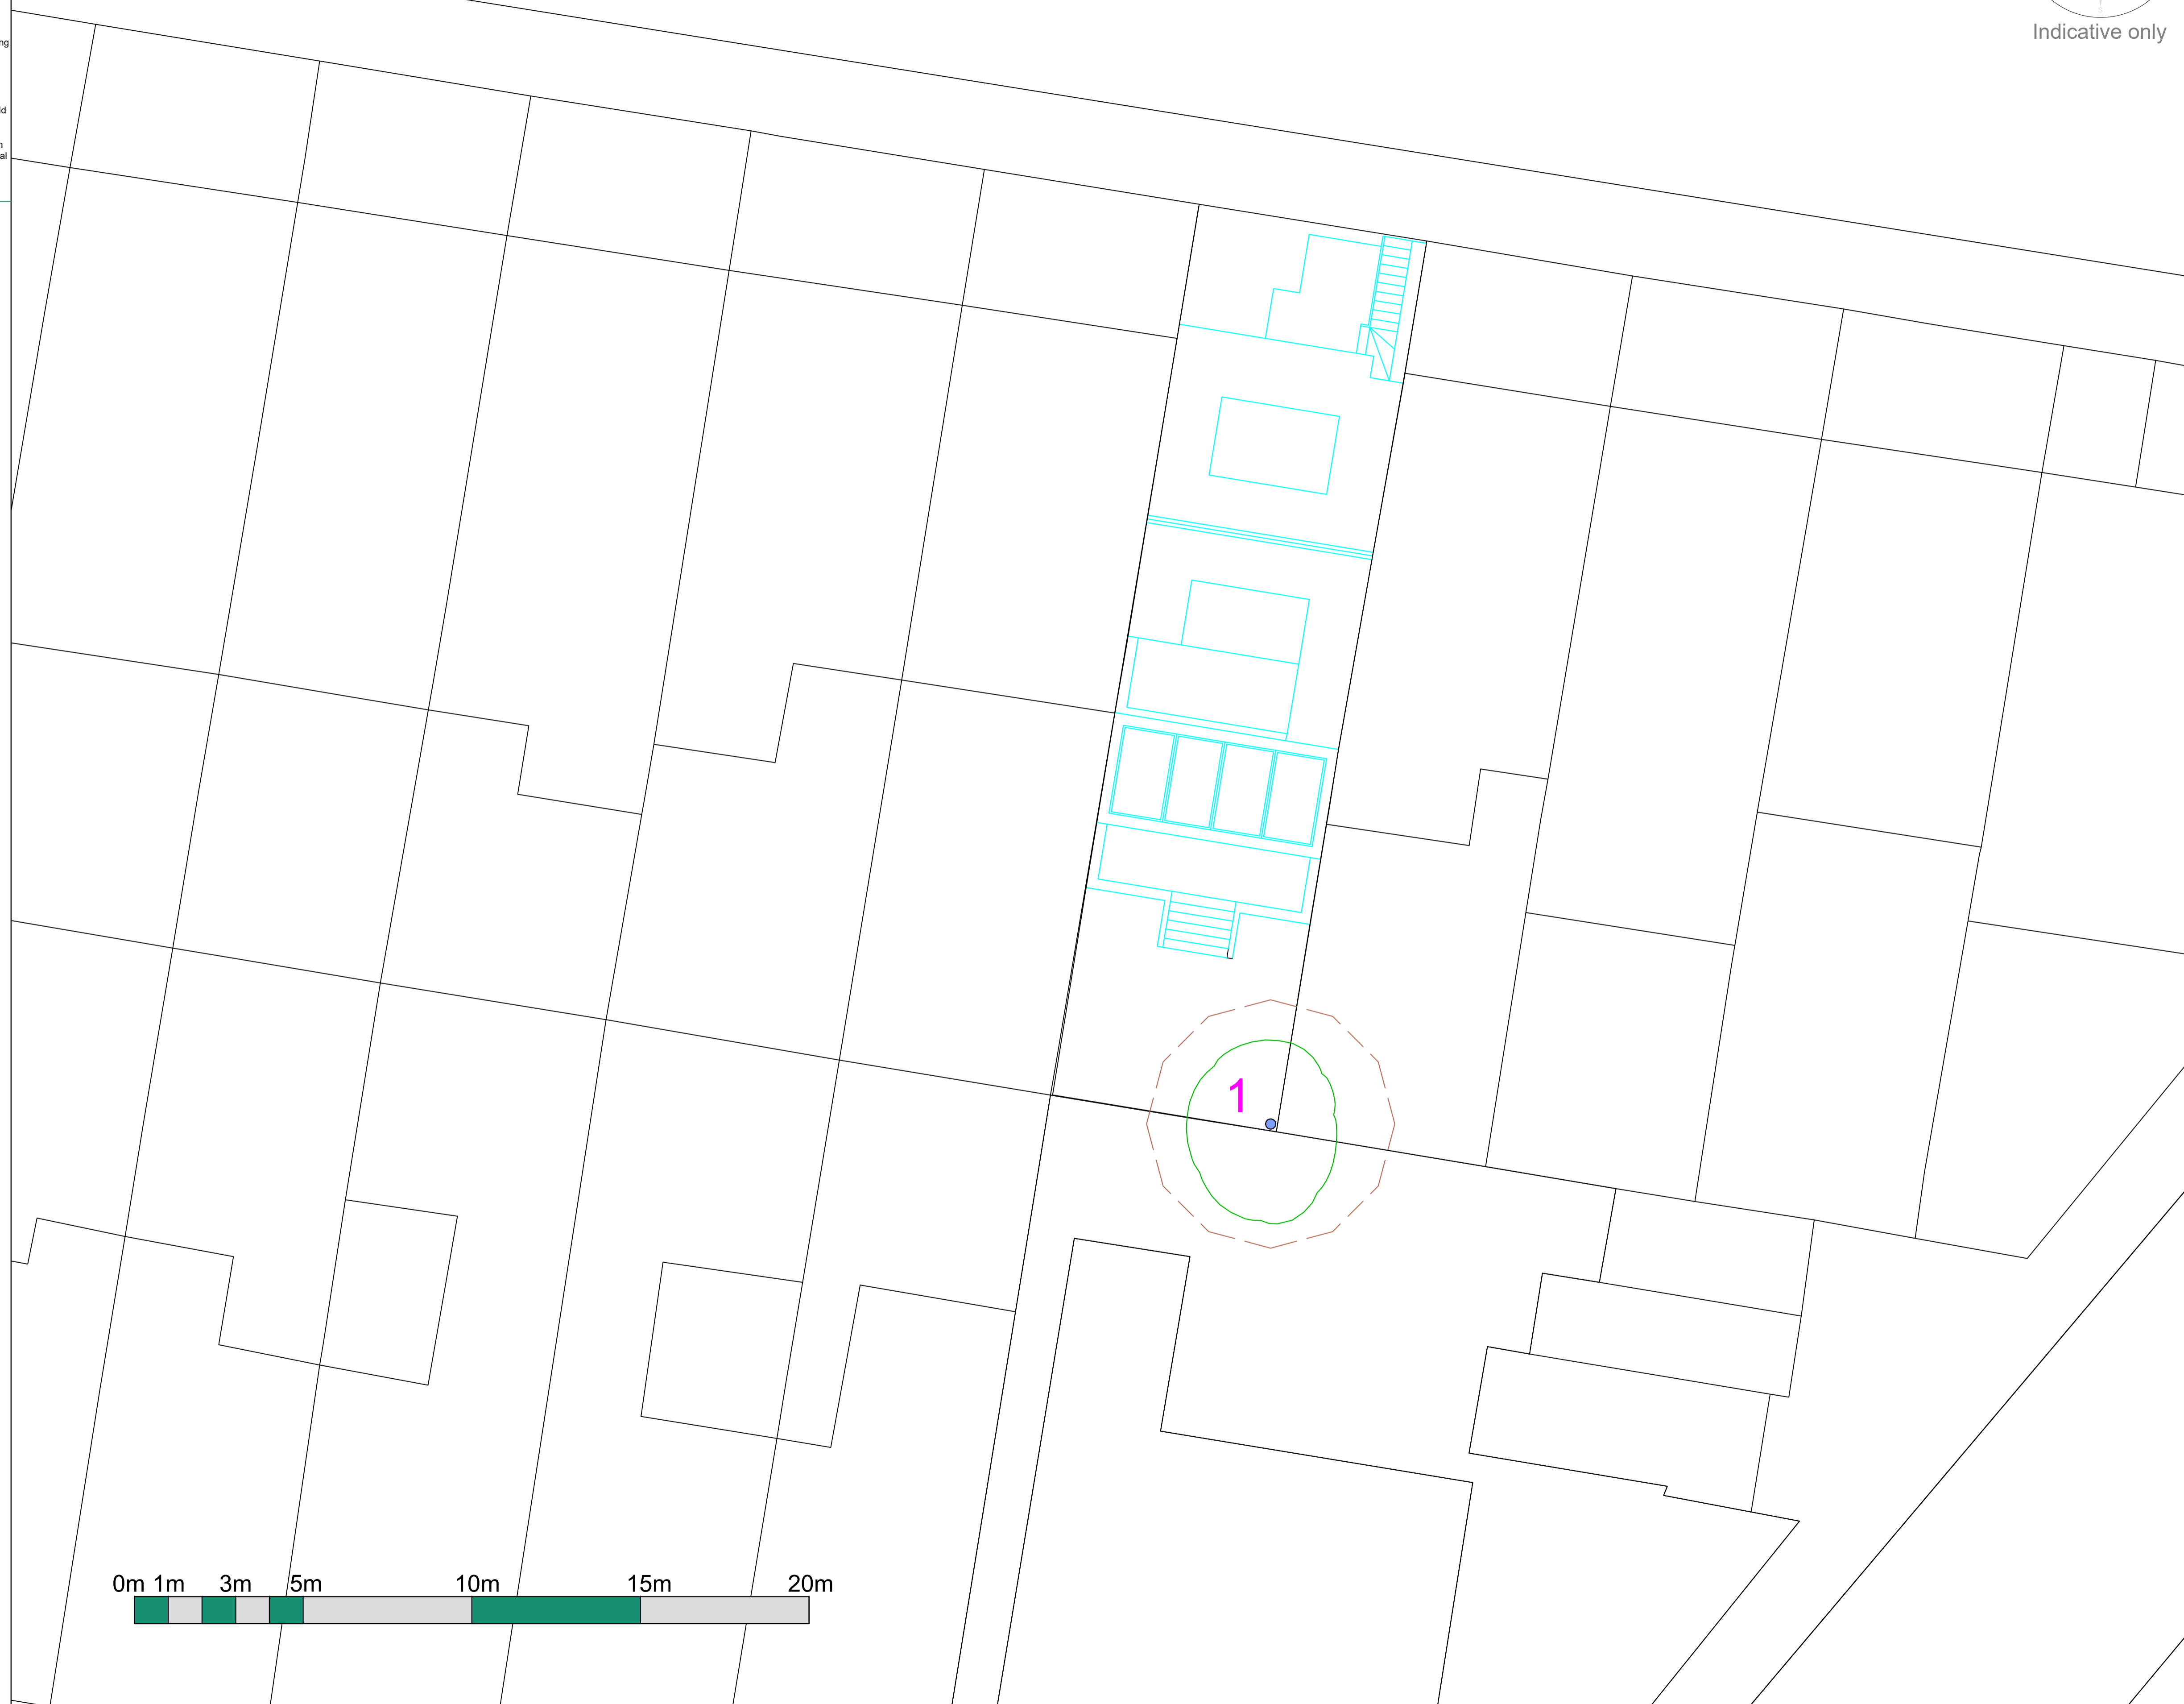
Based on:
 Proposed Site

Tree Nos.:	1	Tree Canopies:	(Green circle)	Trunks:	(Blue dot)
RPAs:	(Red dashed circle)	Category 'B' trees:	(Blue circle)	Proposed site:	(Cyan outline)

Impacts	Nos. of trees
Trees to be removed	0
Groups / Hedges to be removed (Partial removal of groups)	0 (0)
Trees with proposed incursions into RPAs	0
Groups / Hedges with proposed incursions into RPAs	0
Trees that will require pruning	0
Groups / Hedges that will require pruning	0
Trees to be transplanted	0
Groups / Hedges to be transplanted	0
