Subsidence
Monitoring
Services

Monitoring Plus Report

Owners name	Dr Grespi & Dr Rubitel	Suspected cause	To be advised	Monitoring type	Levels
Address	85 St Augustines Road, London NW1 9RR	Principal area of damage	To be advised	Installed	28/02/2019
		Damage category	To be advised	No of visits / weeks	tbc @ 8.7
		Surface geology	To be advised	Completion date	tbc
				Status	open
Home phone	[REDACTED]	Feedback from last visit			
Work phone	[REDACTED]	Ref point in pencil on skirting board; Pts 1 & 6 are rulers			
Correspondence address	[REDACTED]	Sketch showing location of monitoring points			
Comment	Max movement 8.6 Focal area [REDACTED] 0

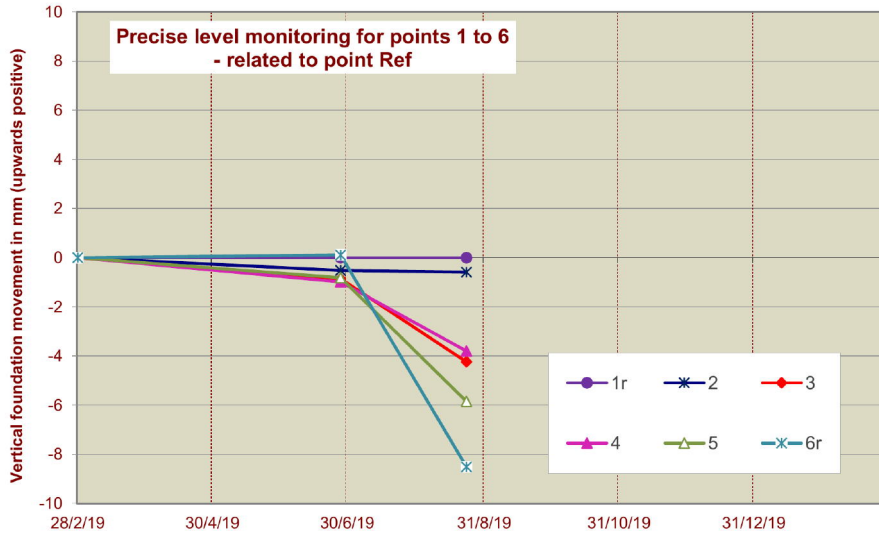
Level monitoring results

Survey:	1 SC		2 CV		3 PB		4		5	
By:										
Date:	28/02/2019		27/06/2019		23/08/2019					
Point ID	levels mm	<i>chngs</i> <i>mm</i>	levels mm	<i>chngs</i> <i>mm</i>	levels mm	<i>chngs</i> <i>mm</i>	levels mm	<i>chngs</i> <i>mm</i>	levels mm	<i>chngs</i> <i>mm</i>
ref	266.32	0.0	265.82	-0.5	n/a					
1r	1000.00	0.0	1000.00	0.0	1000.00	0.0	1000.00	0.0	1000.00	0.0
2	370.32	0.0	369.80	-0.5	369.73	-0.6				
3	345.87	0.0	345.01	-0.9	341.63	-4.2				
4	341.61	0.0	340.62	-1.0	337.81	-3.8				
5	332.36	0.0	331.54	-0.8	326.51	-5.8				
6r	977.19	0.0	977.30	0.1	968.68	-8.5				
closing error (mm)	0.00		0.00		-0.10		0.00		0.00
