Geo-Serv Limited

Issue date: 18/10/2019

following survey No: 5

### Monitoring Plus Report

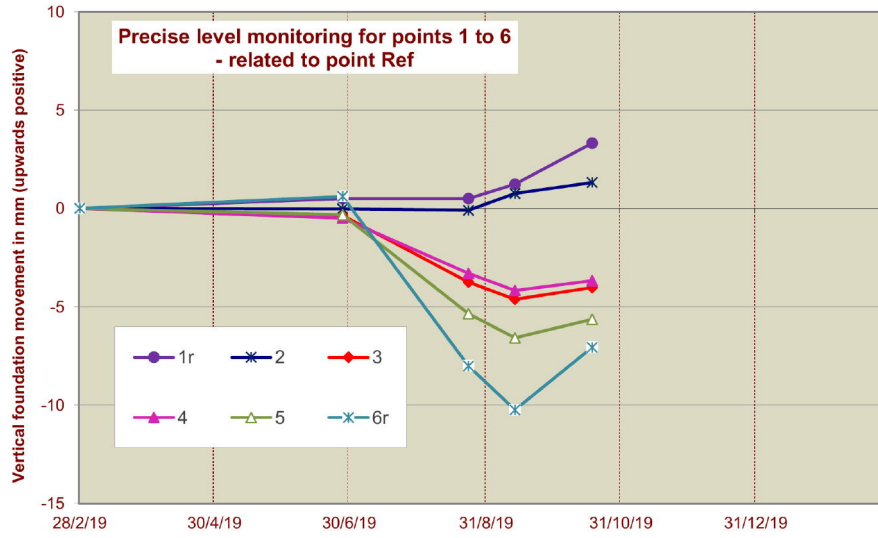
Owners name	[redacted]	Suspected cause	To be advised	Monitoring type	Levels
Address	[redacted]	Principal area of damage	To be advised	Installed	28/02/2019
Home phone	[redacted]	Damage category	To be advised	No of visits / weeks	tbc @ 8.7
Work phone	[redacted]	Surface geology	To be advised	Completion date	tbc
Correspondence address	[redacted]	Feedback from last visit	0		
Comment	Max movement 10.9 Focal area [redacted] 0	Sketch showing location of monitoring points
