Geo-Serv Limited

Issue date: 22/08/2019

Monitoring Plus Report

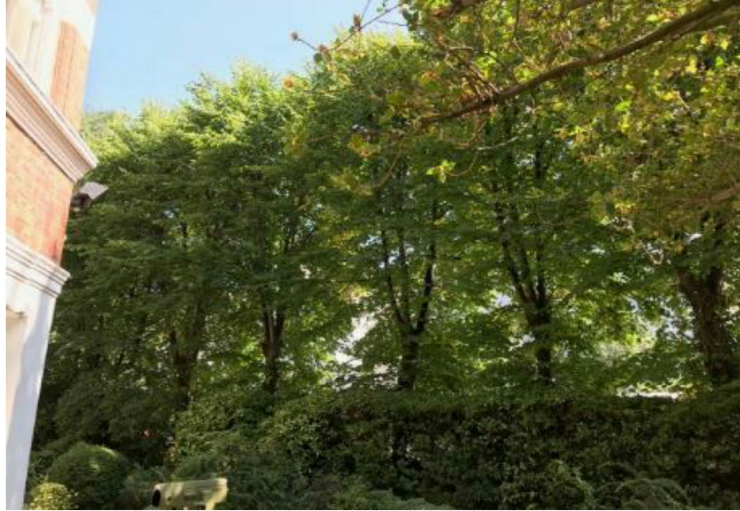
Owners name		Suspected cause	To be advised	Monitoring type	Levels
Address	Flats 11-19 Manor Mansions Belsize Grove London NW3 4NB	Principal area of damage	To be advised	Installed	11/03/2019
Home phone		Damage category	To be advised	No of visits / weeks	7 @ 8.7
Work phone		Surface geology	To be advised	Completion date	Mar-20
Correspondence address		Feedback from last visit		Status	open
Comment		Sketch showing location of monitoring points			
Max movement	2.1	<p style="text-align: center;">FRONT ELEVATION</p>			
Focal area	0

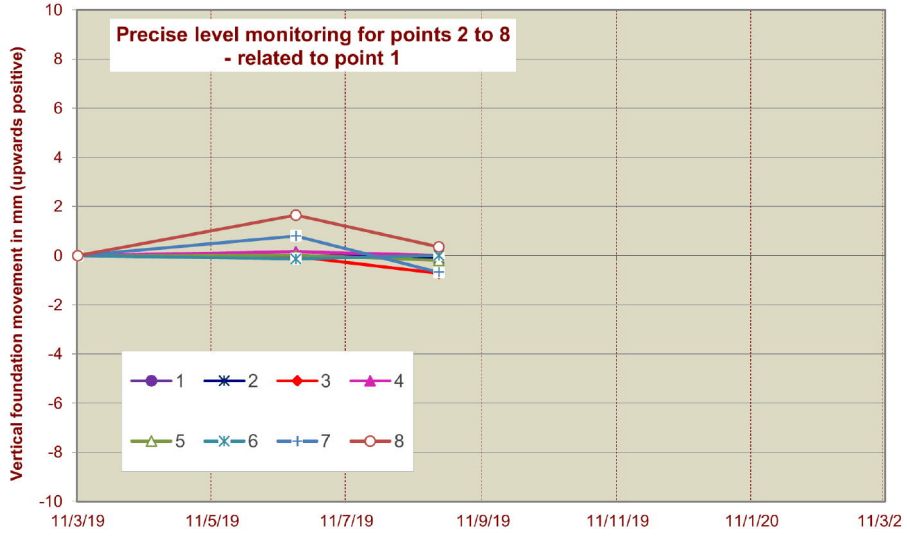
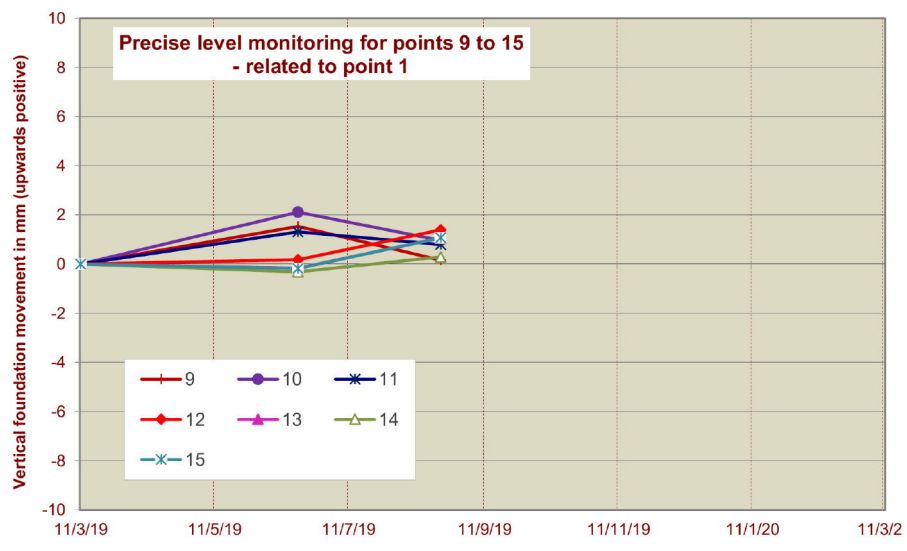
Level monitoring results

Survey:	1		2		3		4		5	
By:	CV		CV		CV					
Date:	11/03/2019		18/06/2019		22/08/2019					
Point ID	levels mm	chngs mm	levels mm	chngs mm	levels mm	chngs mm	levels mm	chngs mm	levels mm	chngs mm
1	1000.00	0.0	1000.00	0.0	1000.00	0.0	1000.00	0.0	1000.00	0.0
2	982.89	0.0	982.90	0.0	982.78	-0.1				
3	979.16	0.0	979.13	0.0	978.44	-0.7				
4	970.87	0.0	971.03	0.2	970.88	0.0				
5	968.46	0.0	968.48	0.0	968.27	-0.2				
6	992.18	0.0	992.05	-0.1	992.19	0.0				
7	1015.88	0.0	1016.68	0.8	1015.20	-0.7				
8	1034.85	0.0	1036.50	1.7	1035.20	0.3				
9	1042.66	0.0	1044.19	1.5	1042.82	0.2				
10	1007.16	0.0	1009.27	2.1	1008.12	1.0				
11	1103.69	0.0	1105.00	1.3	1104.48	0.8				
12	1121.72	0.0	1121.90	0.2	1123.11	1.4				
13	1140.51	0.0	1140.34	-0.2	1141.57	1.1				
14	1147.38	0.0	1147.06	-0.3	1147.67	0.3				
15	1155.46	0.0	1155.28	-0.2	1156.53	1.1				
closing error (mm)	0.13		-0.12		-0.09		0.00		0.00
