Camden Geological, Hydrogeological
and Hydrological Study
Watercourses

213923

**Camden Geological, Hydrogeological
and Hydrological Study**

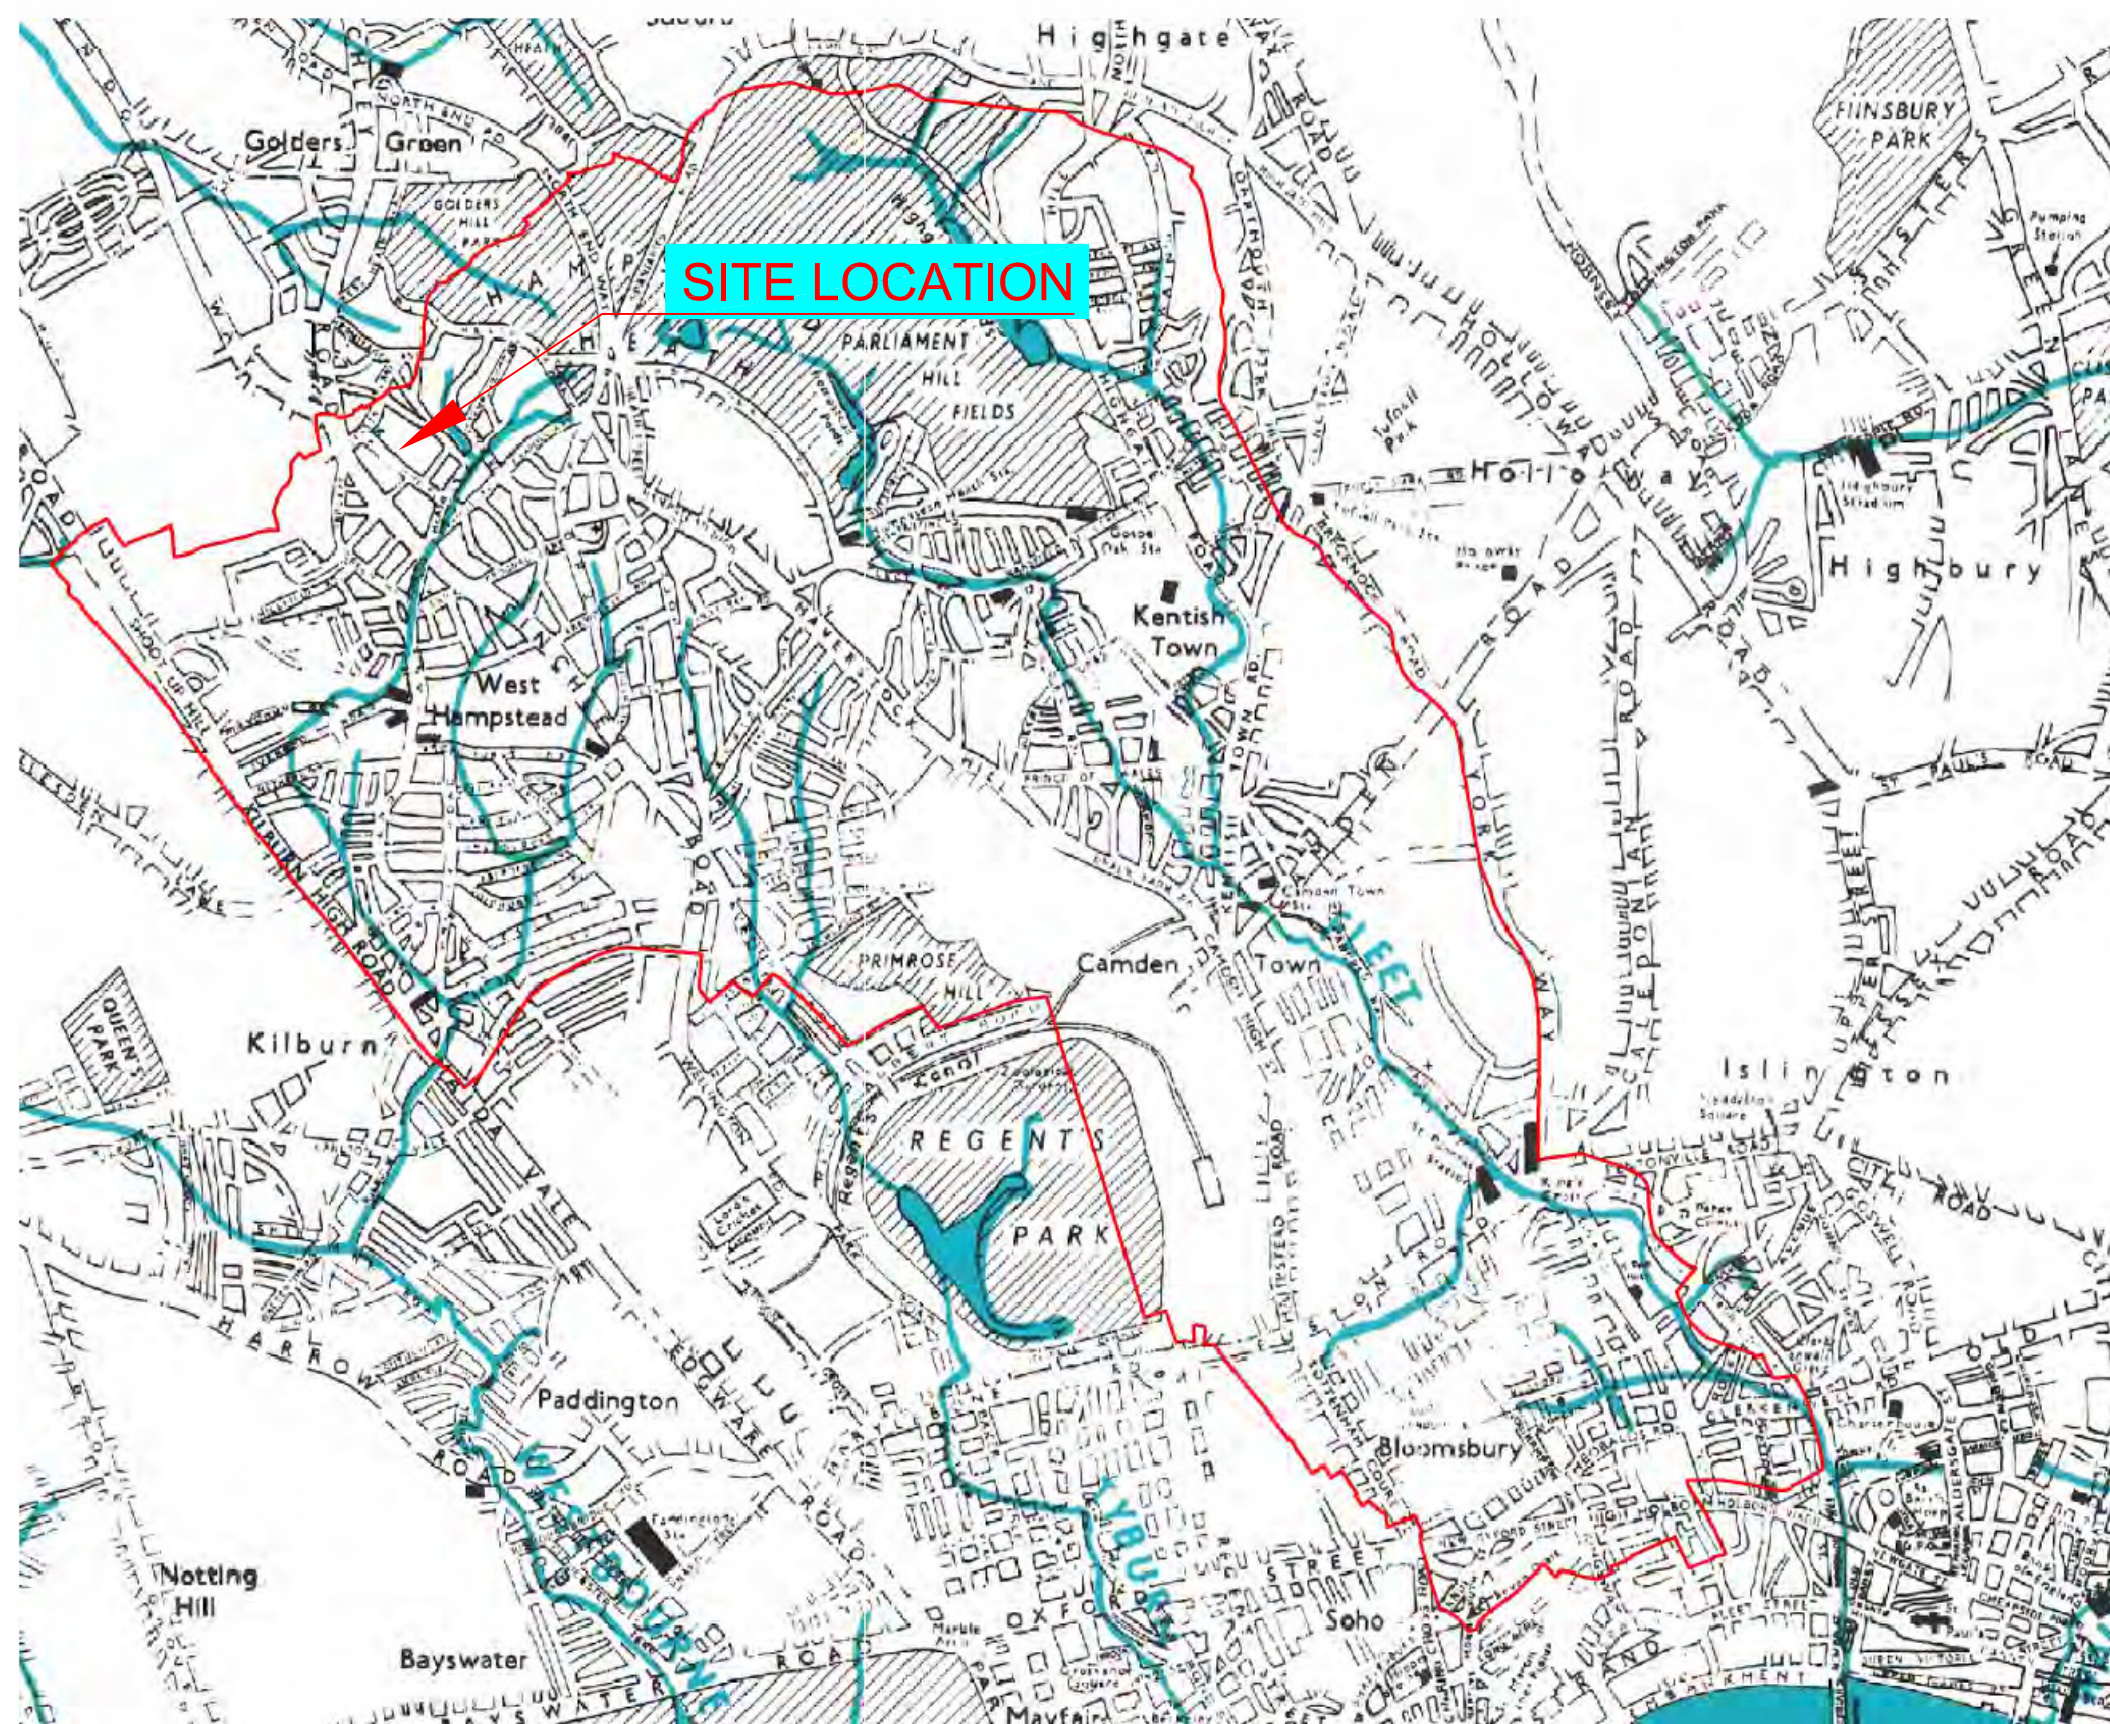
FIGURE 11

Source – Barton, Lost Rivers of London
